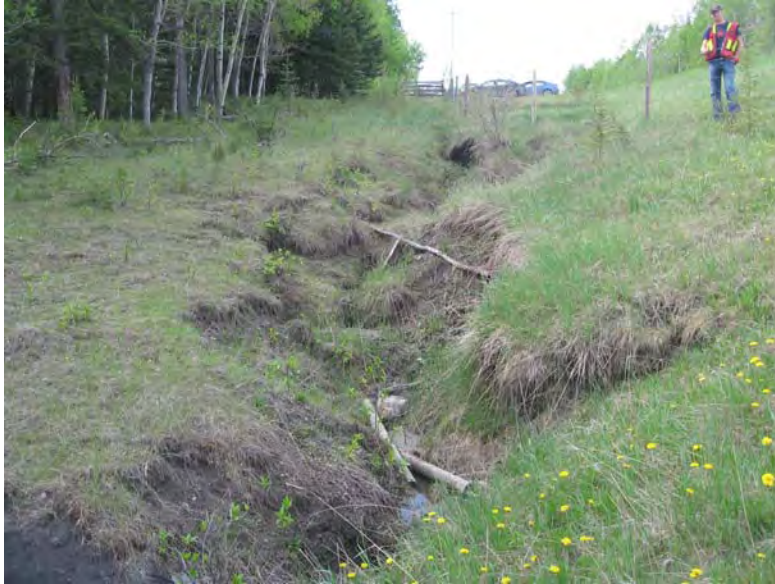
**Photo S10(C)-5 (top) – June 2009**  
Facing southbound along the east road  
ditch, immediately south of the culvert  
outlet.
