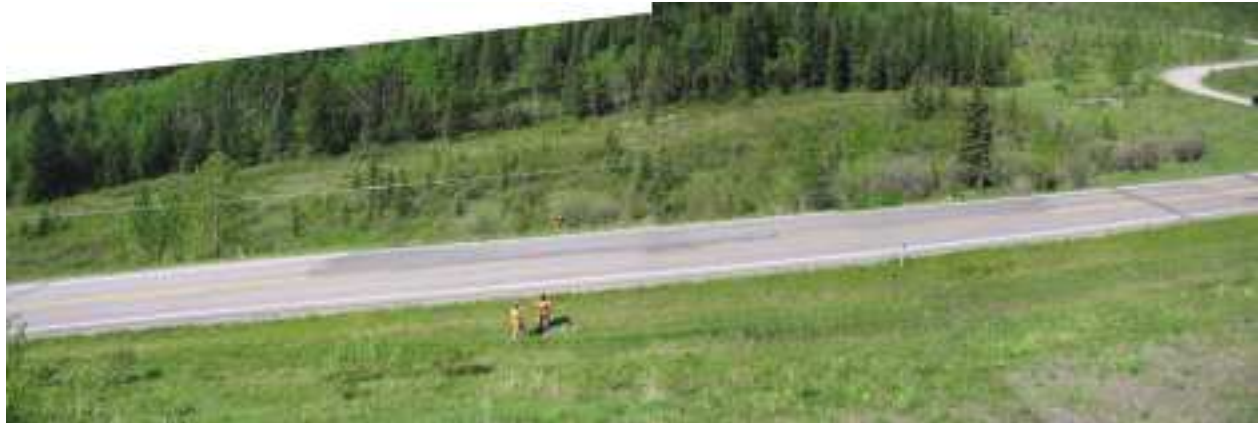
Photo S31-1 (top) – June 2008

Facing downslope/towards the west from near the backslope crest above the damaged segment of the highway. The extent of the overlays on the southbound lane are visible. The person on the far side of the highway is standing near the visible culvert outlet on the slope below the road.
