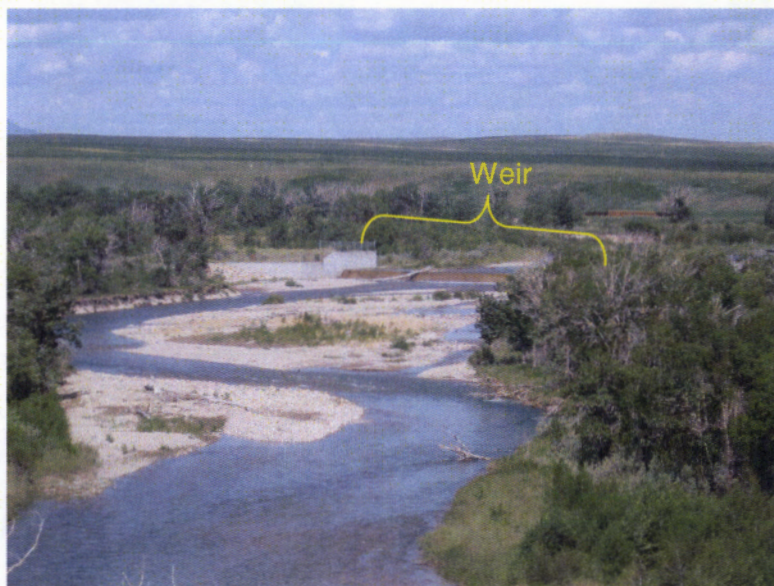
Photo 6 (bottom) – View upstream from the site towards the weir and canal headworks (approximately 500 m upstream from the site).
