Client	<b>Alberta Transportation</b>		<b>Figure 1</b>	
Project	<b>Southern Region Geohazard Assessment</b> <b>S38 - Hwy 22:08 - Callum Creek - Site Plan and Instrumentation Detail</b>		Date:	Revision
			<b>Sep-11</b>	
			Job No.	<b>CG25352.200</b>
			Figure 1.xls

**From:** Clay, Tyler  
**Sent:** Monday, July 18, 2011 5:31 PM  
**To:** Ross Dickson  
**Cc:** Bidwell, Andrew; Bale, Bryan  
**Subject:** S38 - Callum Creek, Hwy 22 Site Conditions (July 2011)  
**Attachments:** July2011\_CallumCk\_Figures.pdf

This email is intended to serve as a summary of the recent instrument data and observations from the July 14, 2011 visit to the S38 - Callum Creek site on Highway 22.

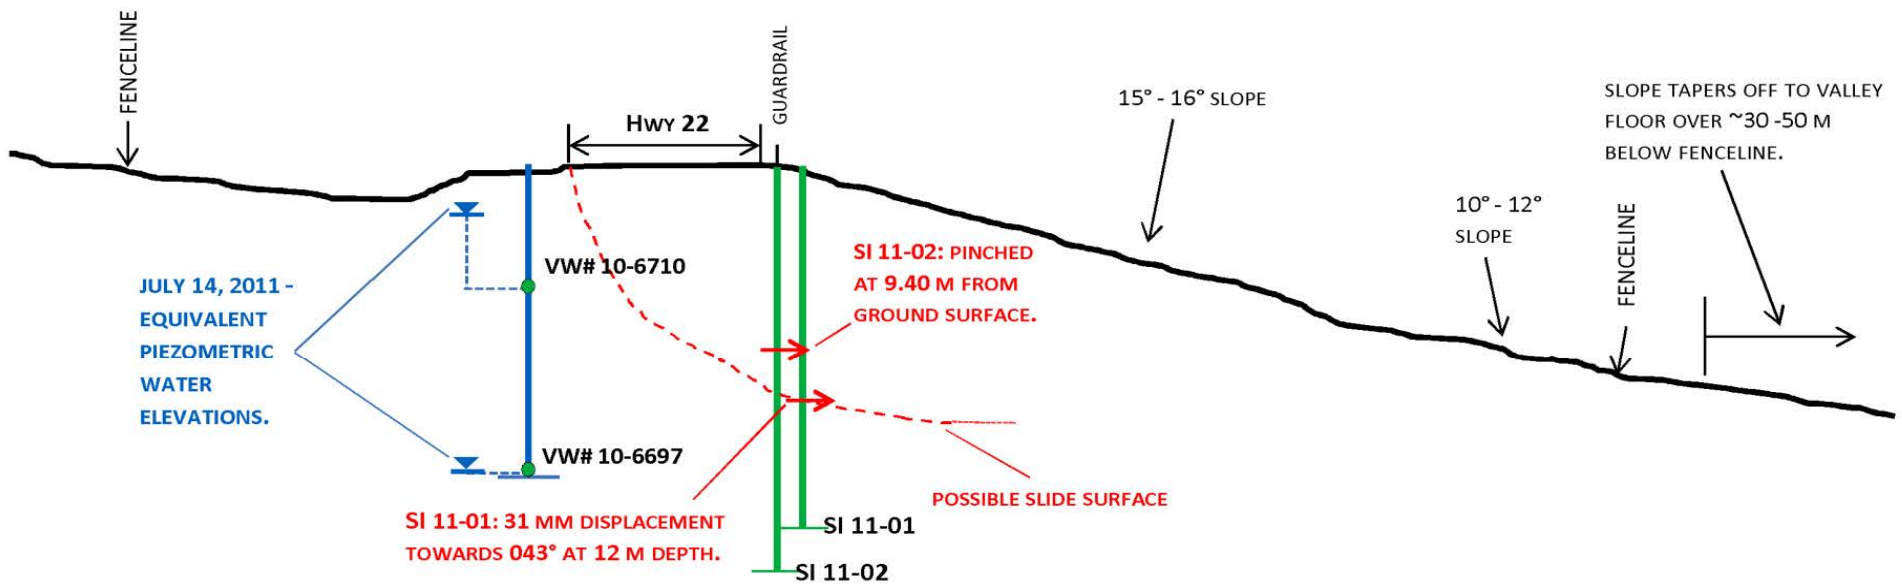
Client	Alberta Transportation		Figure 2	
Project	Southern Region Geohazard Assessment		Date:	Revision
	S38 - Hwy 22:08 Callum Creek		Sep-11	
	Cross-Section		Job No.	
			CG25352.200	
			File No.:	
			Figure 2.xls

**Note:** Approximate cross-section, not surveyed.

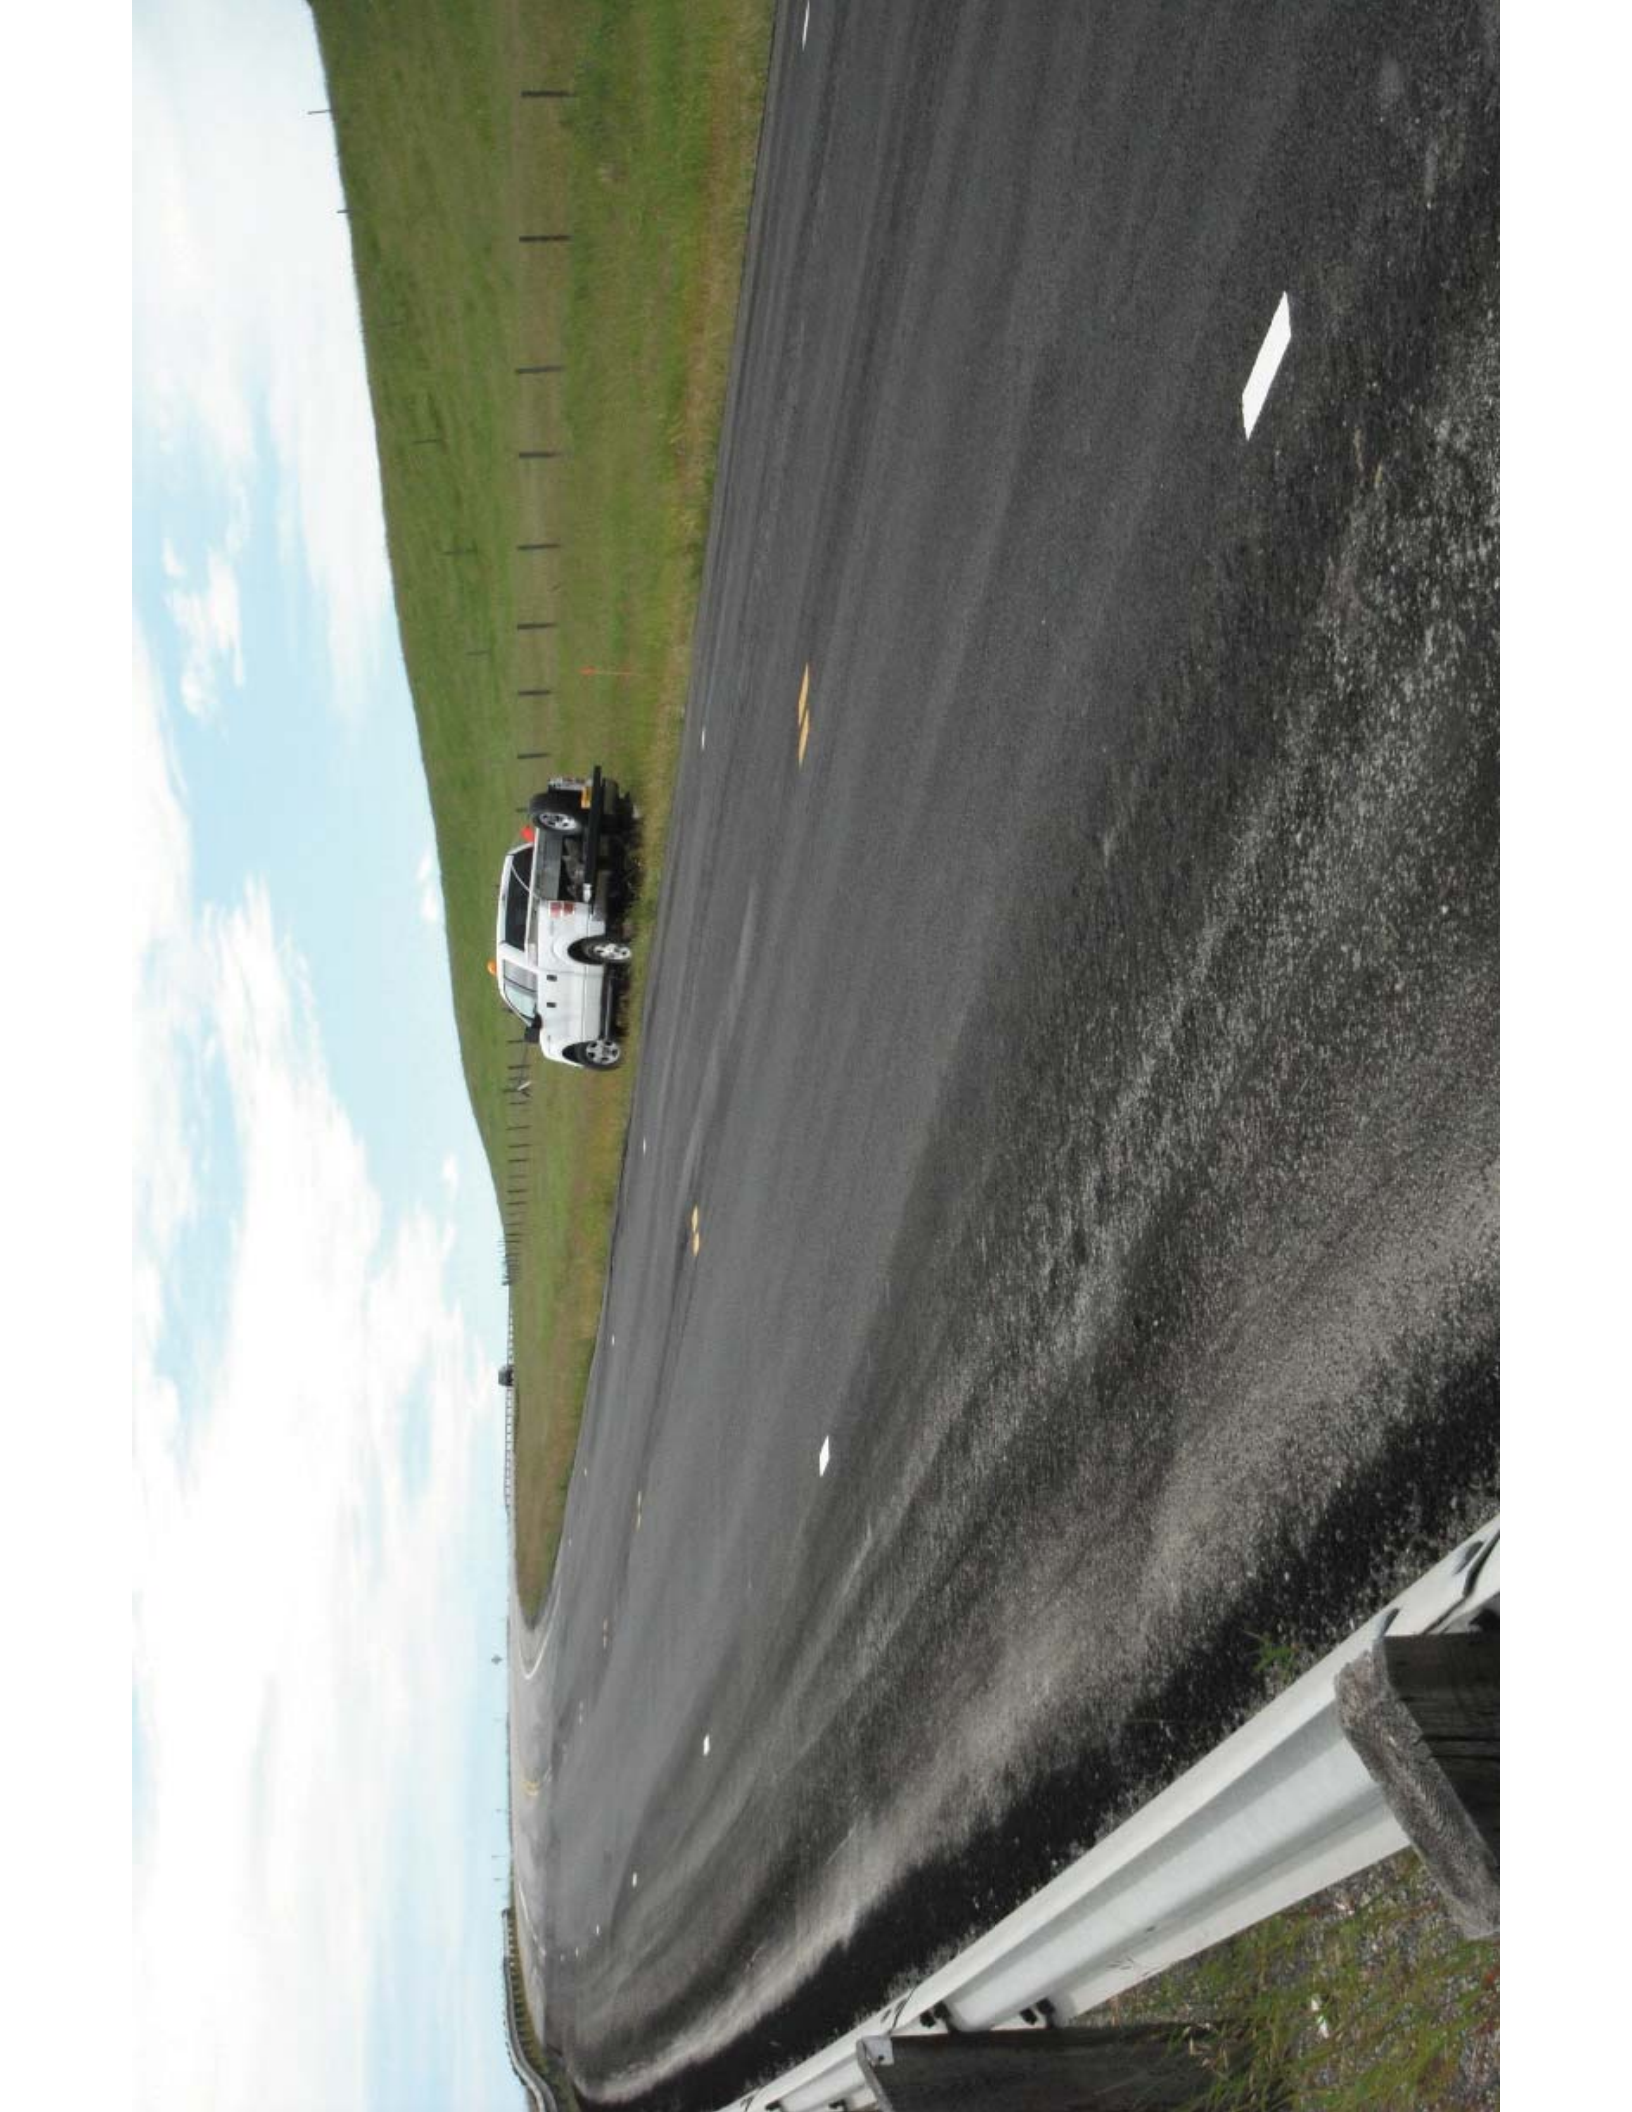
The highway appeared to have a recent overlay patch (within the last month or so) along the section where settlement and cracking had been previously observed (approximately 70 – 100 m length). There were some fresh cracks through the new overlay on the west side of the highway shoulder, approximately 20 m in length with aperture less than 50 mm (see attached photos). There was also roughly 10 mm or less of settlement of a portion of the road within the overlay area (see attached photos). The shape and position of the settled area was consistent with past observations of arc-shaped cracks and settlement. There was also some cracking visible on the east side of the road near SI 11-02 for approximately 10 -15 m and with an aperture less than 20 mm.

Visible edge of settlement  
through overlay

- Continue placing overlays and/or milling down and resurfacing the asphalt to maintain a trafficable surface through the slide area but without accumulating an excessive load from repeated overlays (i.e. loading the upper portion of the landslide area).
- Maintain signage (e.g. "Bump Ahead") along with reduced speed limit as appropriate for the road surface conditions.
- There is a possibility that additional or accelerated landslide movement could lead to the loss of one of both lanes of the highway and the construction of a temporary detour lane in the upslope road ditch may be required.

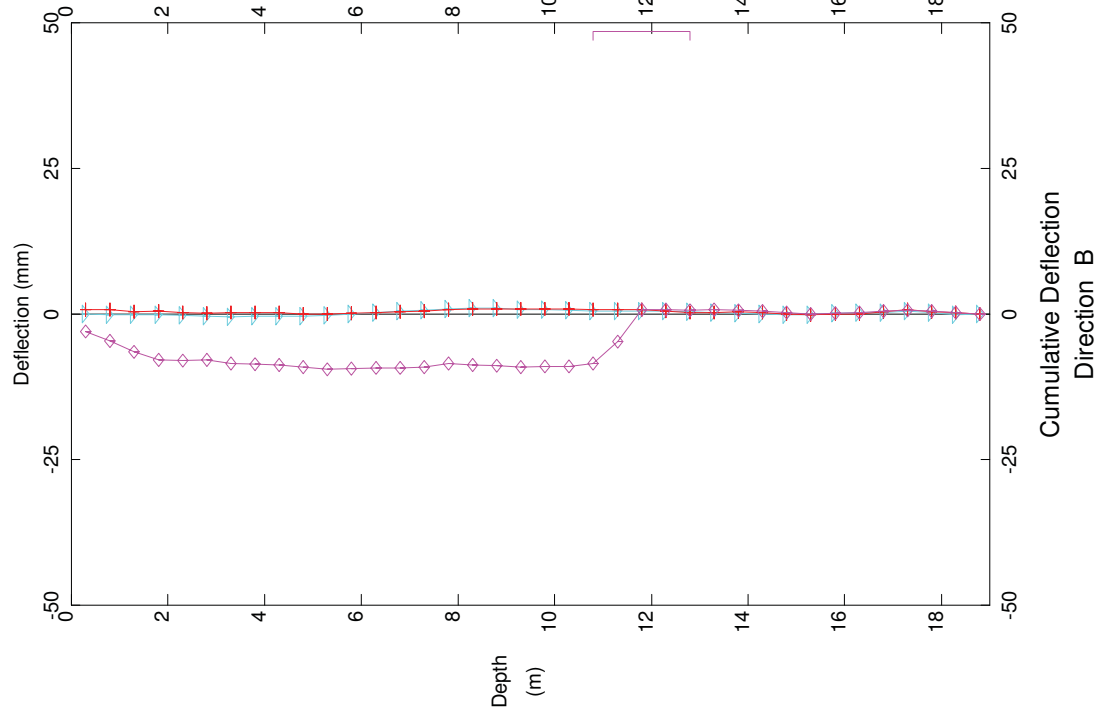
Figure S38-3

S38 - Callum Creek, Inclinator SI 11-01  
Alberta Transportation

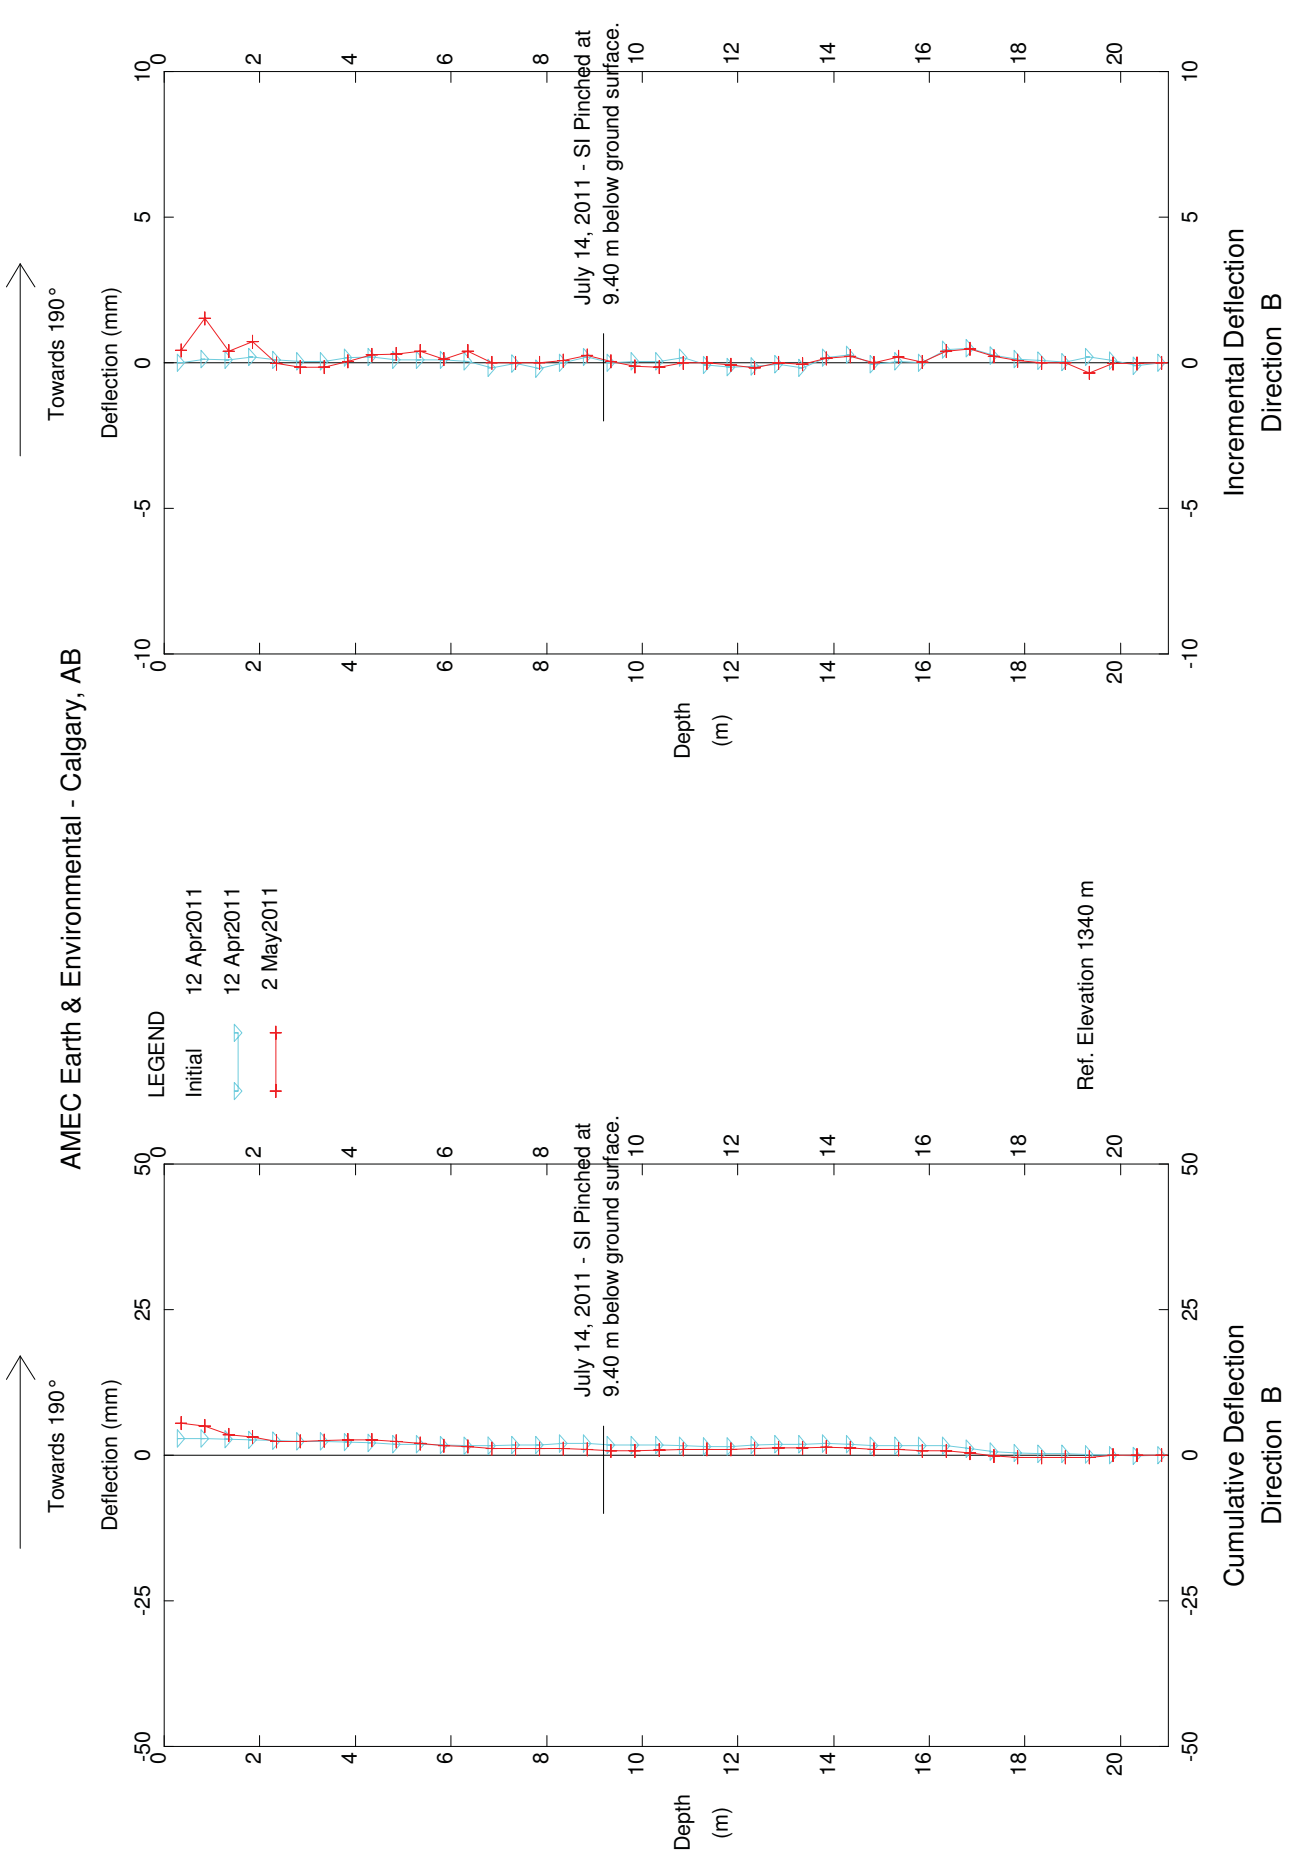
Figure S38-5

- **SI 11-02:** Since the April 12, 2011 initialization this SI has been twice (May 2<sup>nd</sup>, July 14<sup>th</sup>). Prior to the July 14<sup>th</sup> readings there were no confirmed movement zones. On July 14<sup>th</sup>, this SI was found to be pinched off at approximately 9.40 m below ground surface.

Callum Creek, Inclinator 11-02  
Alberta Transportation

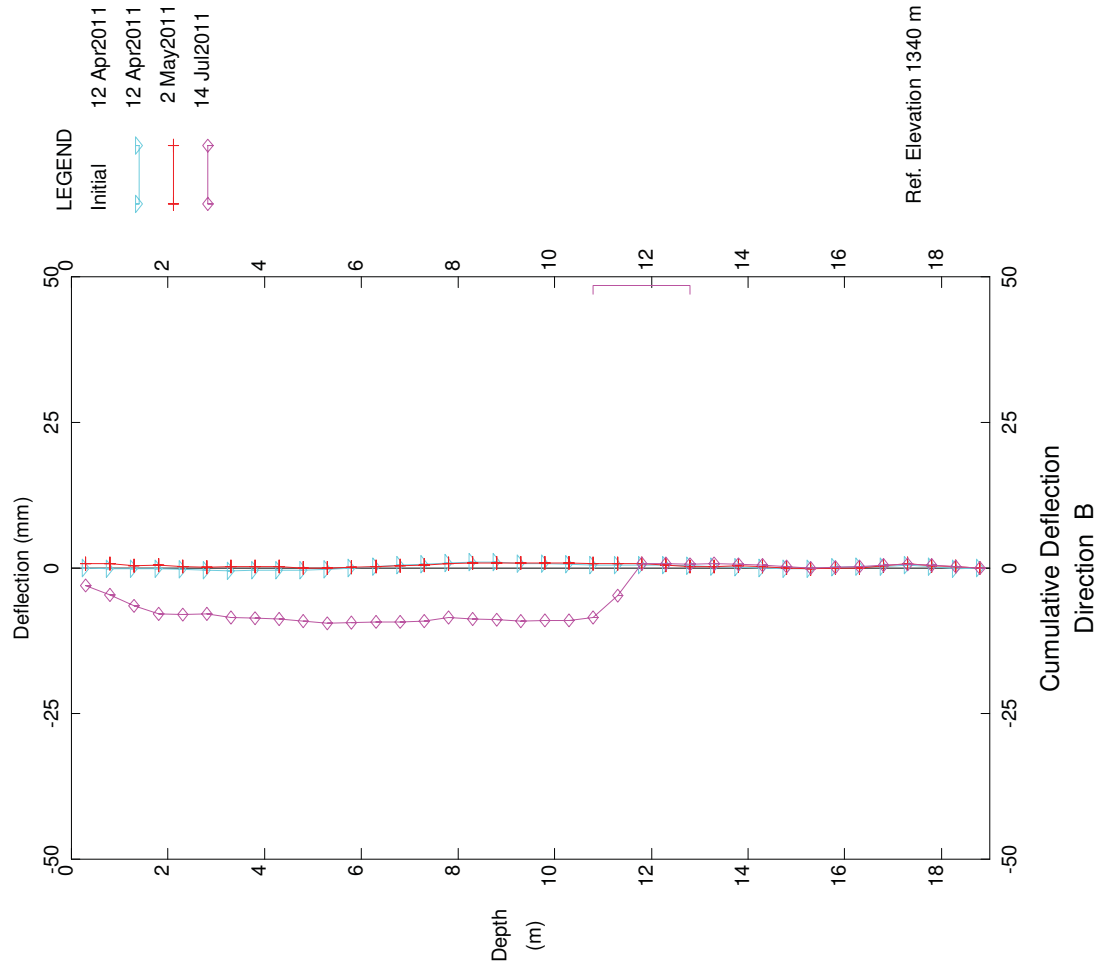
Figure S38-3

S38 - Callum Creek, Inclinator SI 11-01  
Alberta Transportation
