### S5 Chin Coulee

Alberta Transportation/S. Region Landslide Monitoring Program

Site S5 - Chin Coulee

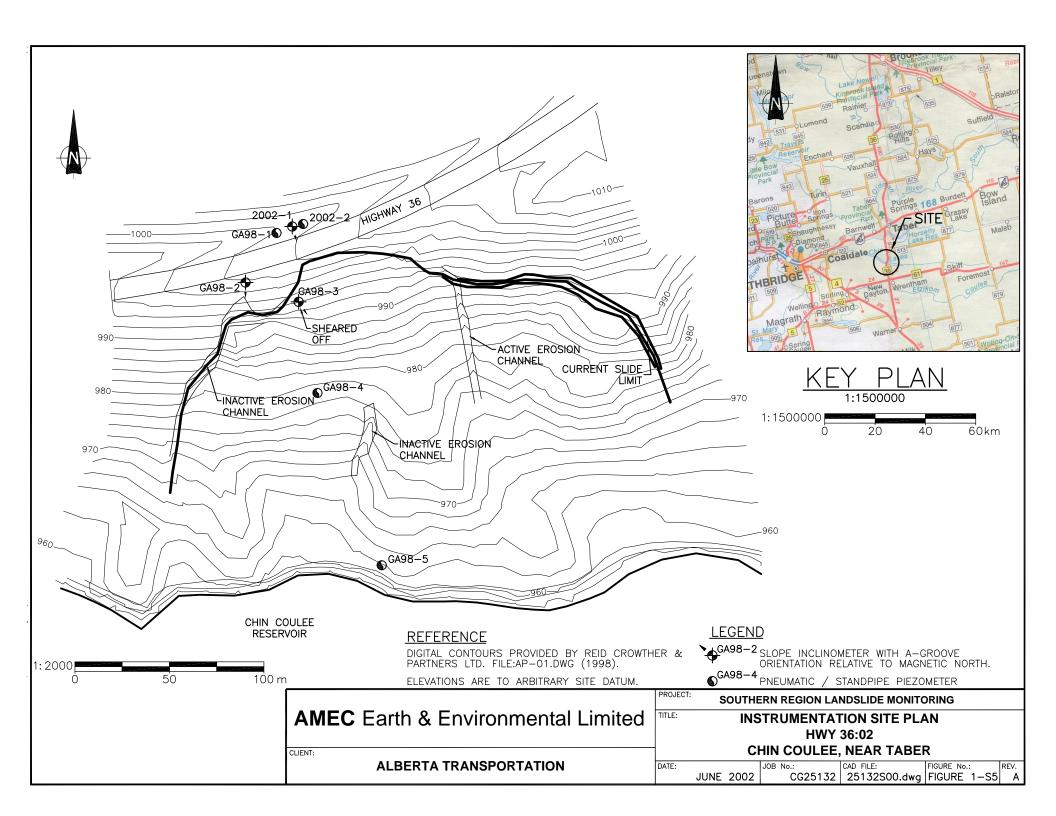
- The scarp area of the slide was directly adjacent to the north shoulder of the road (Photos 1 and 2). No fresh cracking was noted in the road surface.
- No significant new distortion of the guardrail was noted.
- Previously identified slide blocks below the road showed evidence of recent movements.
- Exposed soils in the shallow slide area downslope of the road showed signs of gullying and piping along the tension cracks of some of the shallow slide blocks (Photo 3).

No significant changes were noted since the previous inspection. There is continued shallow landslide movement immediately downslope of the road. The potential for additional deep-seated movement encompassing the road is still present, but no movements have been noted since the previous inspection.

The erosion of exposed soils in the shallow landsliding area, in particular the gullying and piping along tension cracks, was generally worse than during previous inspections.

Maintenance personnel should carefully monitor the surface condition of the road as well as the guardrail alignment. This would be in conjunction with slope indicator and piezometer monitoring to provide as early detection of potential problems below the road as possible.
