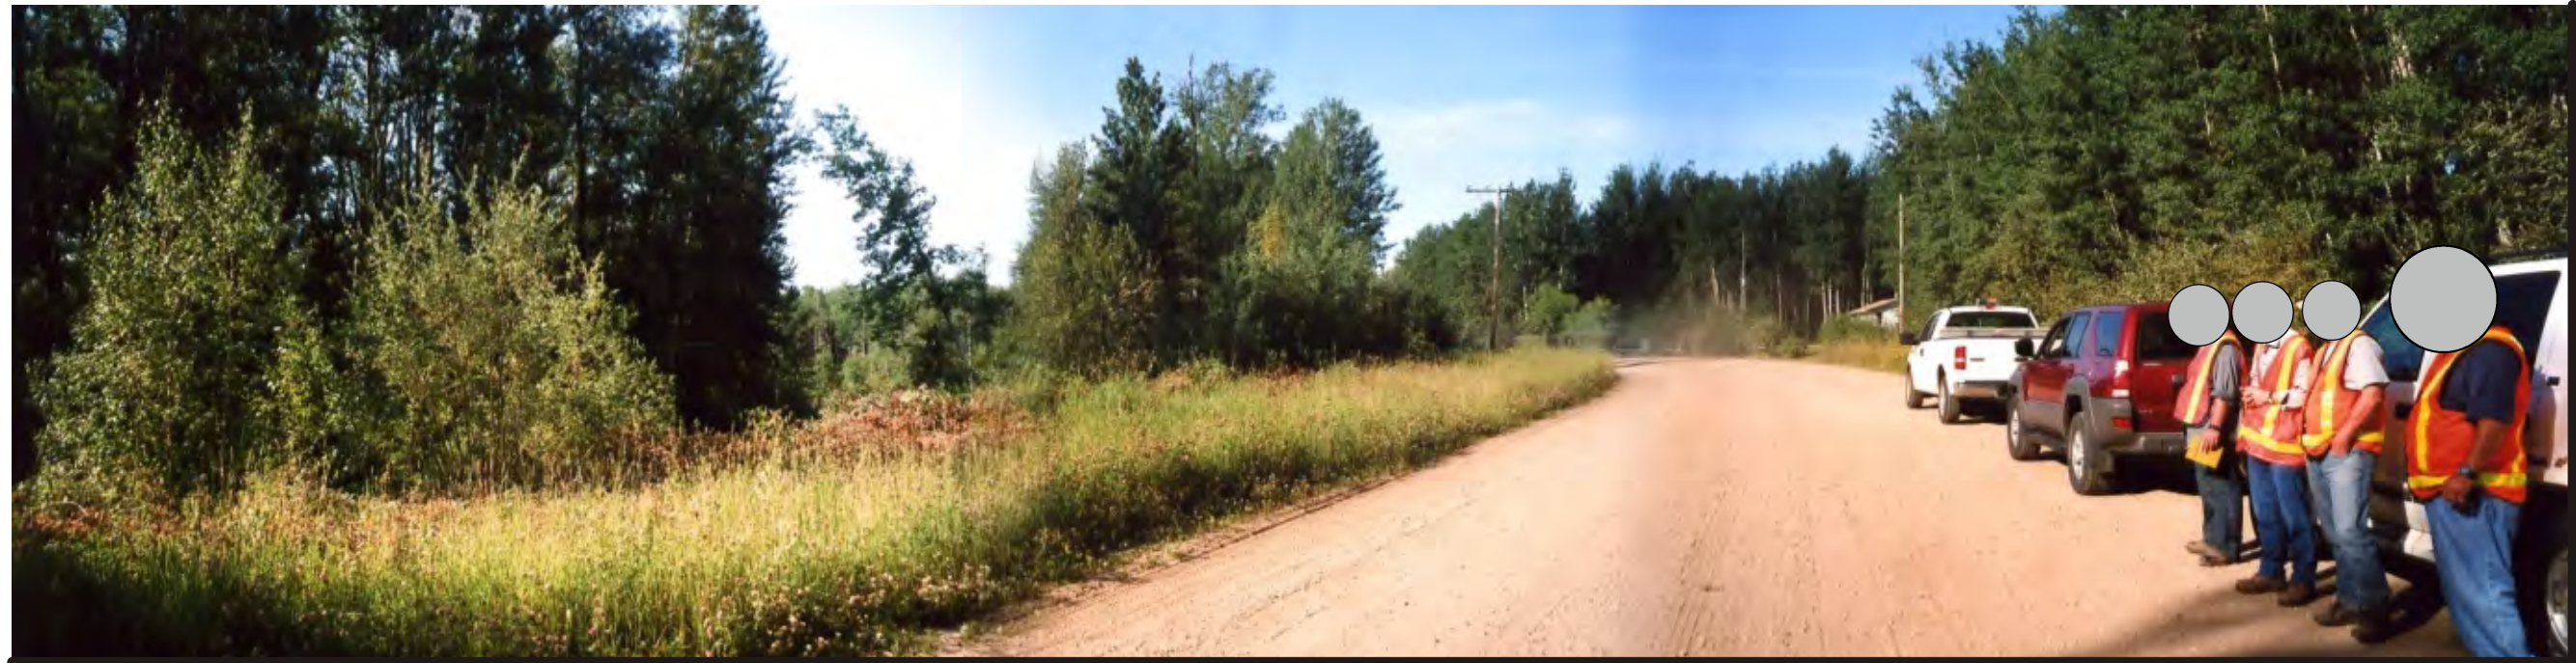
Photo 1

**Looking south away from Hwy 2:50 junction**

- Drift Pile River running north (on left of photo) (on east side) beside local road
- On left (east) side, top of eroded bank at about 7m setback to edge of local road
- On right (west) side, edge of local road is offset about 14m from a dugout pond
