**GEOHAZARD ASSESSMENT PROGRAM**  
**NORTH CENTRAL REGION – ATHABASCA**  
**2020 CALL OUT INSPECTION**

| Site Number | Location | Name | Hwy | km |
|---|---|---|---|---|
| NC XX | 35 km Northwest of the Junction of Hwy 2:46 and Hwy 44:04 | <b>Hwy 2:46 Bridge File 79193 North Embankment Landslide</b> | 2:46 | 38.77 |

| | Date | PF | CF | Total |
|---|---|---|---|---|
| Current Inspection: | June 19, 2020 | 13 | 5 | 65 |

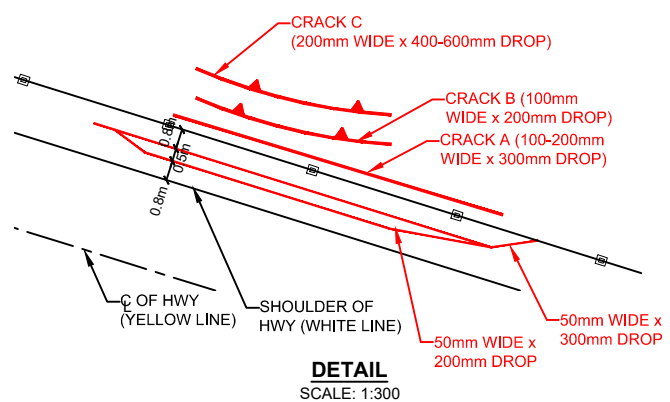
**FIGURE 1**

**NORTH CENTRAL REGION (ATHABASCA AREA)**  
**2020 GEOHAZARD ASSESSMENT**  
**HWY 2:46 km 38.77**  
**BRIDGE FILE NO. 79193**  
**NORTH EMBANKMENT LANDSLIDE**  
**JUNE 19, 2020 CALLOUT PLAN**
