ALBERTA TRANSPORTATION AND  
ECONOMIC CORRIDORS GRMP  
NORTH CENTRAL (ATHABASCA AND FORT  
McMURRAY DISTRICTS)  
INSTRUMENTATION MONITORING - SPRING 2025

| Site Number | Location | Name | Hwy | km |
| NC103<br>(NC024-3) | HWY 41:23 C1 7.89 | Kehiwin Lake | 41:23 | km 7.8 |

| <b>Current Monitoring:</b> | 24-May-2025 | <b>Previous Monitoring</b> | 11-Sep-2024 |

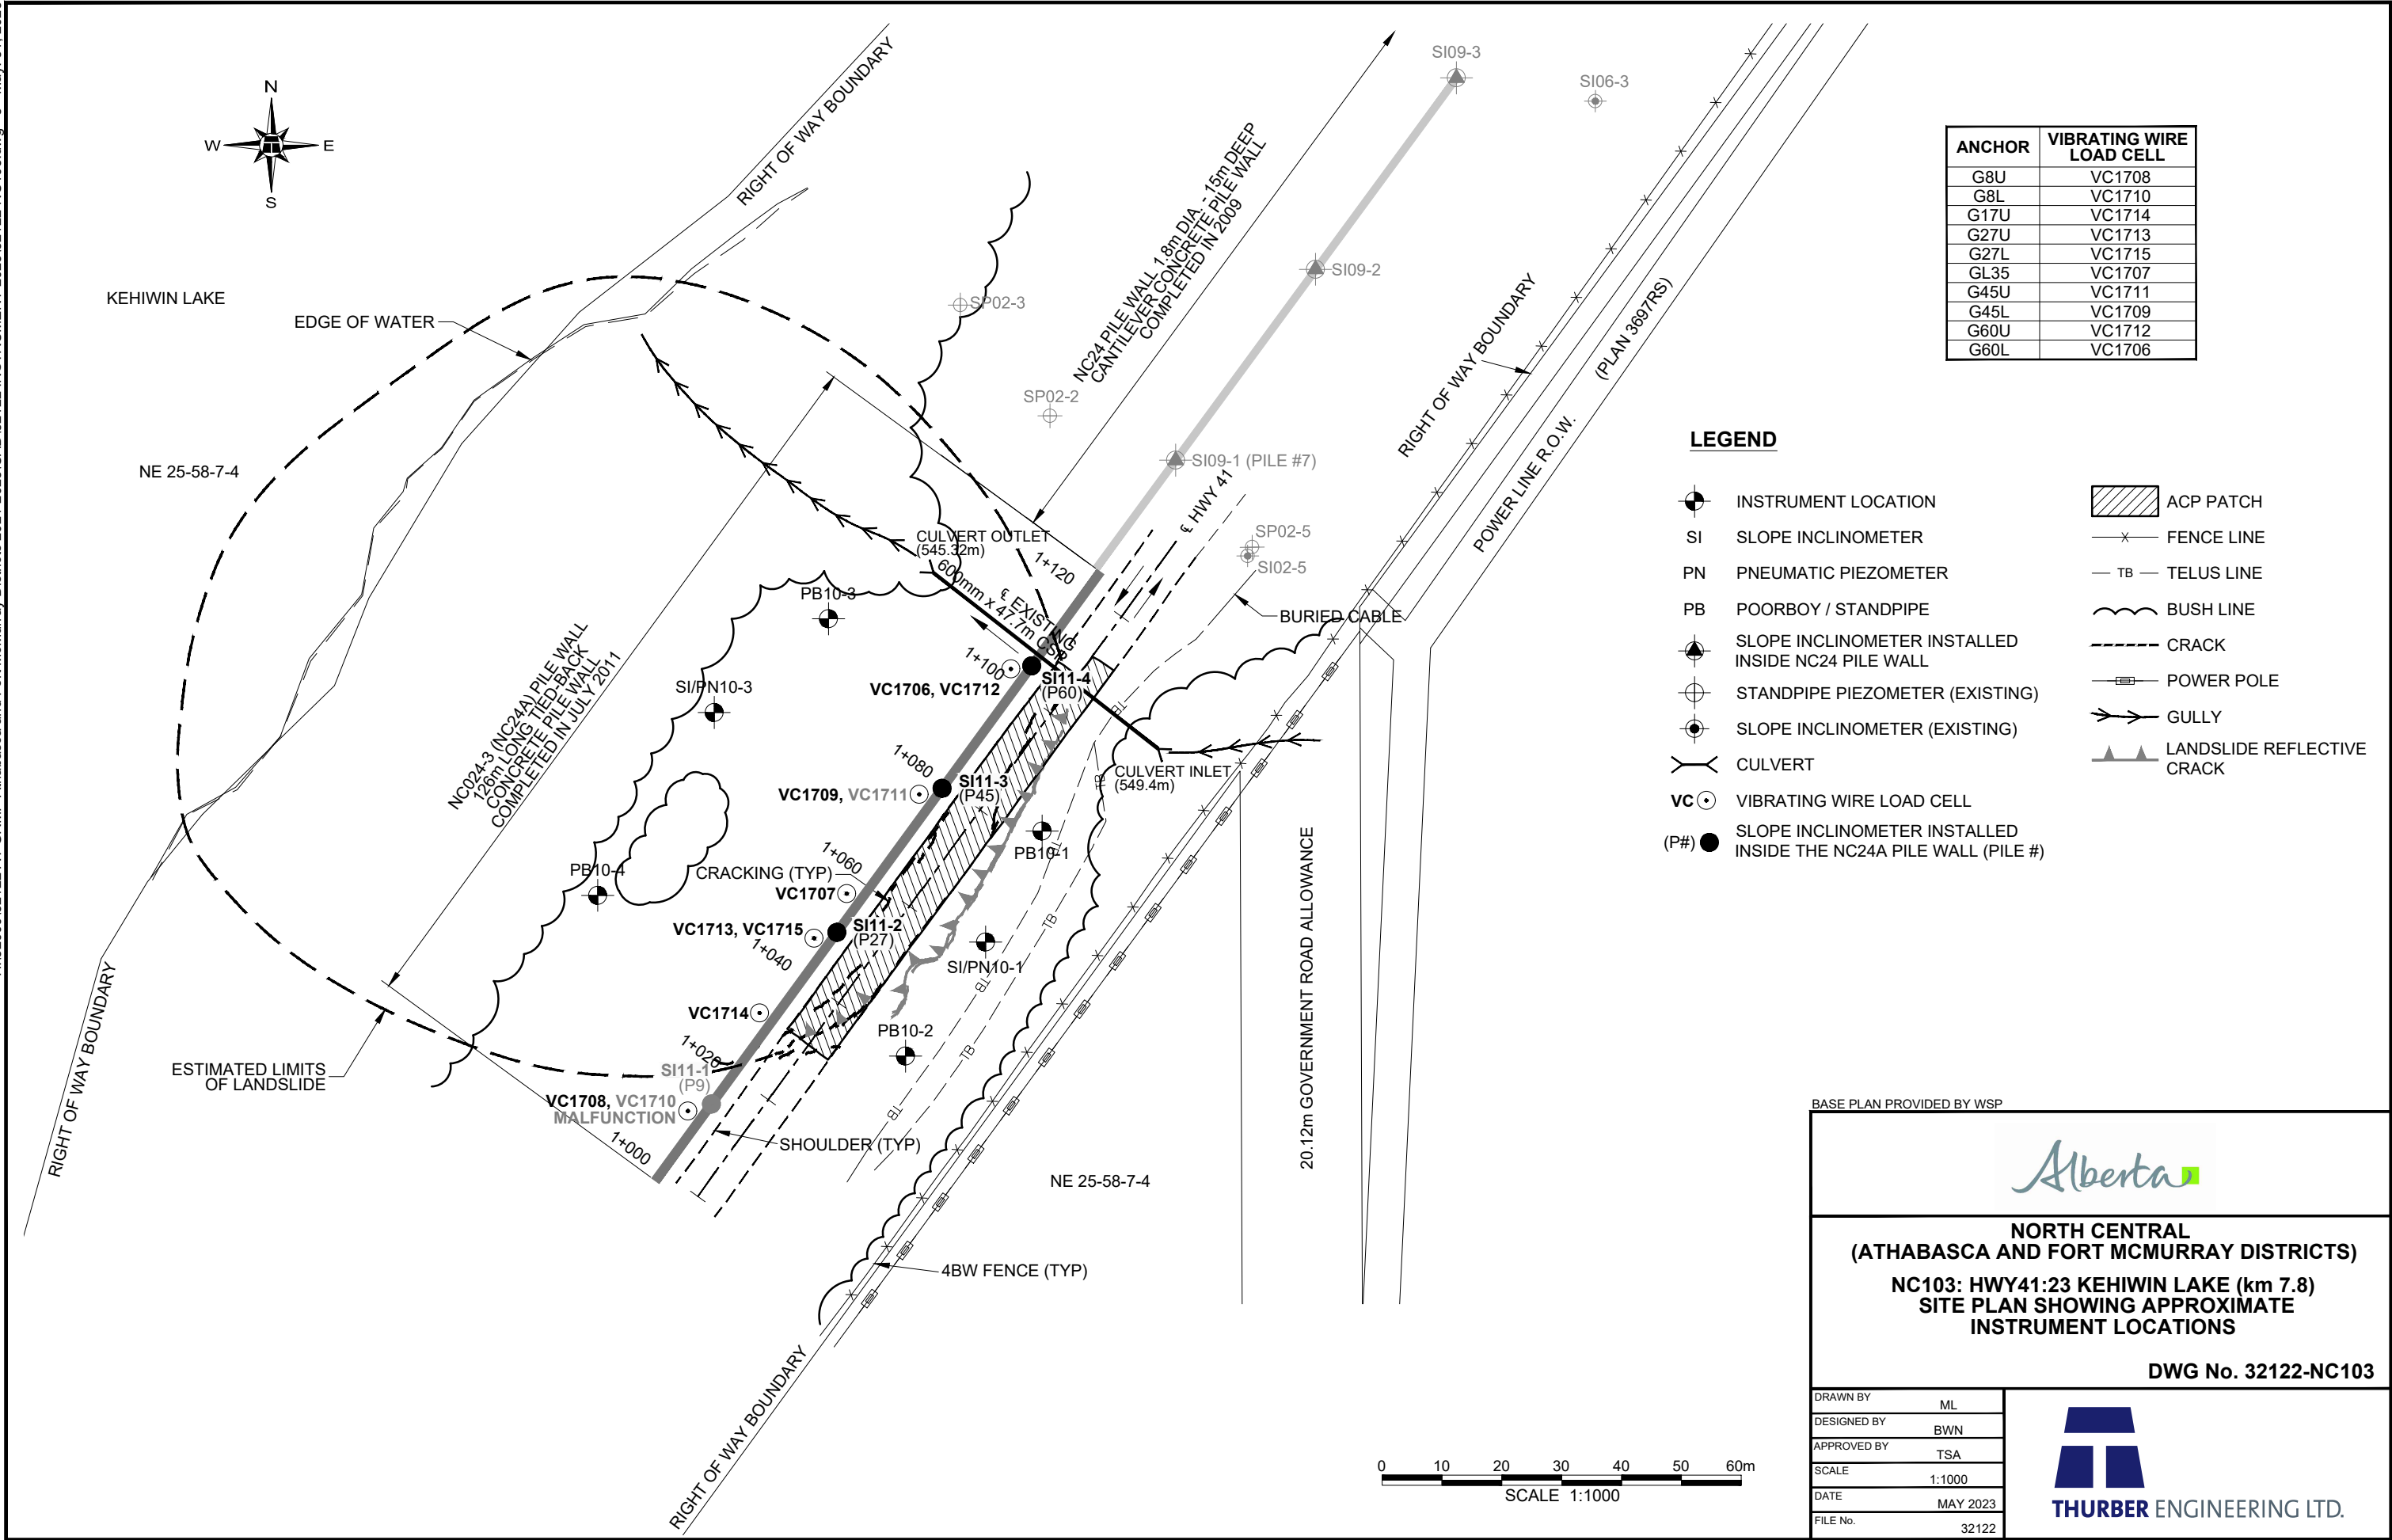
H:\32000\32122 AT GRMP Athabasca and Fort McMurray Districts 2021-2025\CAD\32122 INSTRUMENT 2023\32122-NC103.dwg - 3 - May 31, 2023

| VW1714. only 1 sensor working. |
