**ALBERTA TRANSPORTATION AND  
ECONOMIC CORRIDORS GRMP  
NORTH CENTRAL (ATHABASCA AND FORT  
MCMURRAY DISTRICTS)  
2025 SITE INSPECTION**

| Site # | Location | Name | Hwy | km |
|---|---|---|---|---|
| NC008 | 15.6 Km North of Hwy 63 & 55 Intersection | La Biche River (0.8 to 0.9 km North of Bridge) | 63:02 | 15.6 |

| | Date | PF | CF | Total |
|---|---|---|---|---|
| Current Inspection: | May 14, 2025 | 11 | 4 | 44 (New Landslide) |

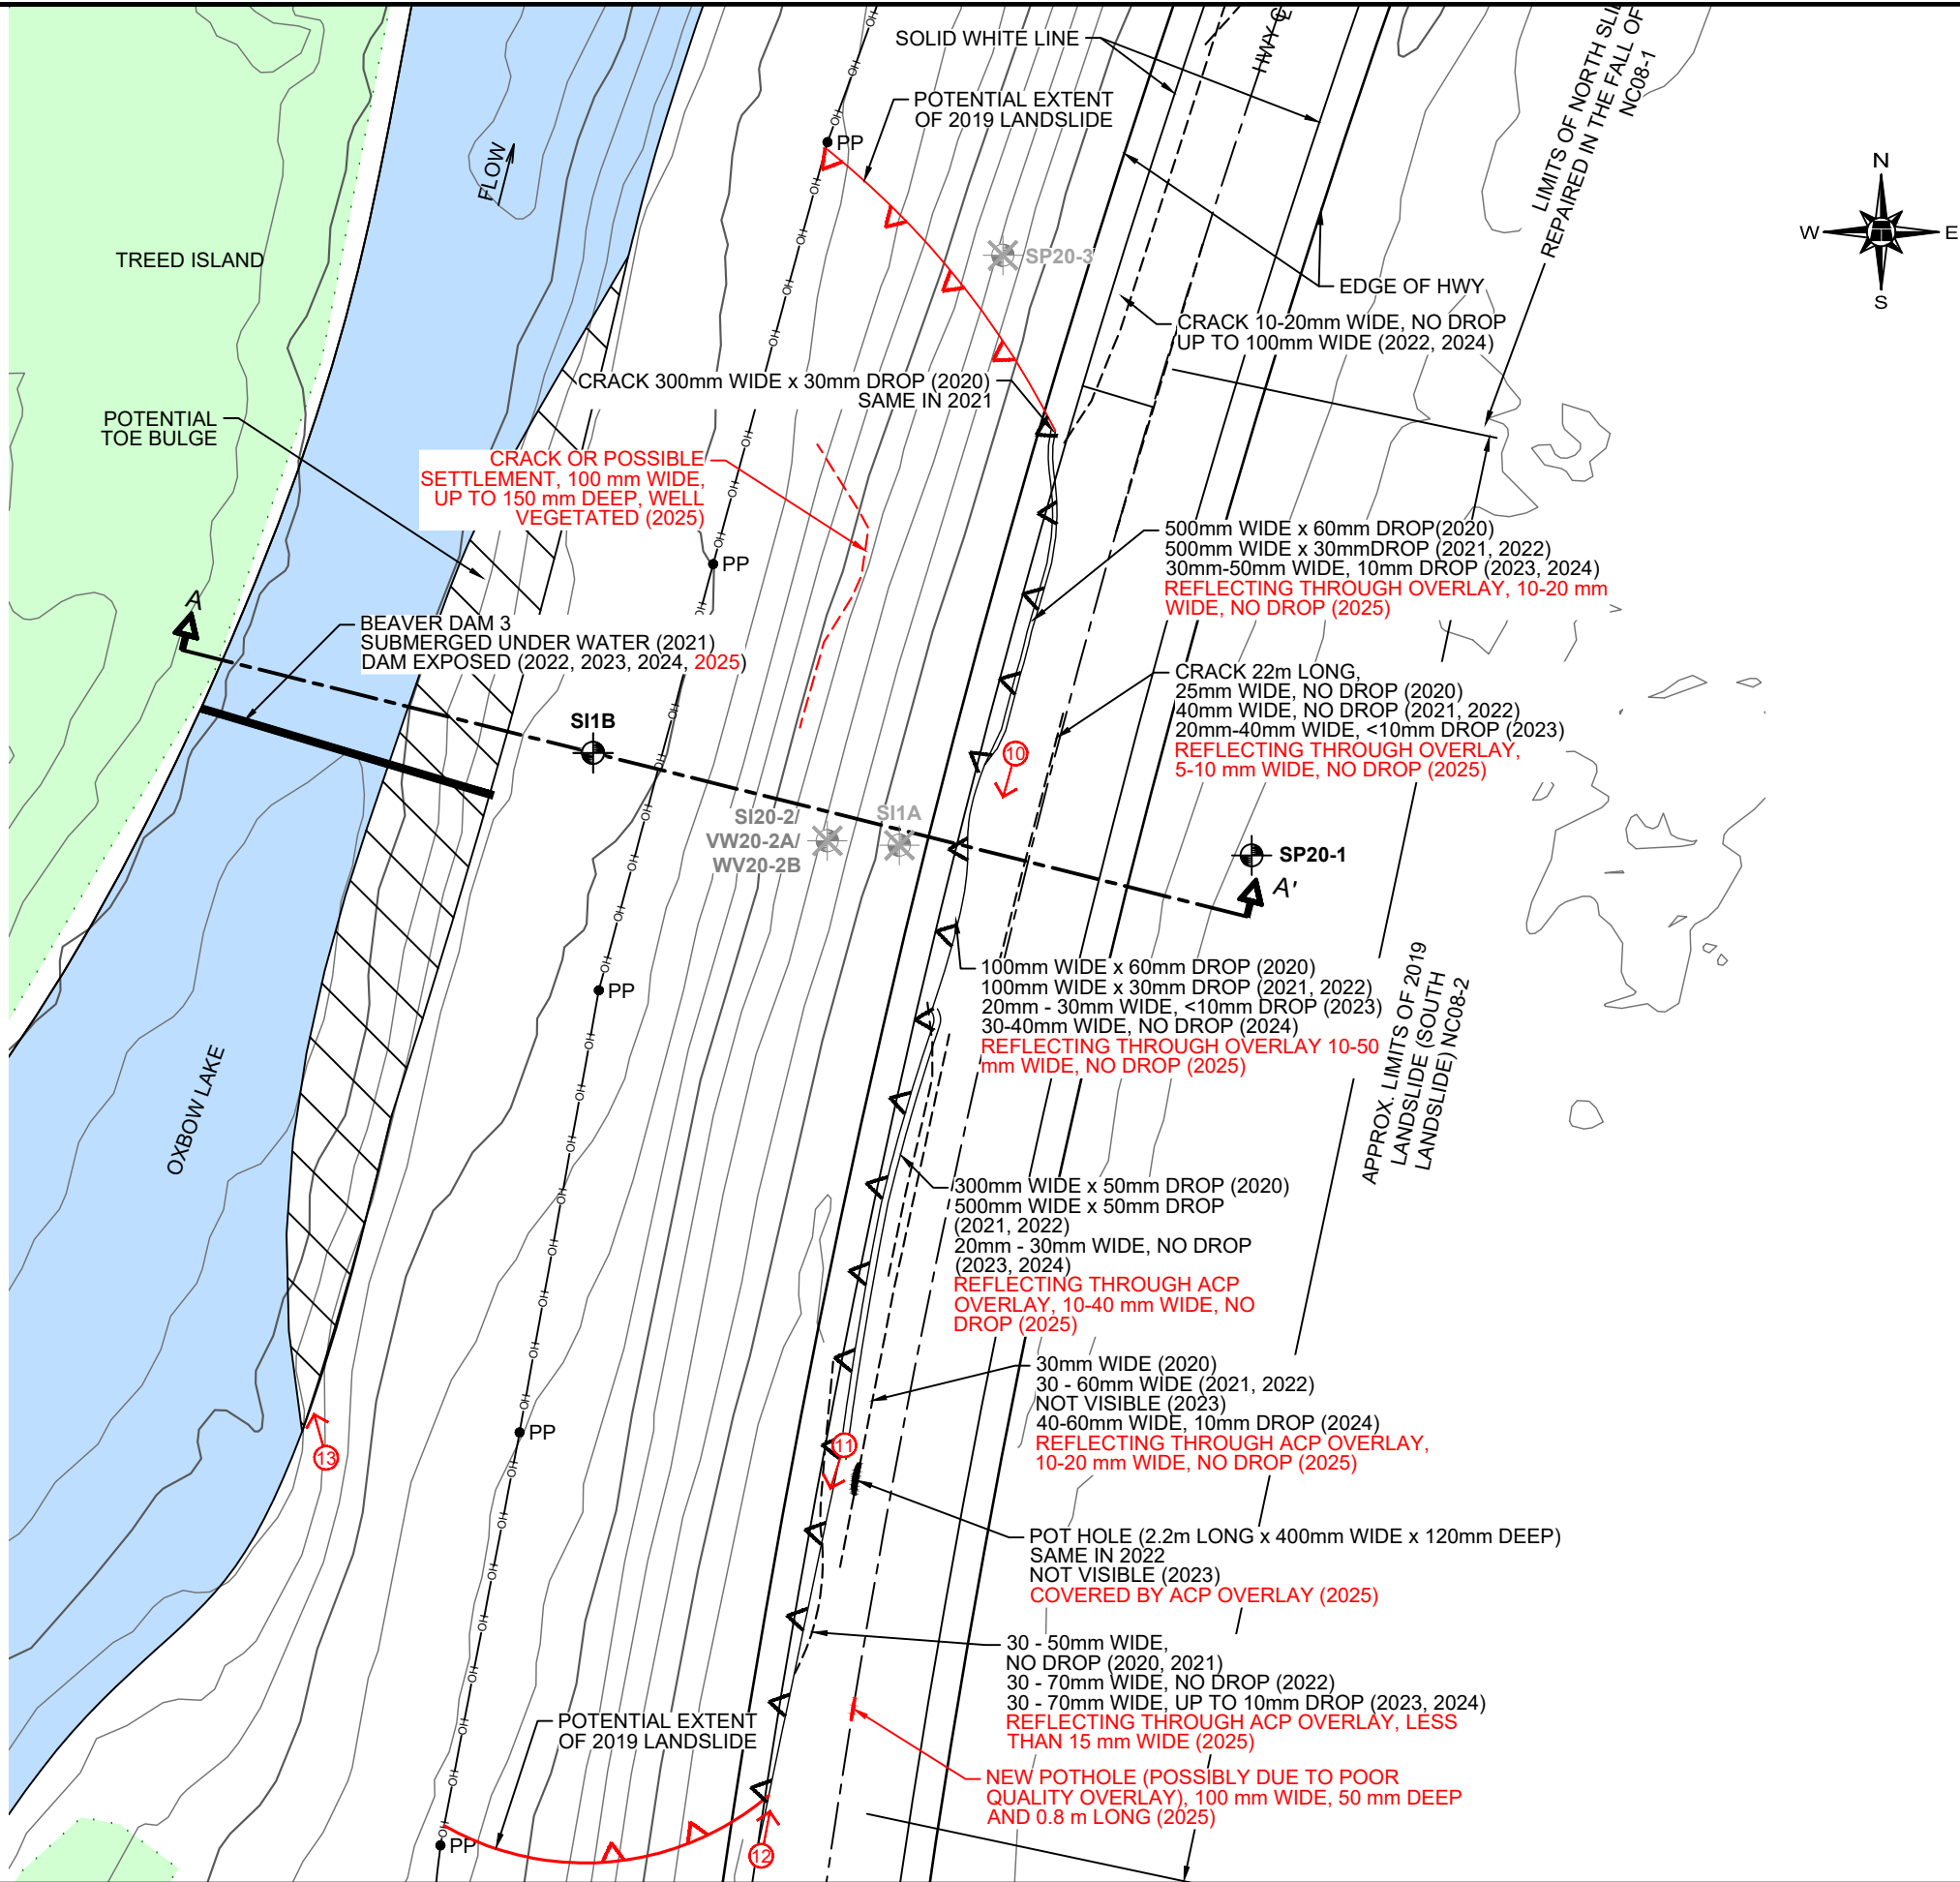
| <b>Primary Site Issue</b> | An active landslide within the western side slope of the highway southbound lanes, causing a severe drop and deterioration to western half of the highway southbound lanes. |
| <b>Dimensions:</b> | About 90 m wide (parallel to the highway alignment) and 40 m long (perpendicular to the highway alignment). |

- (a) Monitor the highway surface periodically for signs of distress and watch closely for the development of additional cracks and highway dip (particularly after prolonged rainfall events). The highway surface cracks at NC008-2 location should be sealed to prevent surface water infiltration into the landslide mass.
- (b) Consider removing all beaver dams within the oxbow lake to further reduce water levels within the highway embankment.

Based on a preliminary engineering assessment prepared by Thurber in 2024, TEC has selected a long-term repair option consisting of two rows of driven steel pile walls parallel to the highway alignment. The estimated cost to construct the pile walls is in the range of \$3,500,000.
