ALBERTA TRANSPORTATION AND ECONOMIC CORRIDORS GRMP NORTH CENTRAL (ATHABASCA AND FORT McMURRAY DISTRICTS) **INSTRUMENTATION MONITORING - FALL 2025**

Site Number	Location	Name	Hwy	km
NC093	HWY 813:06, C1 4.631	Rock Island Bridge	813:06	km 4.6
Legal Description: 9-5-74-22 W4		UTM Co-ordinates		
		12U E 351689	N 613	39948

SITE NC093: HWY 813 ROCK ISLAND RIVER BRIDGE NW APPROACH FILL LANDSLIDE (BF79692)

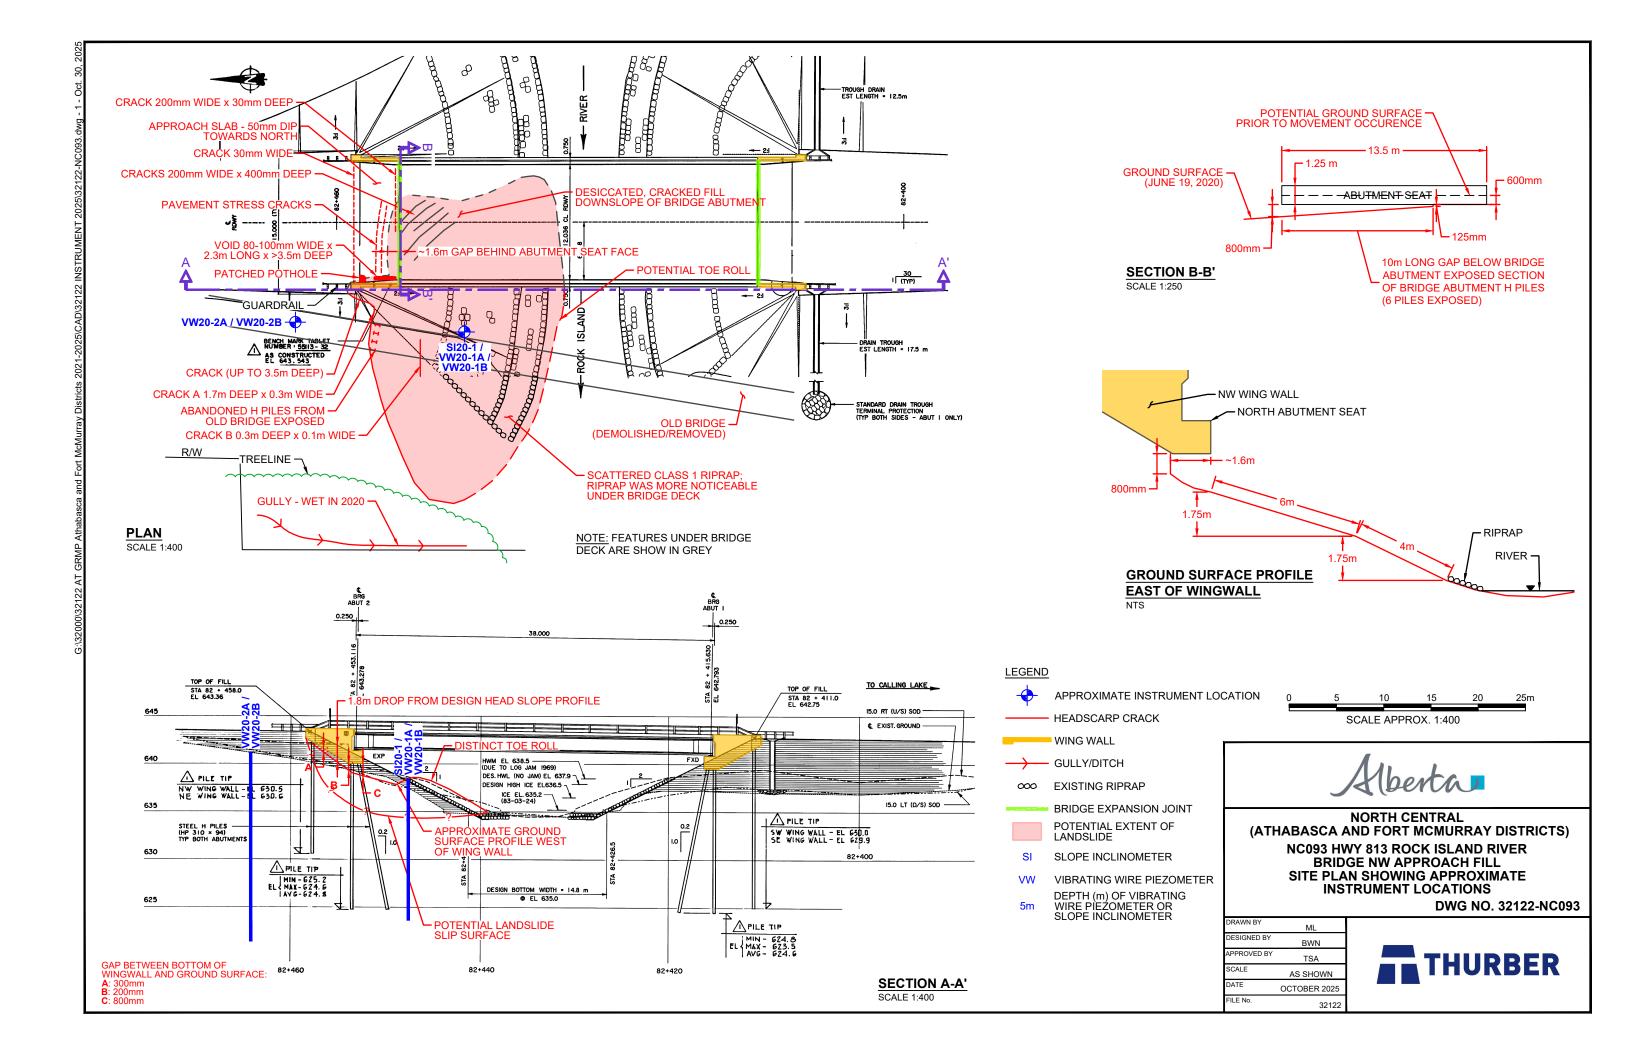
FIGURE NC093-1
HWY 813 ROCK ISLAND RIVER BRIDGE (BF79692)
VIBRATING WIRE PIEZOMETER DATA

Discussion						
Zones of New Movement:	None					
Interpretation of Monitoring Results:	Vibrating wire piezometers VW20-1A and VW20-1B showed decreases in groundwater level of 0.26 m and 0.22 m, respectively, since the spring of 2025 readings. The current groundwater levels are within the historical levels.					
Future Work:	The instruments should be read again in the spring of 2026.					
Instrumentation Repairs:	Consideration should be given to repairing SI20-1 to continue monitoring the landslide movement rate at this site. A mechanical or hydrovac excavation will be required to repair the SI.					
Additional Comments:
