July 8, 2023

**ALBERTA TRANSPORTATION AND ECONOMIC CORRIDORS GRMP (CON0022163)  
NORTH CENTRAL (ATHABASCA AND FORT McMURRAY DISTRICTS)  
INSTRUMENTATION MONITORING RESULTS – SPRING 2023**

**SECTION C**

**SITE NC099: HWY 63:10 HANGINGSTONE RIVER BRIDGES**

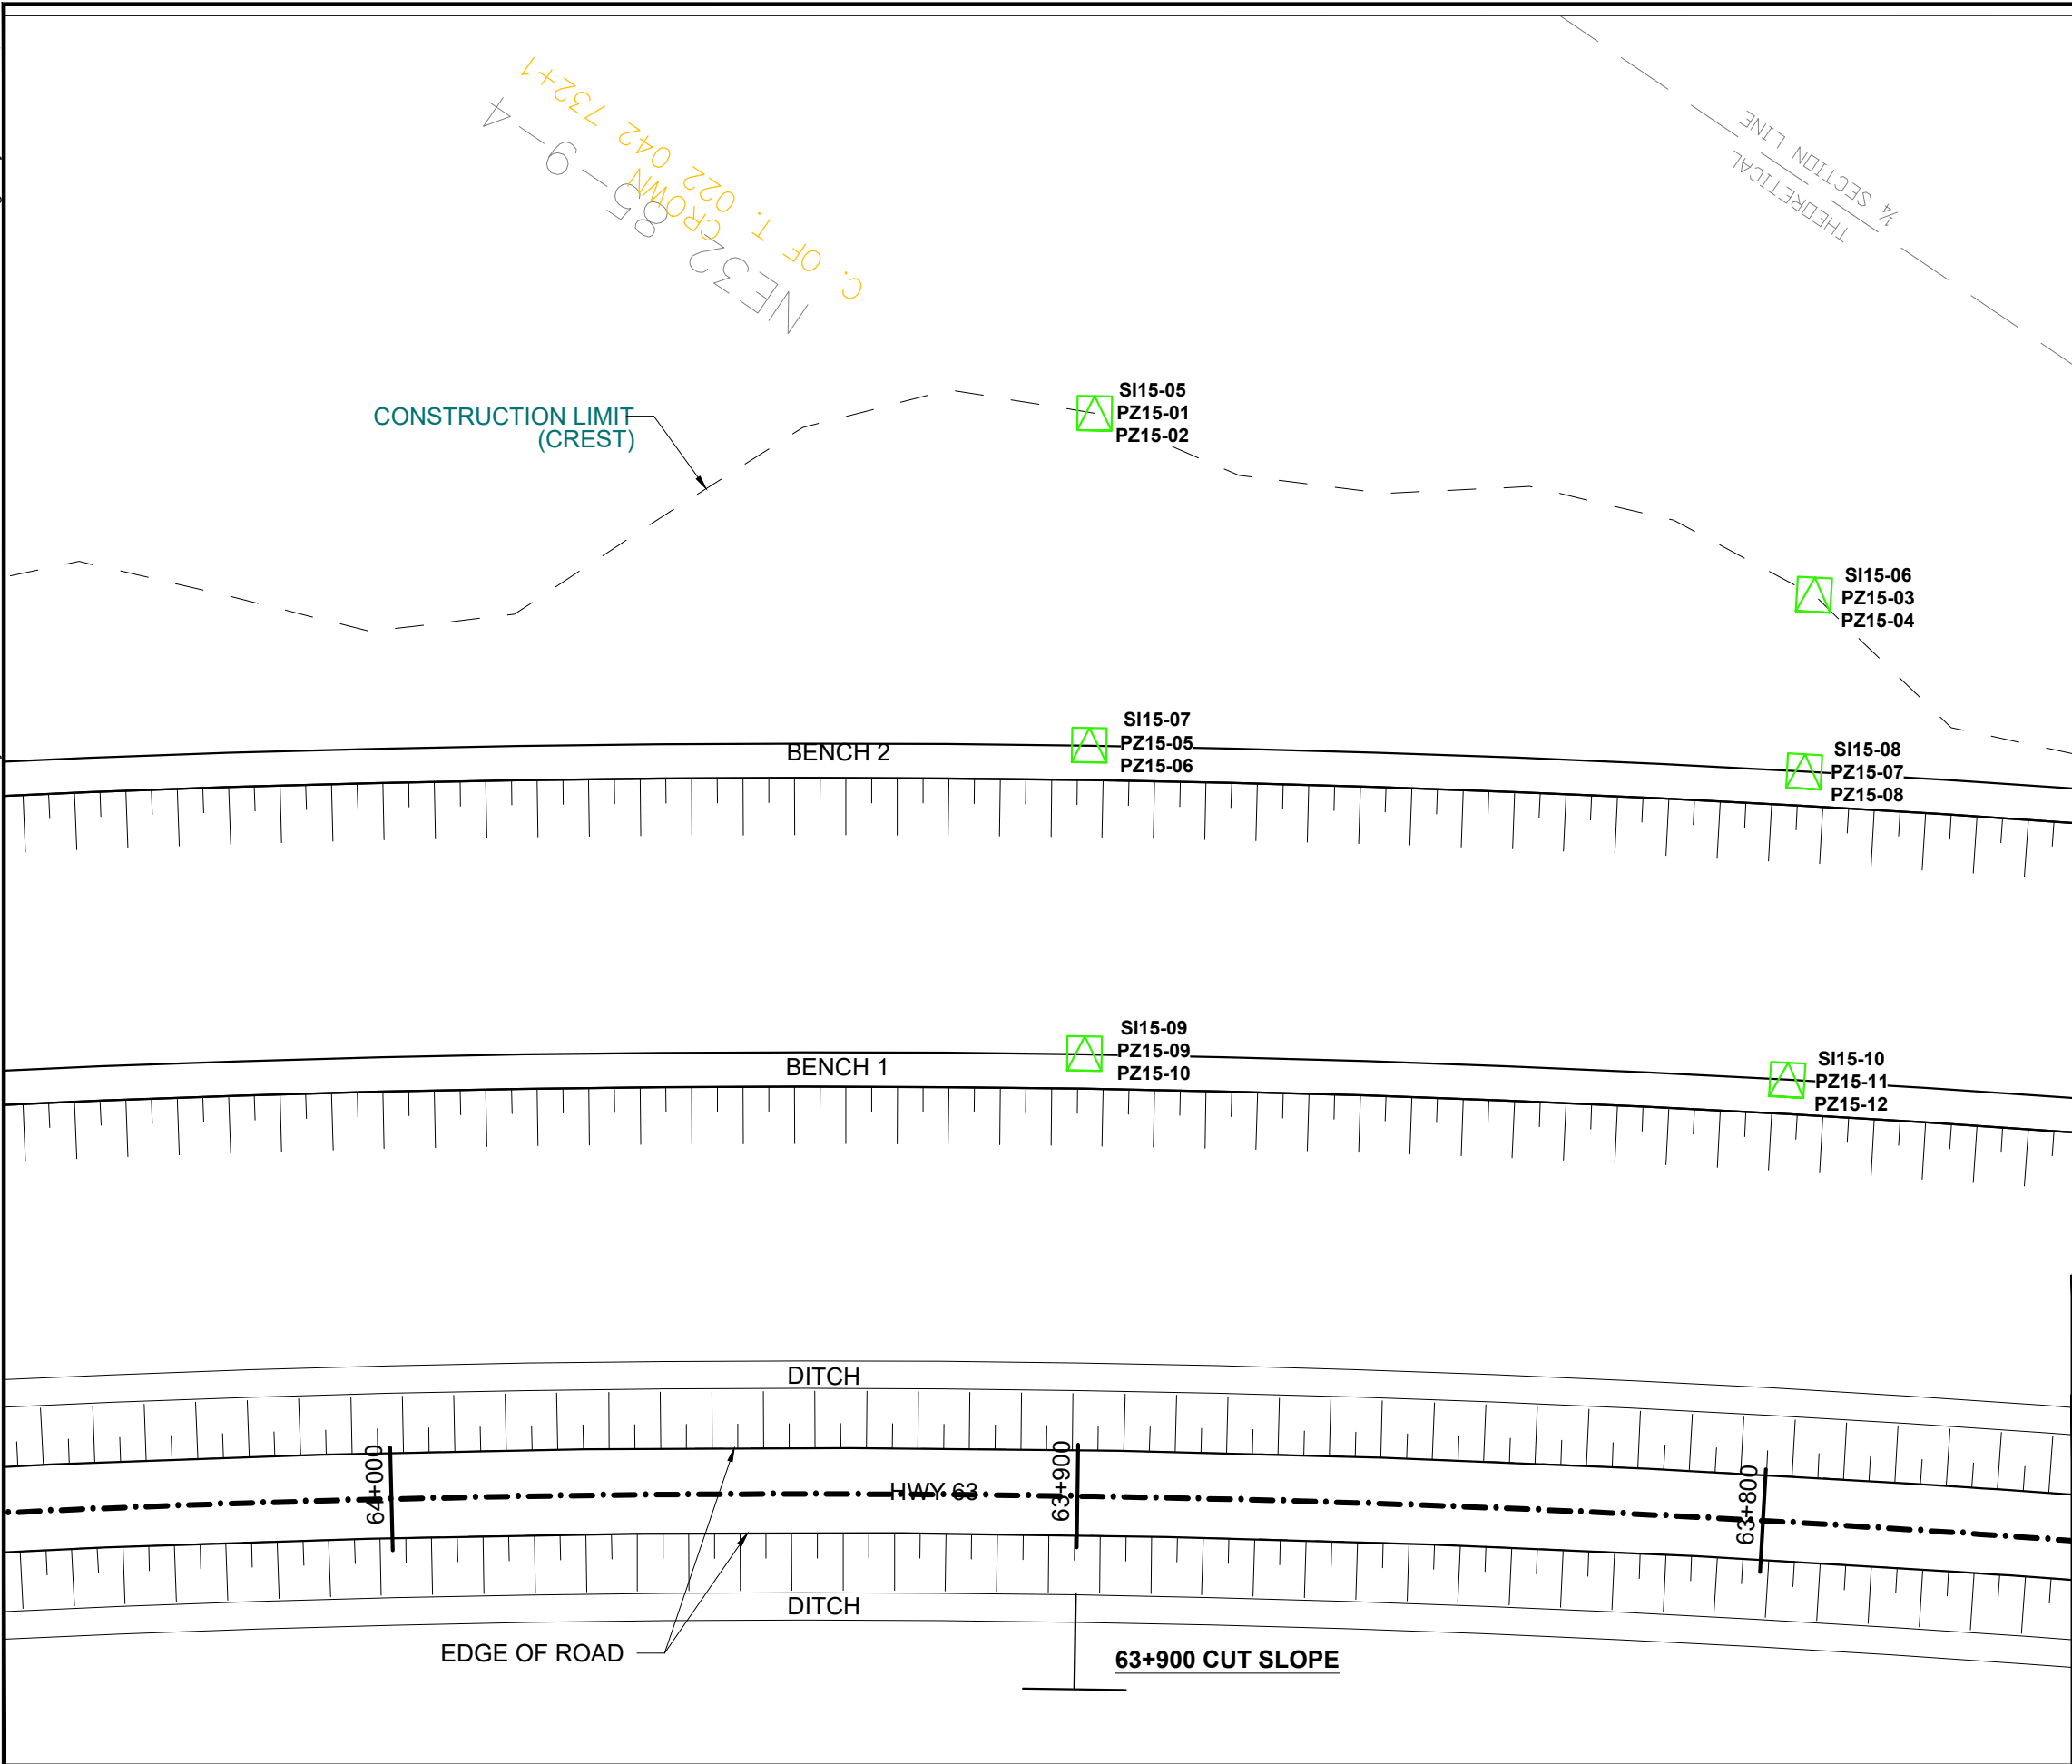
H:\32000\32122 AT GRMP Athabasca and Fort McMurray Districts 2021-2025\CAD\32122 INSTRUMENT 2023\32122-NC099-1.dwg - Layout1 - Jun. 22, 2023

Site plans showing the approximate instrumentation locations are included in Appendix A.

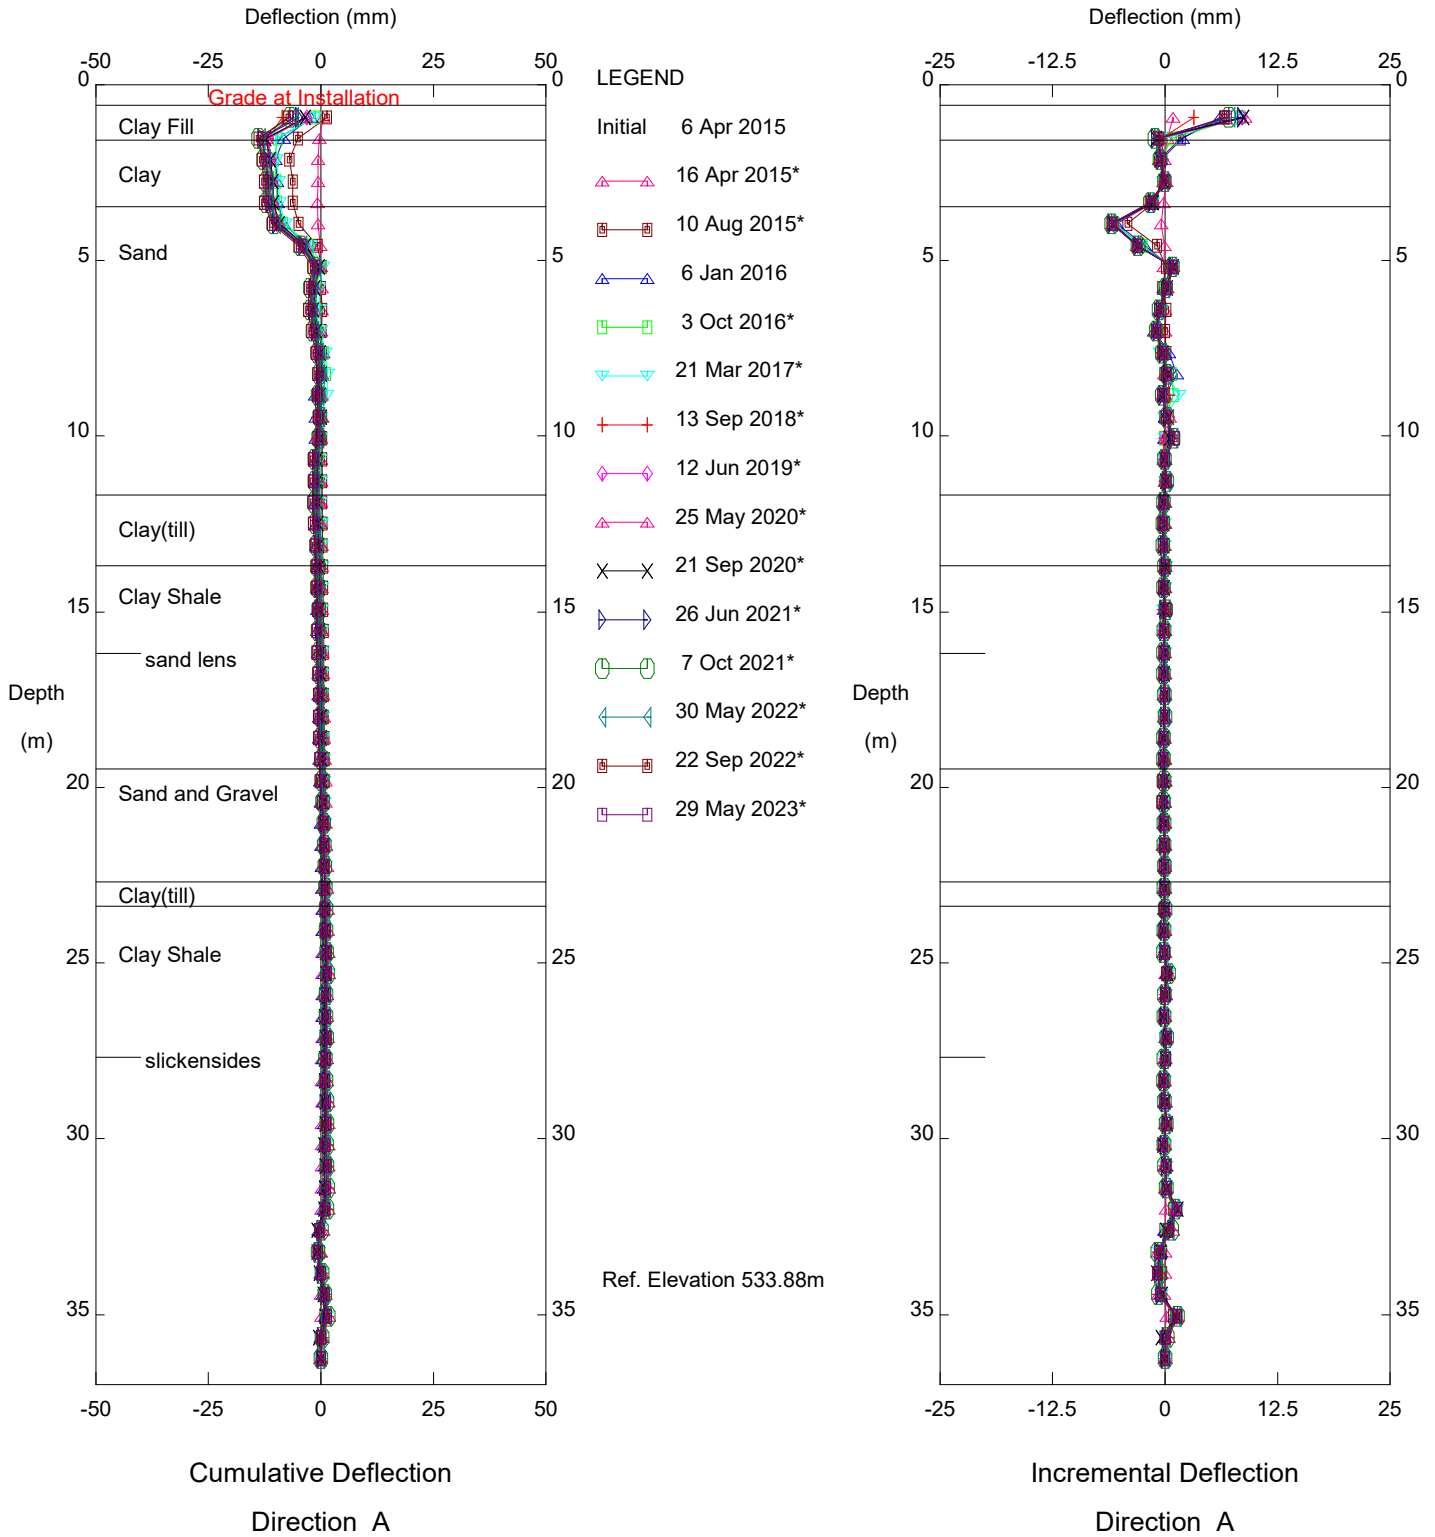
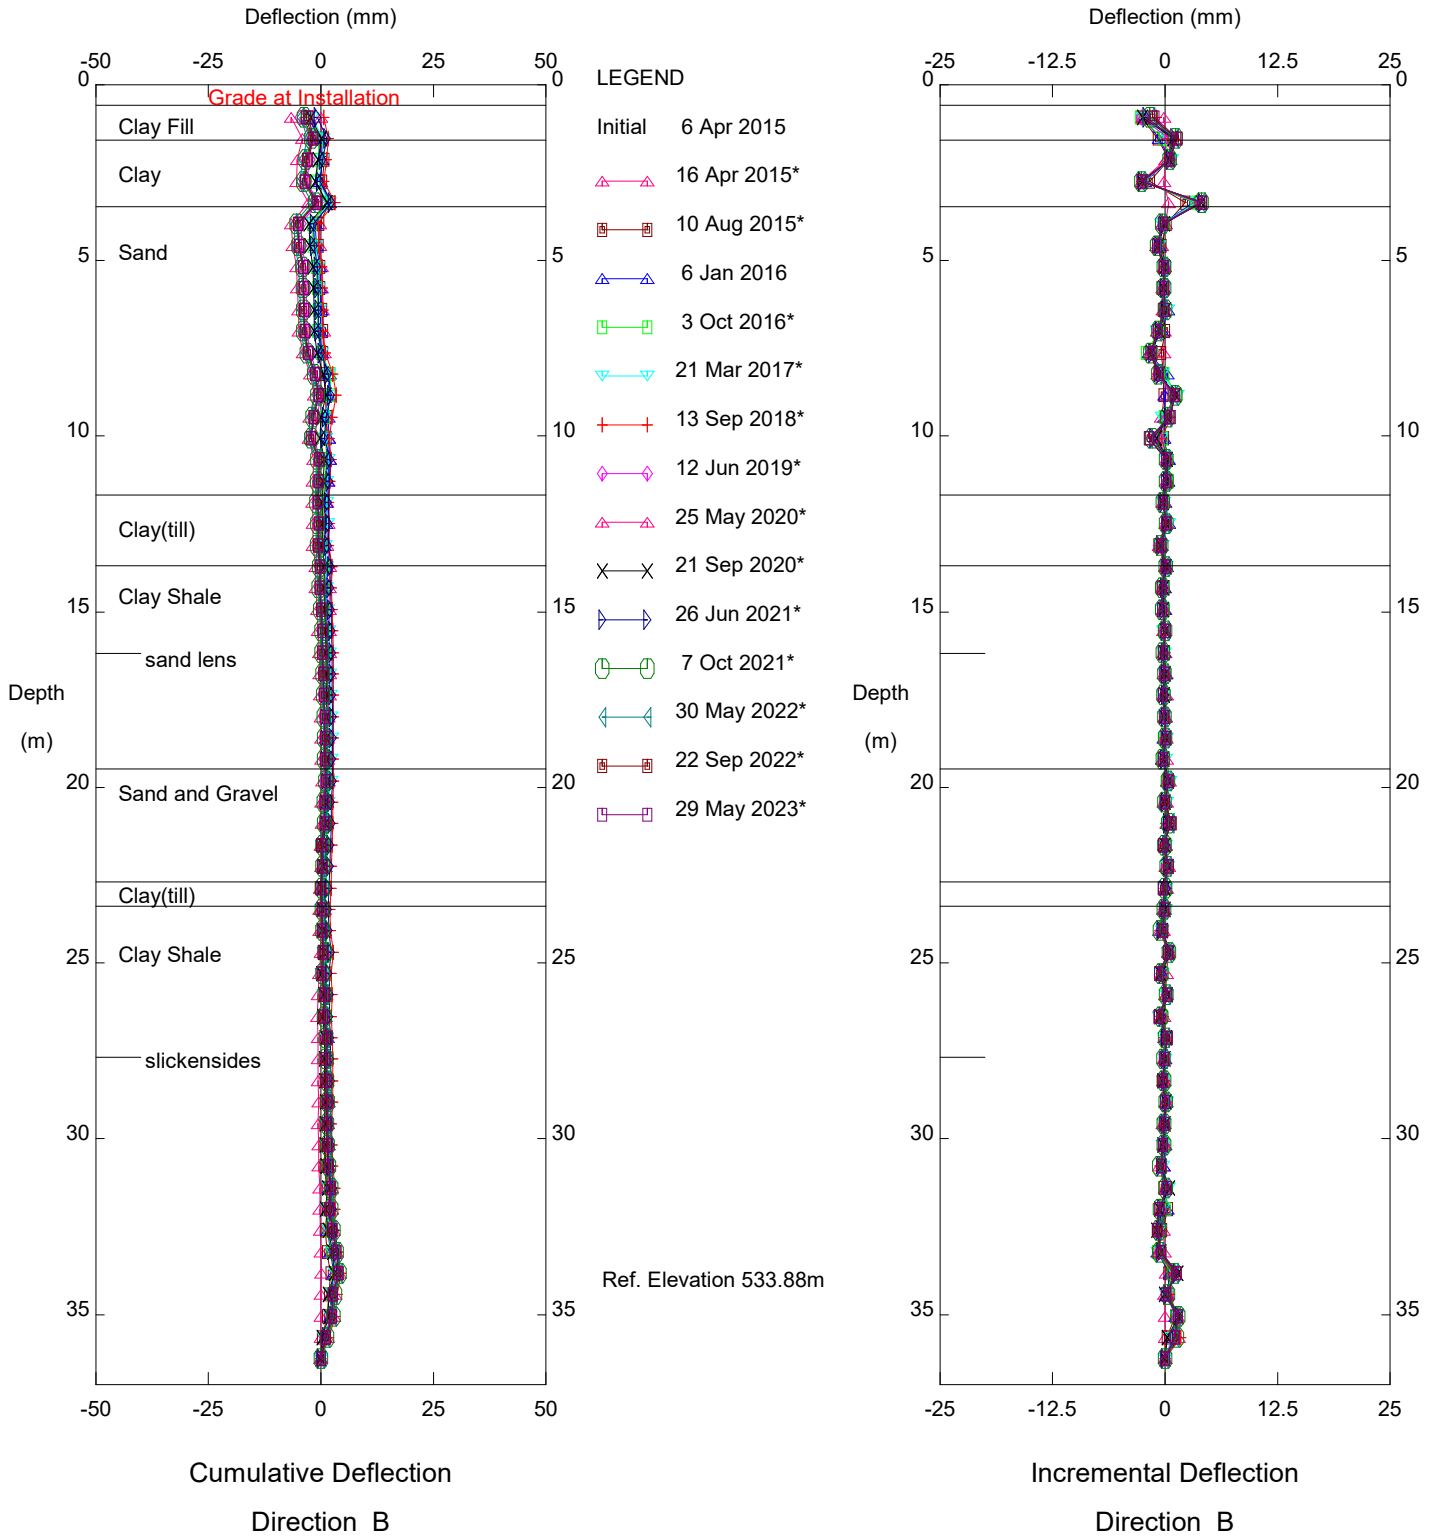
NC099 Cut Slope - Crest, Inclinometer 15-05

Zones of new movement were not observed in the SIs, previously monitored by Thurber, since the previous readings in the fall of 2022.
