**CENTRAL REGION
GEOHAZARDS RISK ASSESMENT
SITE INSPECTION FORM**

SITE NUMBER AND NAME C29 Meridian Pit		HIGHWAY & KM	PREVIOUS INSPECTION DATE July 18, 2003	INSPECTION DATE May 19, 2004
LEGAL DESCRIPTION NE/SE26-53-01-W4	NAD 83 COORDINATES N 5939566 E 565036		RISK ASSESMENT PF: 9 CF: 2 TOTAL: 18

1. SITE C29 H17:08 GABION STRUCTURE REPAIR

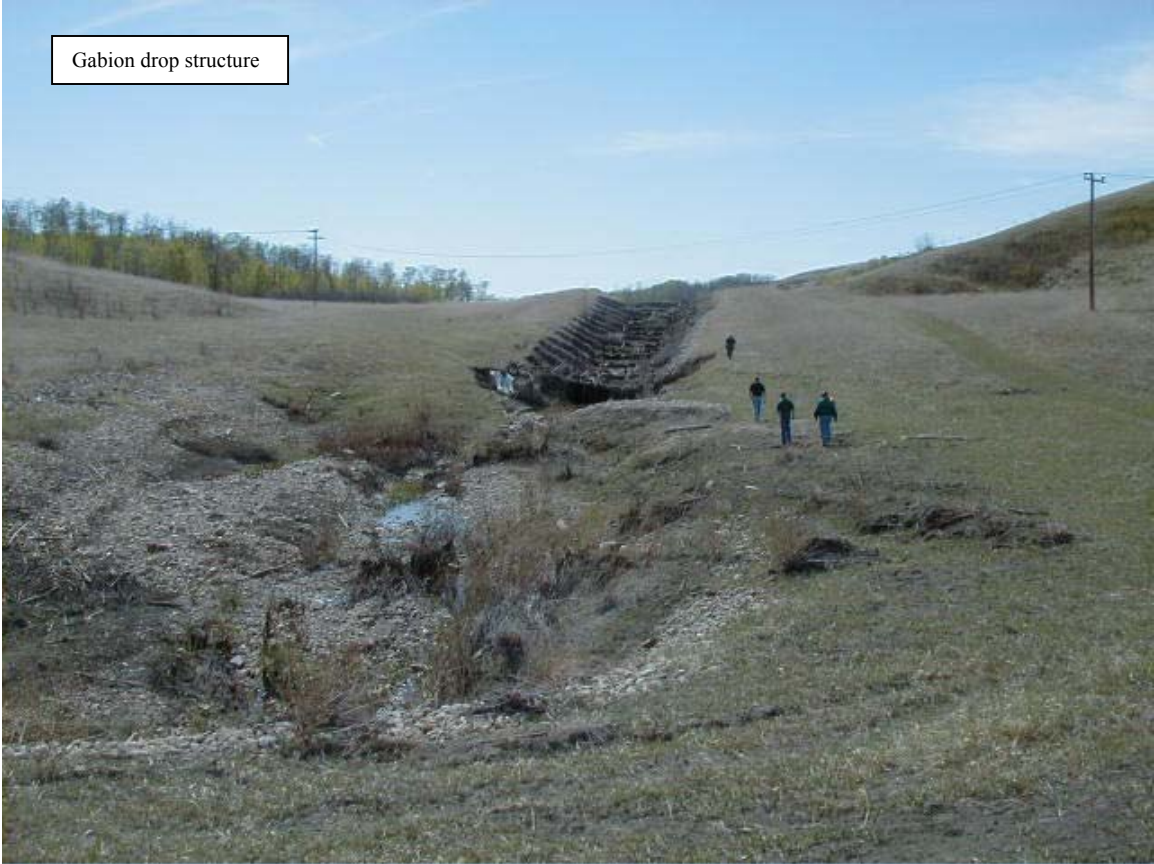
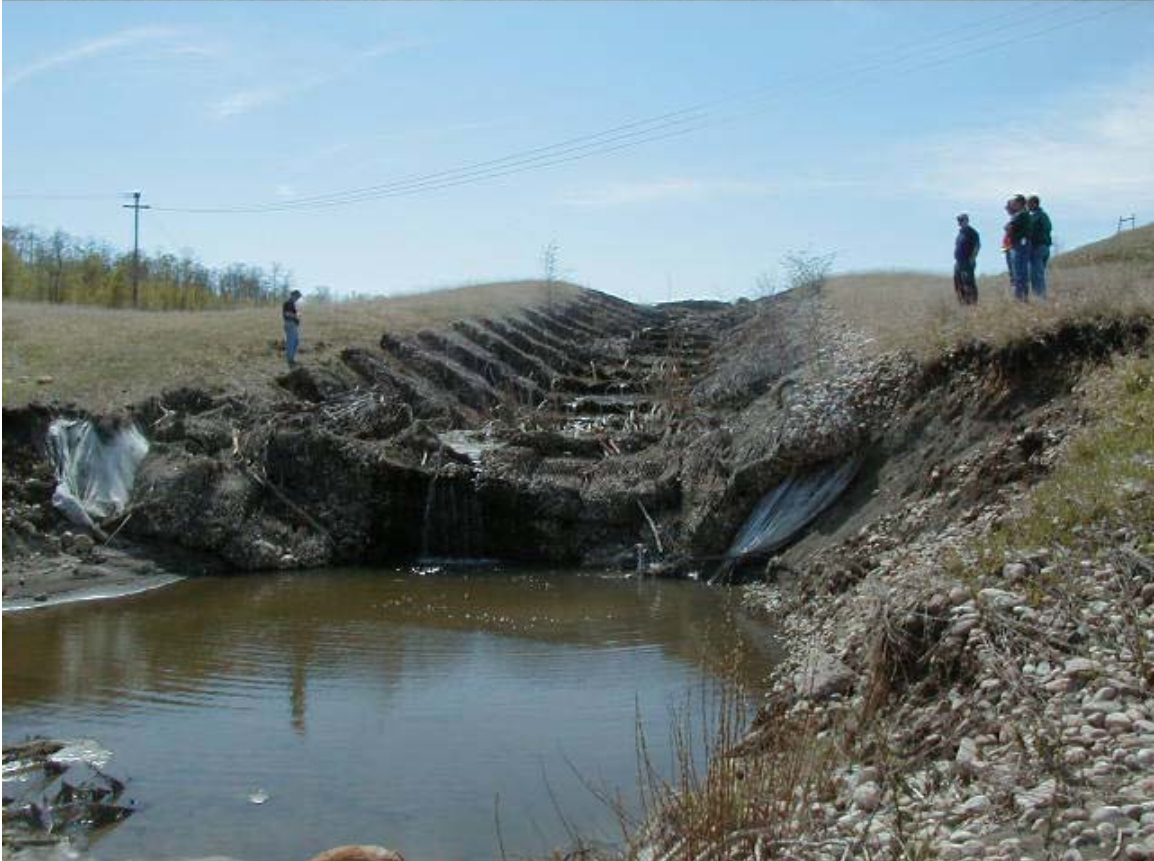
At the end of the gabion structure, a plunge pool has formed and the end of the gabion structure has been damaged. It is recommended that the end of the structure be repaired and the plunge pool area remediated.

Gabion drop structure
