SITE NUMBER AND NAME C061 Frost Heave		HIGHWAY & KM H20:02; km 12.212	PREVIOUS INSPECTION DATE March 2, 2017	INSPECTION DATE Feb 28, 2018
LEGAL DESCRIPTION SE 33-39-1-W5	NAD 83 COORDINATES Northing Easting 52°23.564' 114°4.592'		RISK ASSESSMENT PF: 8 CF: 3 TOTAL: 24	
2017 Average Annual Daily Traffic (Ref. 997219) (AADT): 5930 (northbound) 6260 (southbound)		Contract Maintenance Area (CMA): 19

NOTES: 1. HORIZONTAL DATUM: NAD83 2. GRID ZONE: UTM Zone 11N 3. IMAGE SOURCE: Bing Maps 2018, Microsoft Corporation. Image dated September 2013 4. Site visit photos dated February 28, 2018	CLIENT 	PROJECT CENTRAL REGION GEOHAZARD RISK MANAGEMENT PROGRAM
		TITLE C061 Site Inspection Hwy 20:02 km 12.212
SCALE 1:1,000	PROJECT No. A05115A02	FIG No. 1

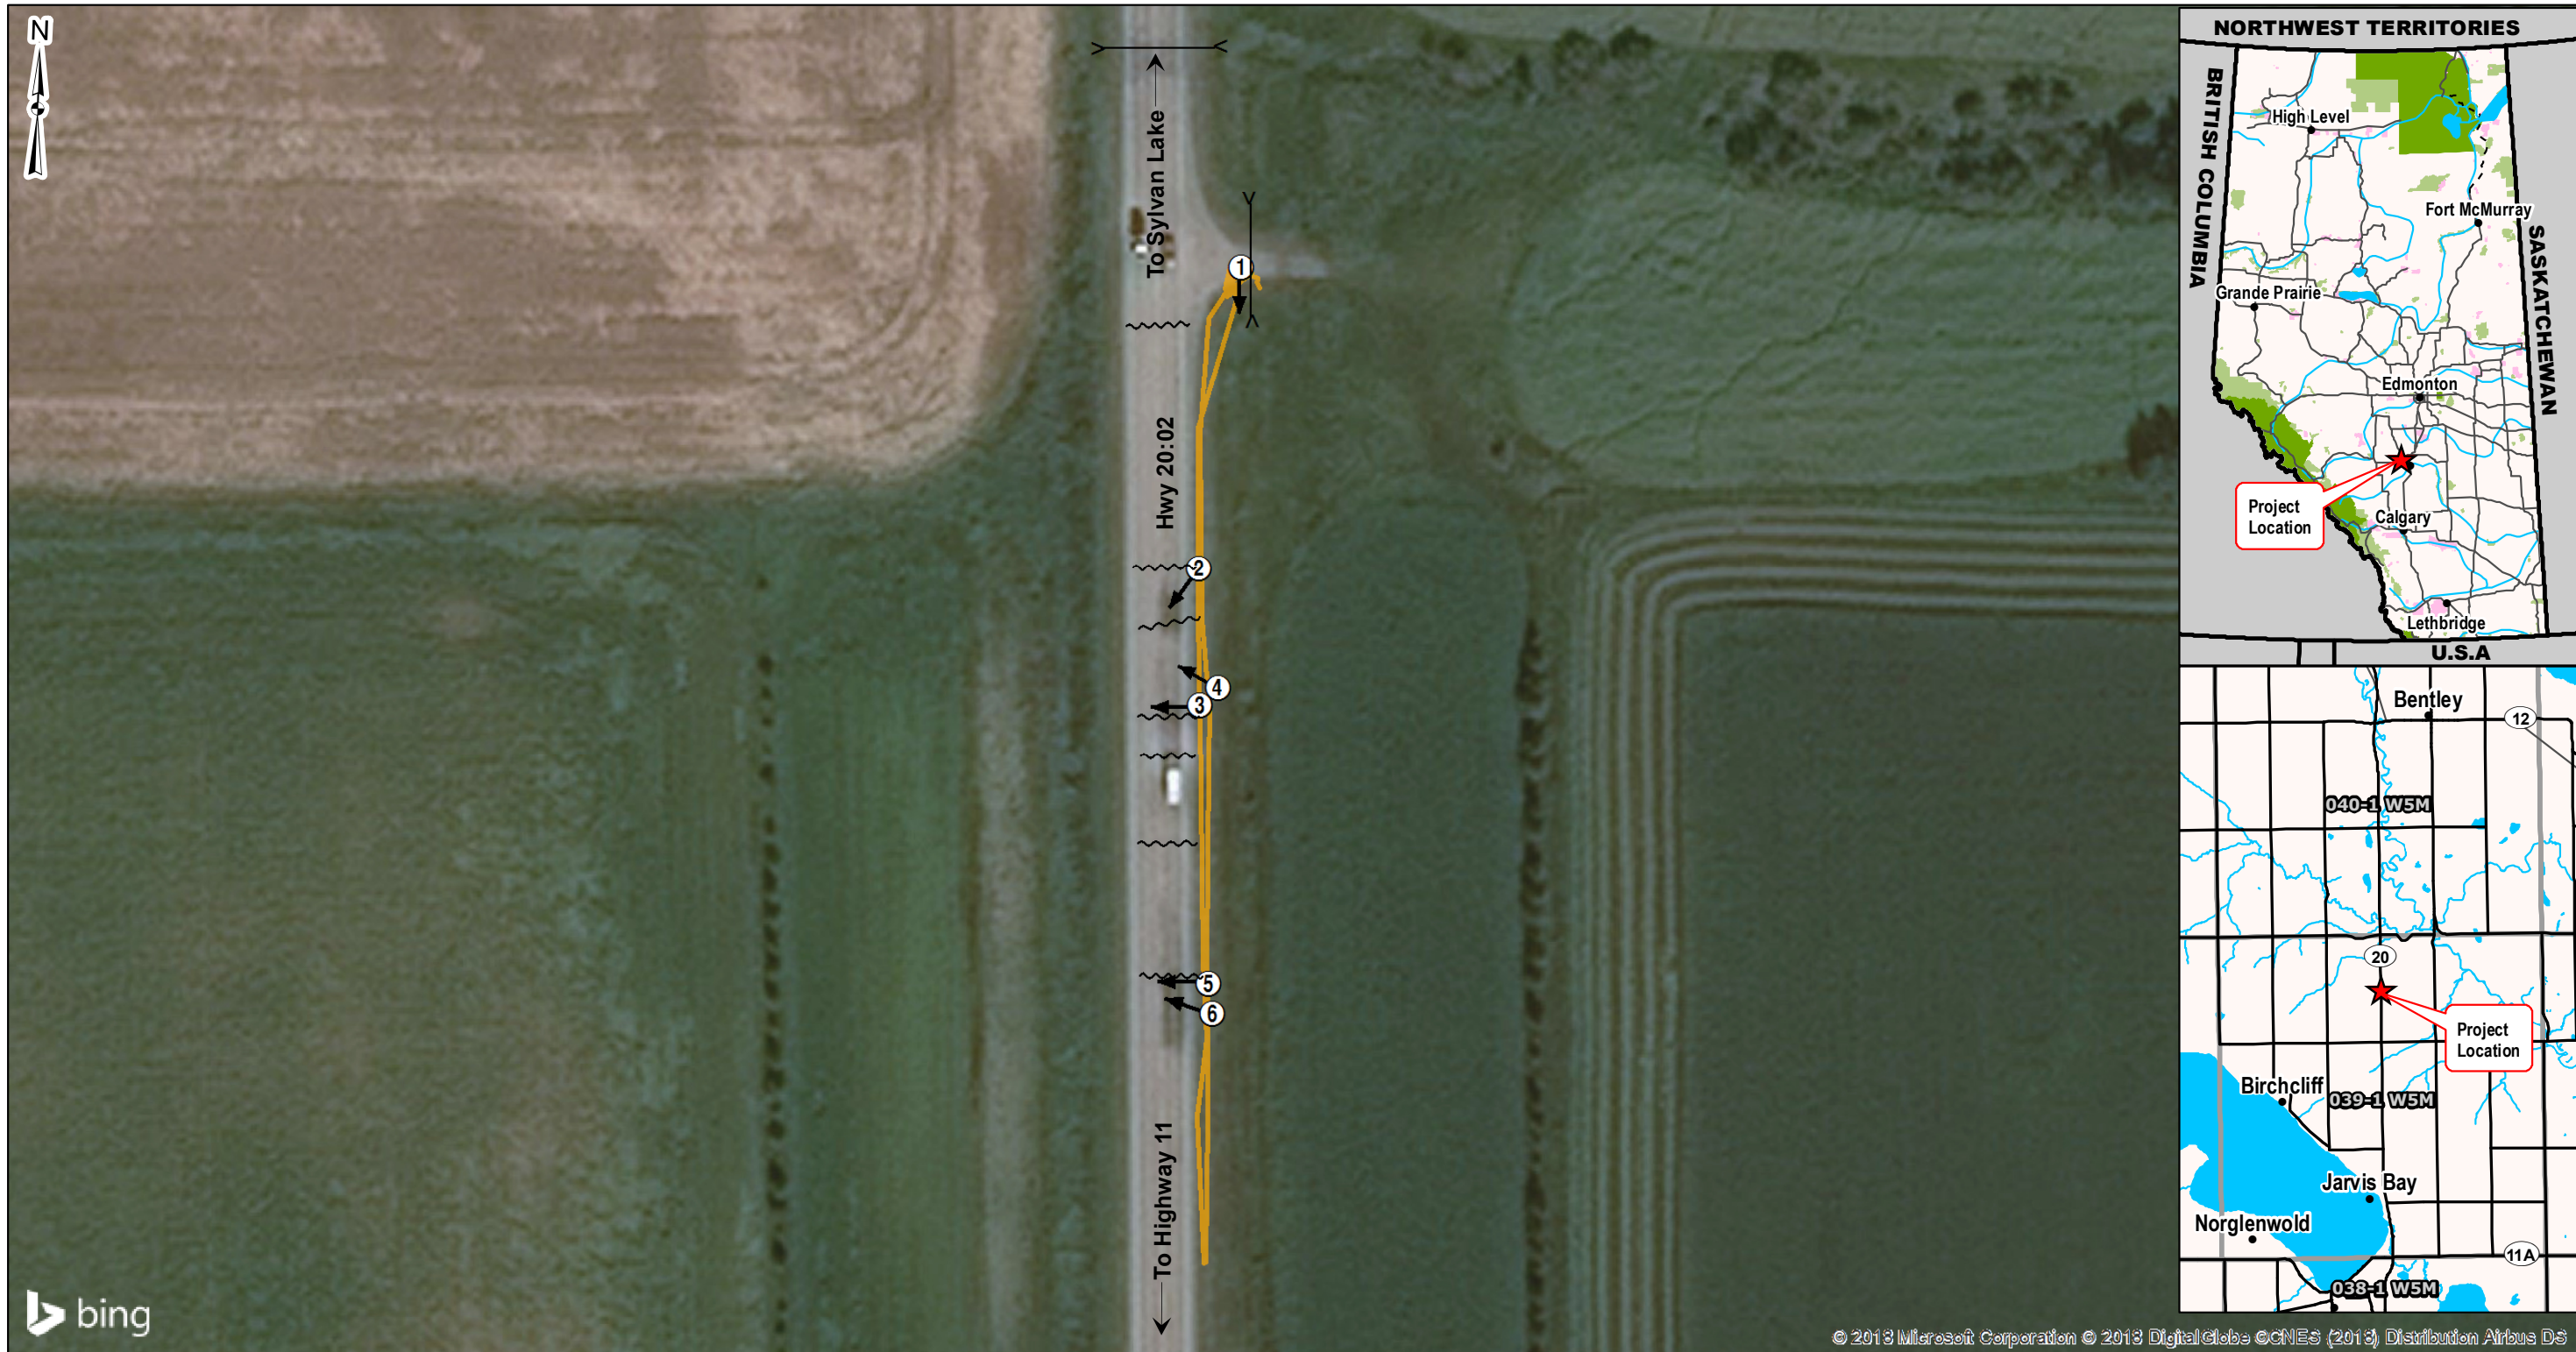
COMMENTS
Traffic does not seem to be slowing down despite hazard signs warning drivers of uneven pavement and a 65 km/hr speed limit.
Northbound lane observed to be heaving more than the southbound lane.
Transverse pavement cracks observed at the three patched areas. Pavement cracks extend the entire width of the highway.
The maintenance contractor usually fills in the depressions with asphalt patch at the heaved locations in the winter and then mills the asphalt in the spring when the heaves subside.
The MCI reported that the heaving conditions are slightly worse this winter as compared to the previous winters.
A Preliminary Engineering Report was issued by KCB on September 19, 2017 providing KCB's recommendations for repair work.
Discussed with AT on site that the west ditch should be cleaned out and/or graded to establish positive drainage towards the north culvert and creek.
KCB will arrange to have a winter pavement-LiDAR survey of the site (both lanes).
