SITE NUMBER AND NAME H21:22 Pavement Distress		HIGHWAY & KM from km 16.4 to km 17.7	PREVIOUS INSPECTION DATE	INSPECTION DATE May 15, 2007
LEGAL DESCRIPTION	NAD 83 COORDINATES	RISK ASSESMENT PF: 9 CF: 4 TOTAL: 36

LAST READING DATE:	
PRIMARY SITE ISSUE: Pavement distress	
APPROXIMATE DIMENSIONS:	
DATE OF ANY REMEDIAL ACTION:

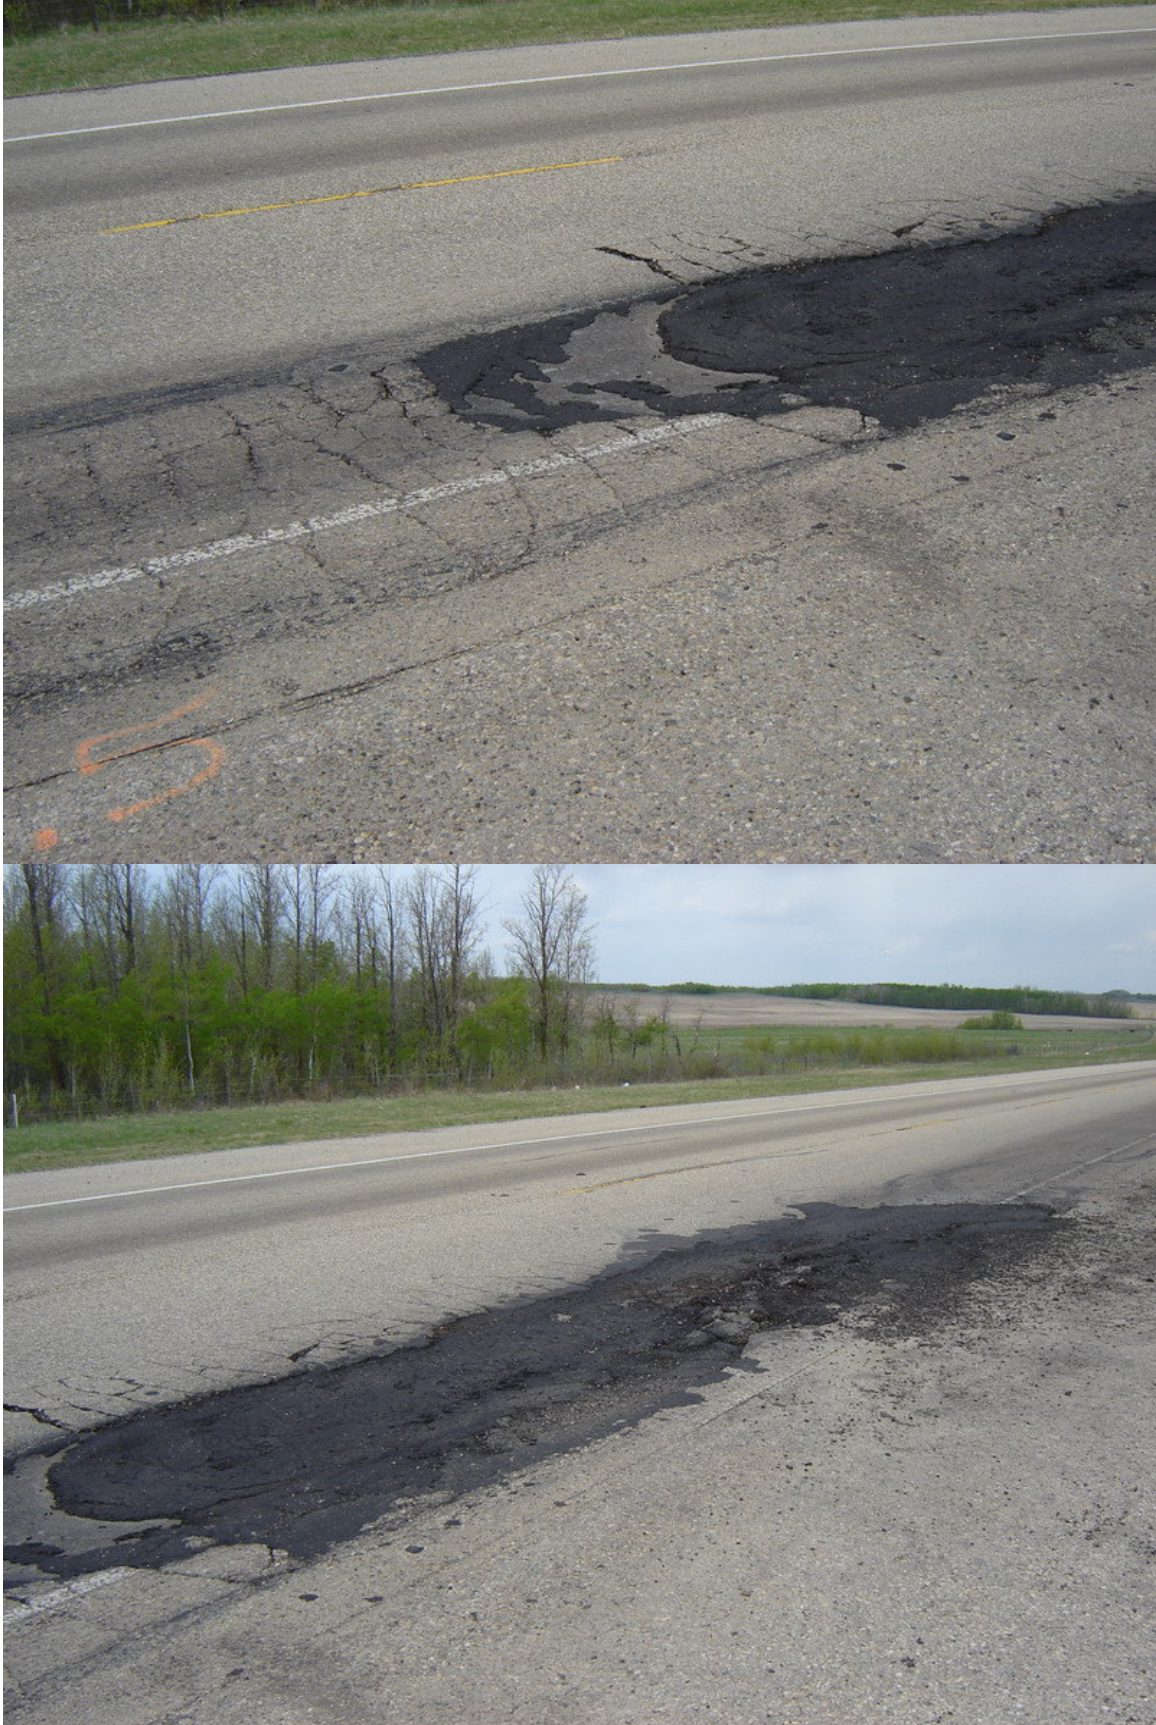
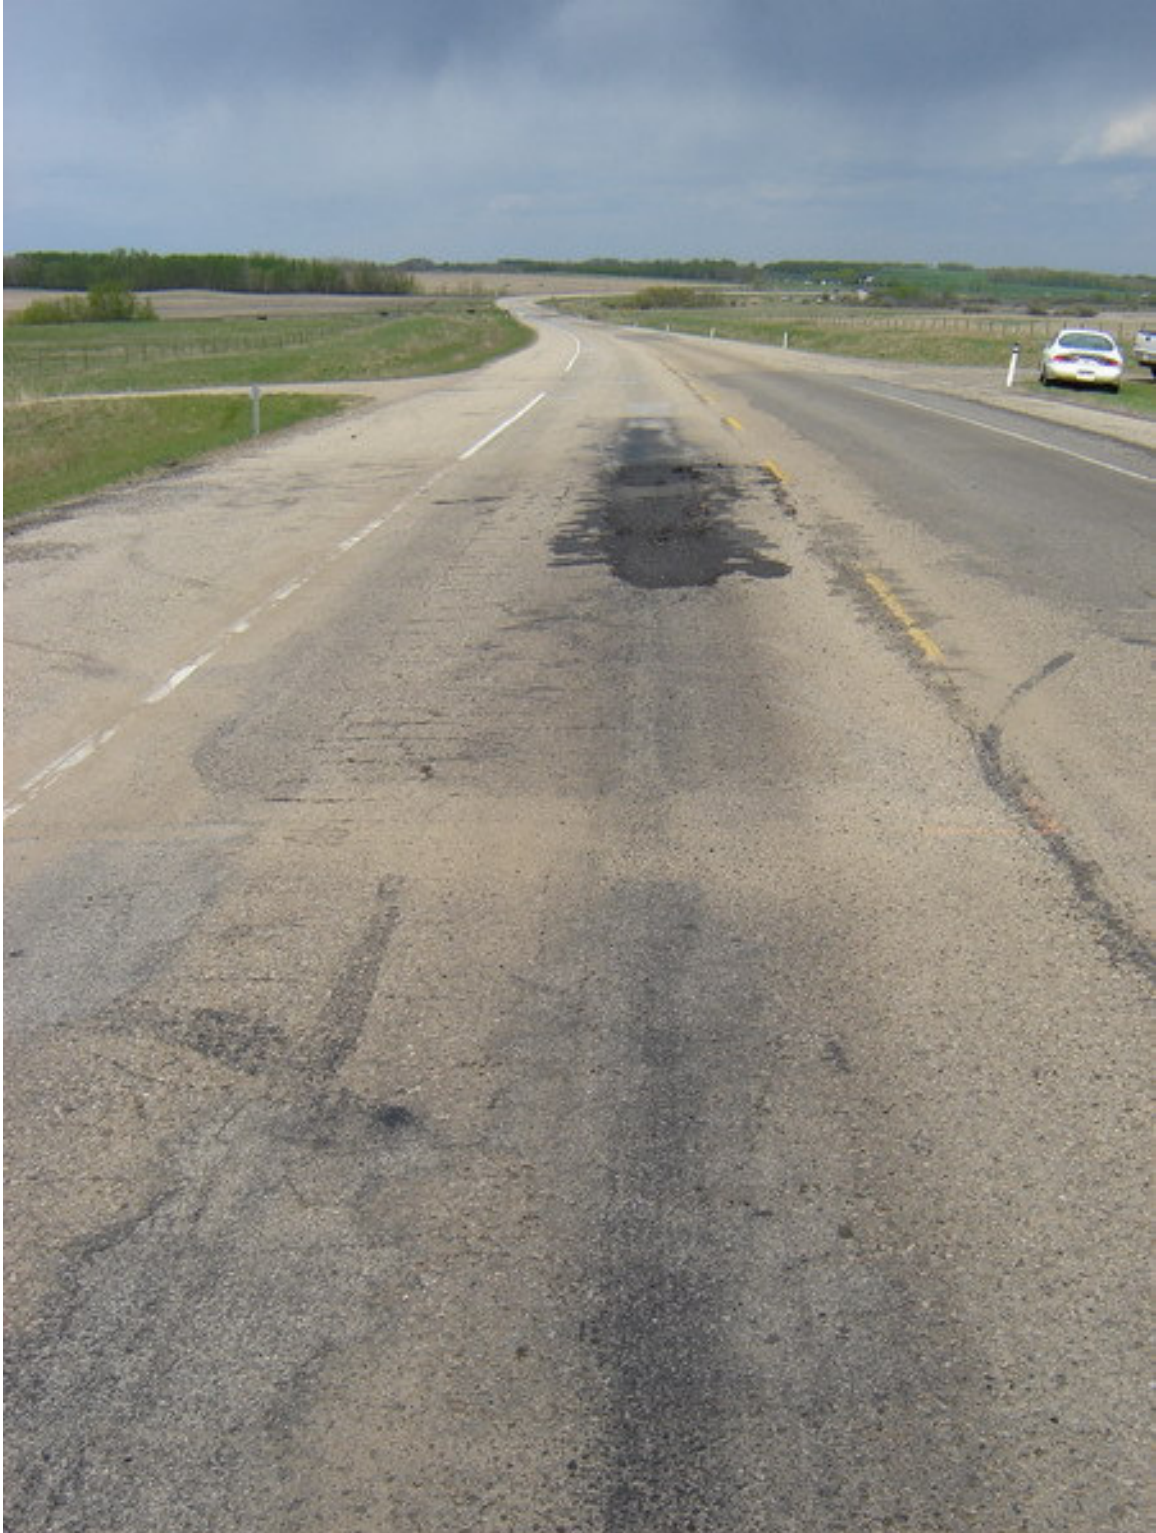
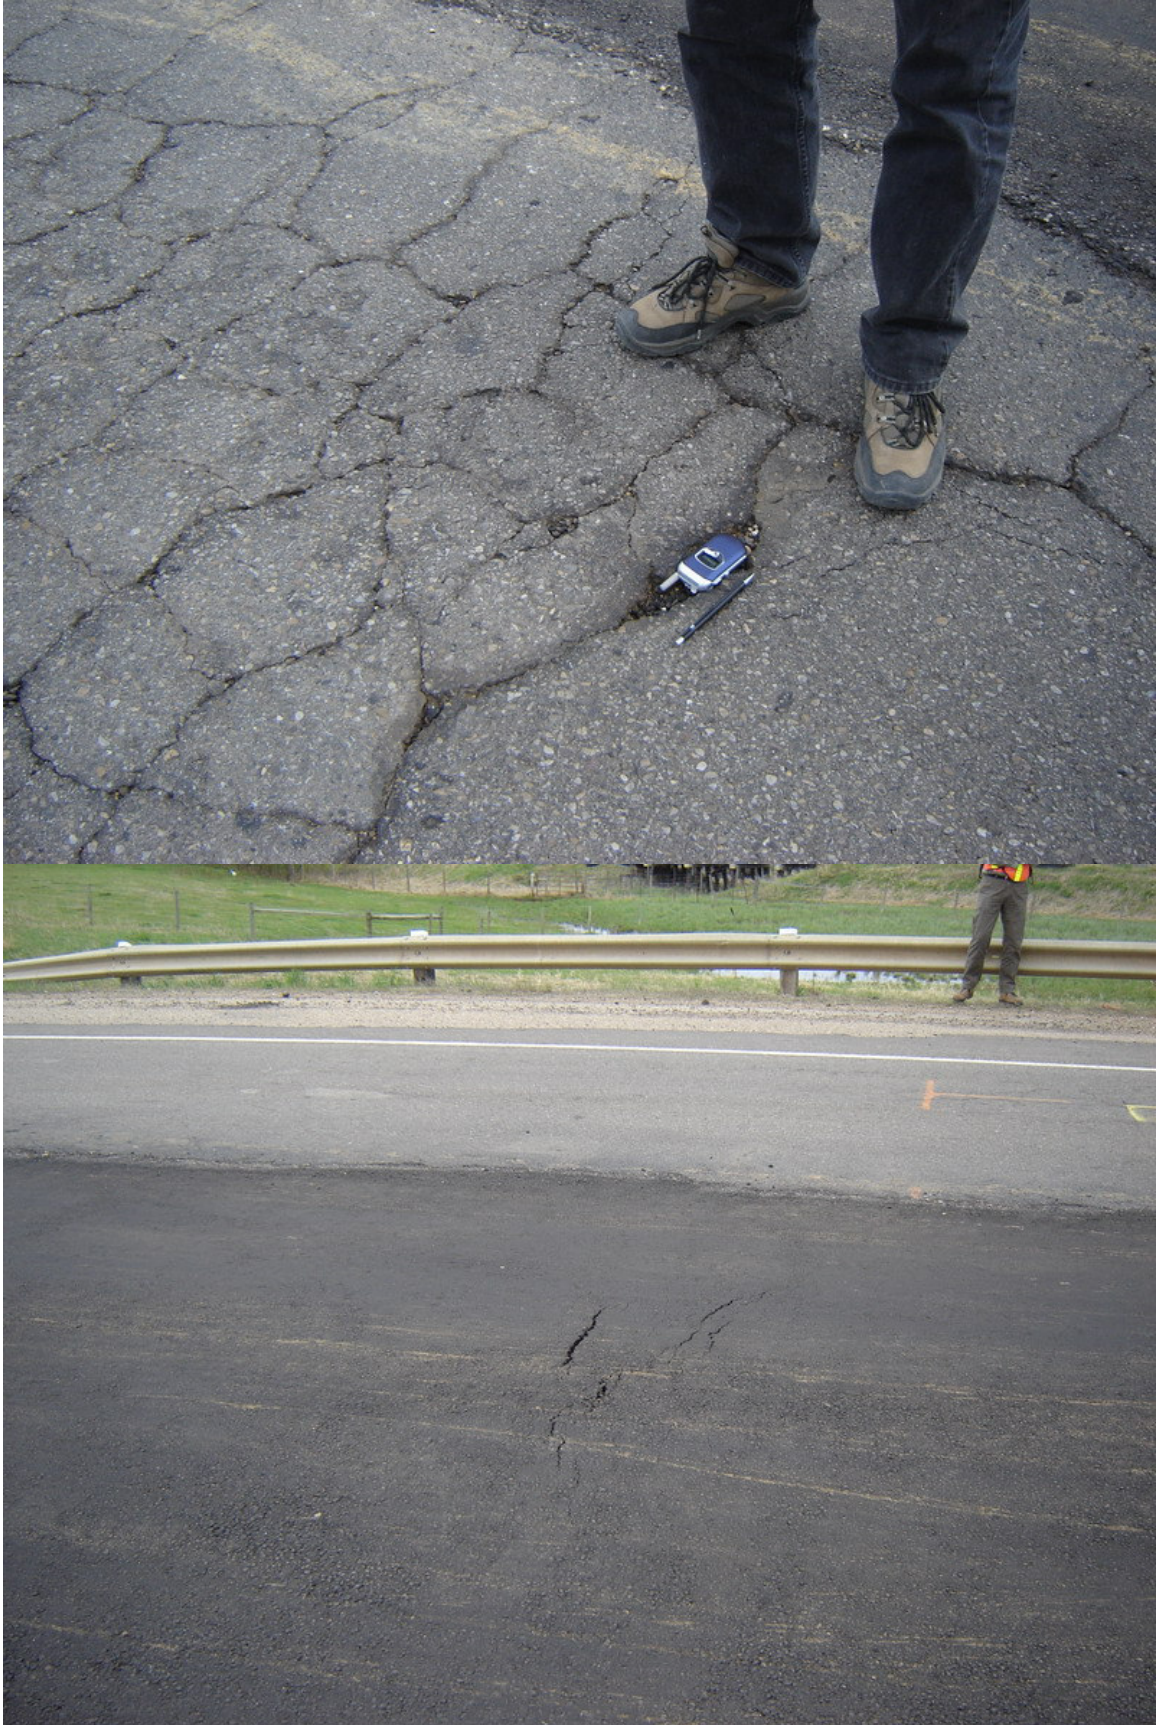
ITEM	CONDITION EXISTS		DESCRIPTION AND LOCATION	NOTICABLE CHANGE FROM LAST INSPECTION	
	YES	NO		YES	NO
Pavement Distress	X		Three areas of severe fatigue cracking in pavement, indicative of a soft subgrade.		X
Slope Movement		X			X
Erosion		X			X
Seepage		X			X
Culvert Distress		X			X

COMMENTS
Refer to attached photographs and description overpage.
Distress is observed in 3 areas: the 2 southernmost areas comprise one lane only and measure about 10 m long by 5 m wide. The area immediately south of the railway crossing is more extensive and measures about 50 m long by 10 m wide.

This type of pavement failure generally occurs when the pavement has been stressed to the limit of its fatigue life by repetitive axle load applications. Fatigue cracking is often associated with loads which are too heavy for the pavement structure or more repetitions of a given load than provided for in design. The problem is often made worse by inadequate pavement drainage which contributes to this distress by allowing the pavement layers to become saturated and lose strength. Fatigue cracking is also often caused by repetitive passes with overweight trucks and/or inadequate pavement thickness due to poor quality control during construction. Fatigue cracking can lead to the development of potholes when the individual pieces of asphalt physically separate from the adjacent material and are dislodged from the pavement surface by the action of traffic. Potholes generally occur when fatigue cracking is in the advanced stages and when relatively thin layers of asphalt comprise the bound portion of the pavement (such as a patch).

We would recommend that a sub-base removal and replacement approach be adopted for this site. It is understood that the highway structure comprises the following:

For the distressed pavement areas, it is recommended that the soft subgrade soils be excavated to a depth of about 1 m (or to a depth where a competent subgrade is encountered). A layer of woven geotextile with a minimum grab tensile strength of 1400N (e.g. Nilex Woven 2006 or equivalent) should be placed on the subgrade and the excavation backfilled with compacted pitrun gravel (Des. 80). A further layer of woven geotextile should be placed on the surface of the pitrun gravel followed by 250 mm of GBC and 250 mm of ACP. It is recommended that the excavation be inspected by a geotechnical engineer to evaluate the subgrade soils and modify the recommendations accordingly.
