May 24, 2001

**Central Region Landslide Assessment Site C1**  
**H27:10 Ghostpine Creek Slide**  
**2001 Annual Inspection Report**

This report was prepared by Klohn Crippen Consultants Ltd. for Alberta Transportation Central Region under Contract No. CE053/2000.

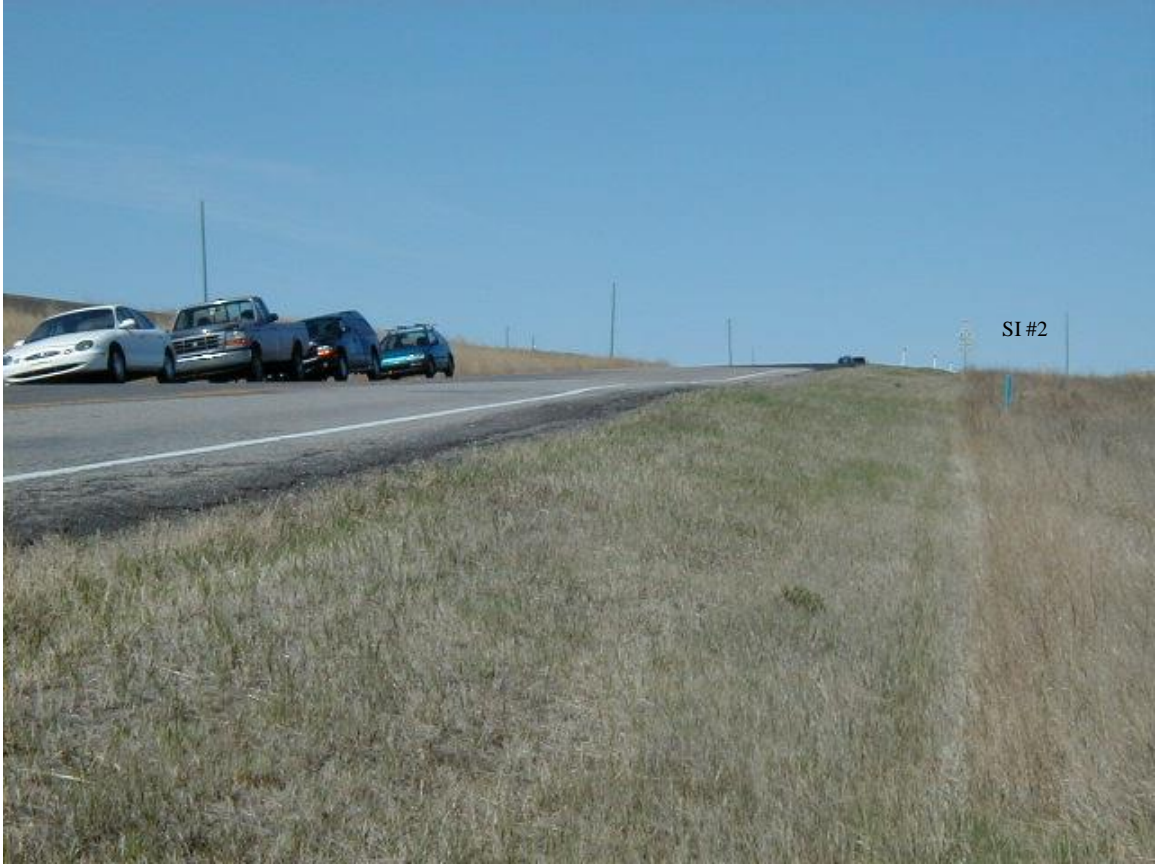
Looking west at area patched in 1999

- As the movement in the area is very slow, it is recommended that highway pavement be milled down and patched to remove the cracks, dips and bumps in this road section as part of the overlay construction.

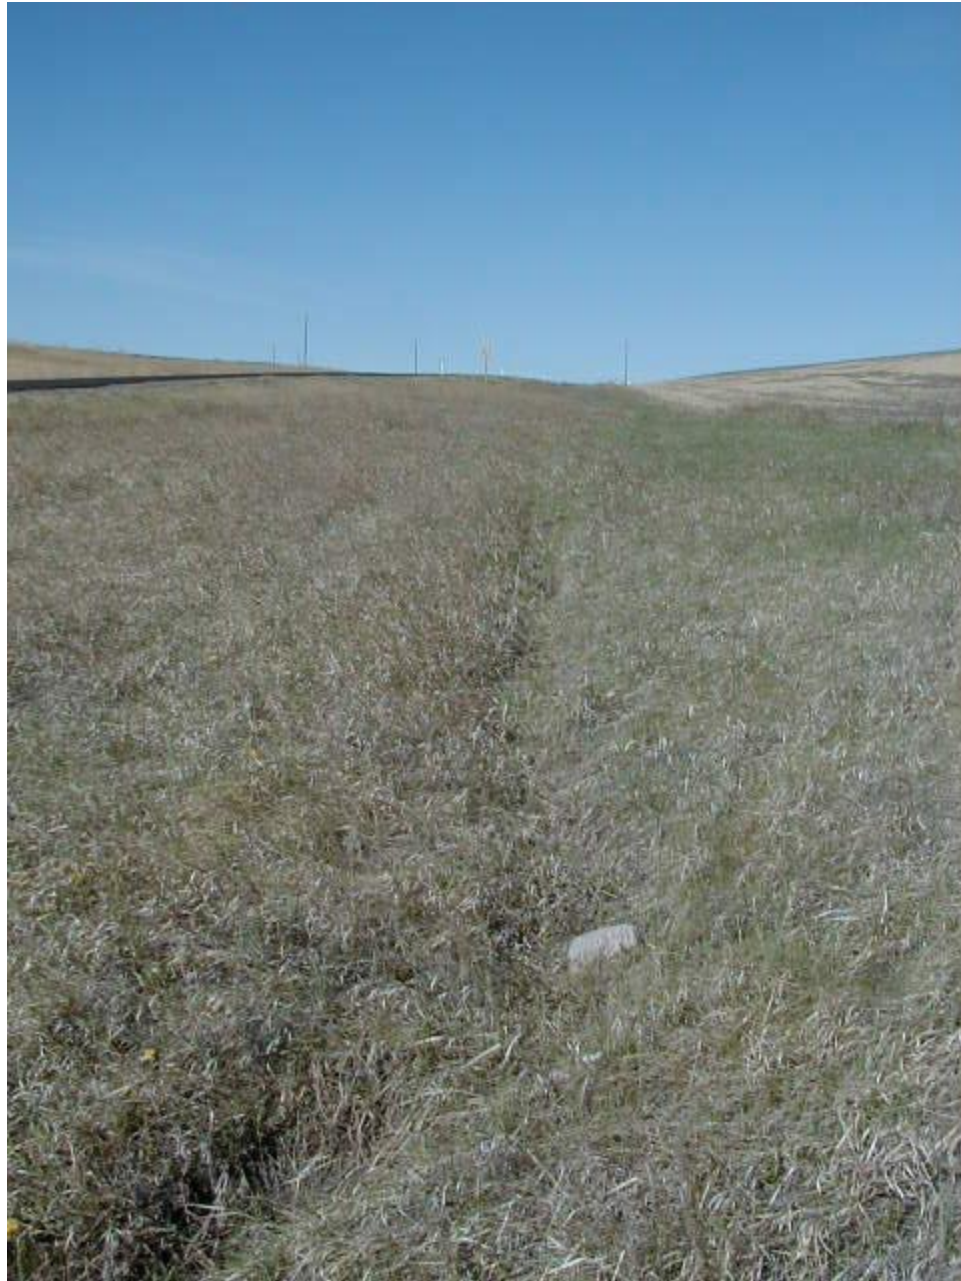
Looking west at small erosion channel forming on north side of highway

- The eroded cracks on the north side of the highway should be repaired by constructing drainage channels, say 0.5 m wide, with similar cobble size erosion protection as the south side. For the large eroded gully down the steeper portion of the side slope, it is recommended that a 600 mm CSP be provided in the gully for

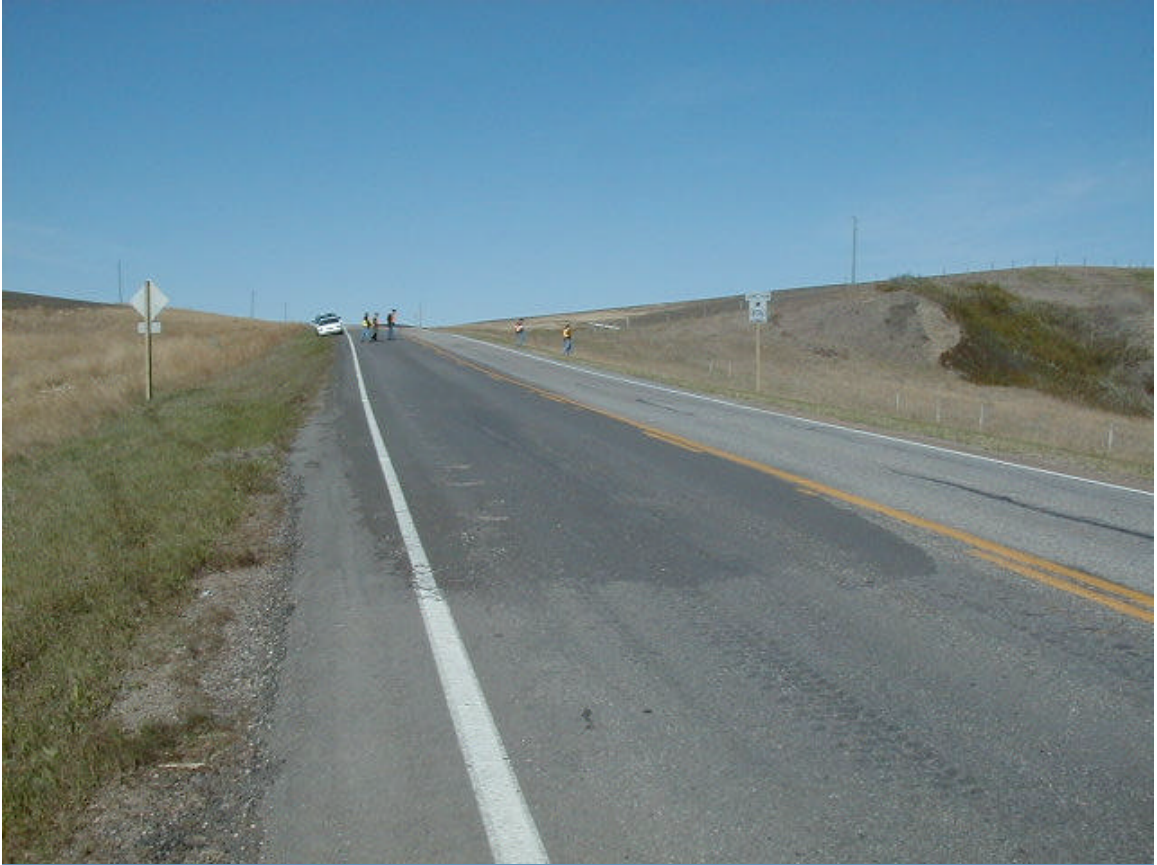
Looking west (newest patched area in background (2000))

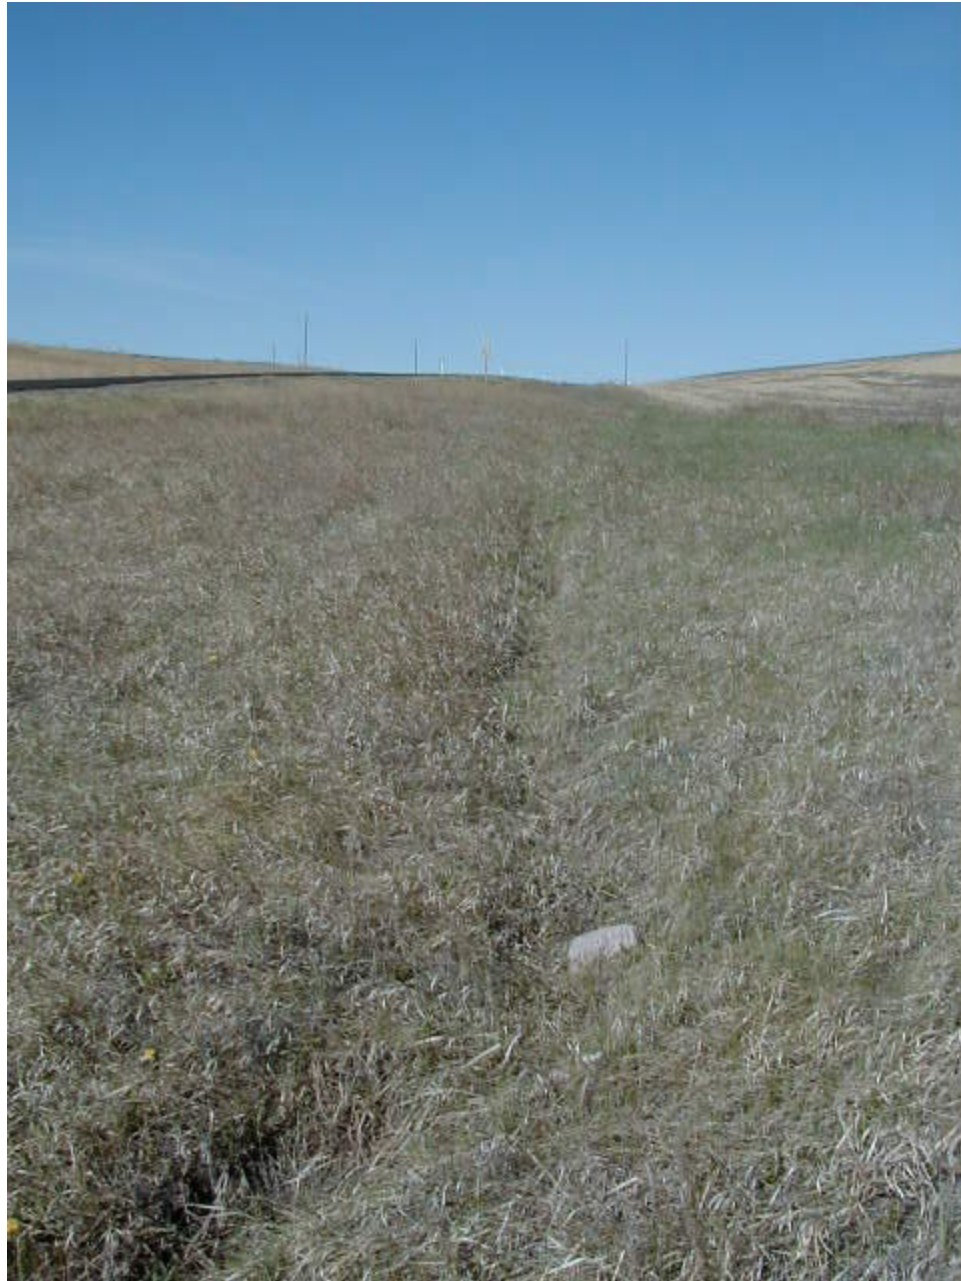
Looking west at small erosion channel forming on north side of highway
