SITE NUMBER AND NAME C57 H41:14 Pavement Distress		HIGHWAY & KM km 22	PREVIOUS INSPECTION DATE October 23, 2009	INSPECTION DATE May 18, 2010
LEGAL DESCRIPTION SE18-37-6-W4	NAD 83 COORDINATES N 5780380 E 510040		RISK ASSESMENT PF: 9 CF: 4 TOTAL: 36

Central Region GeoHazard Assessments
Site C57 H41:14 km 22 Pavement Distress
May 2010 Site Assessment Report

Site C57 H41:14 Pavement Distress
May 18, 2010

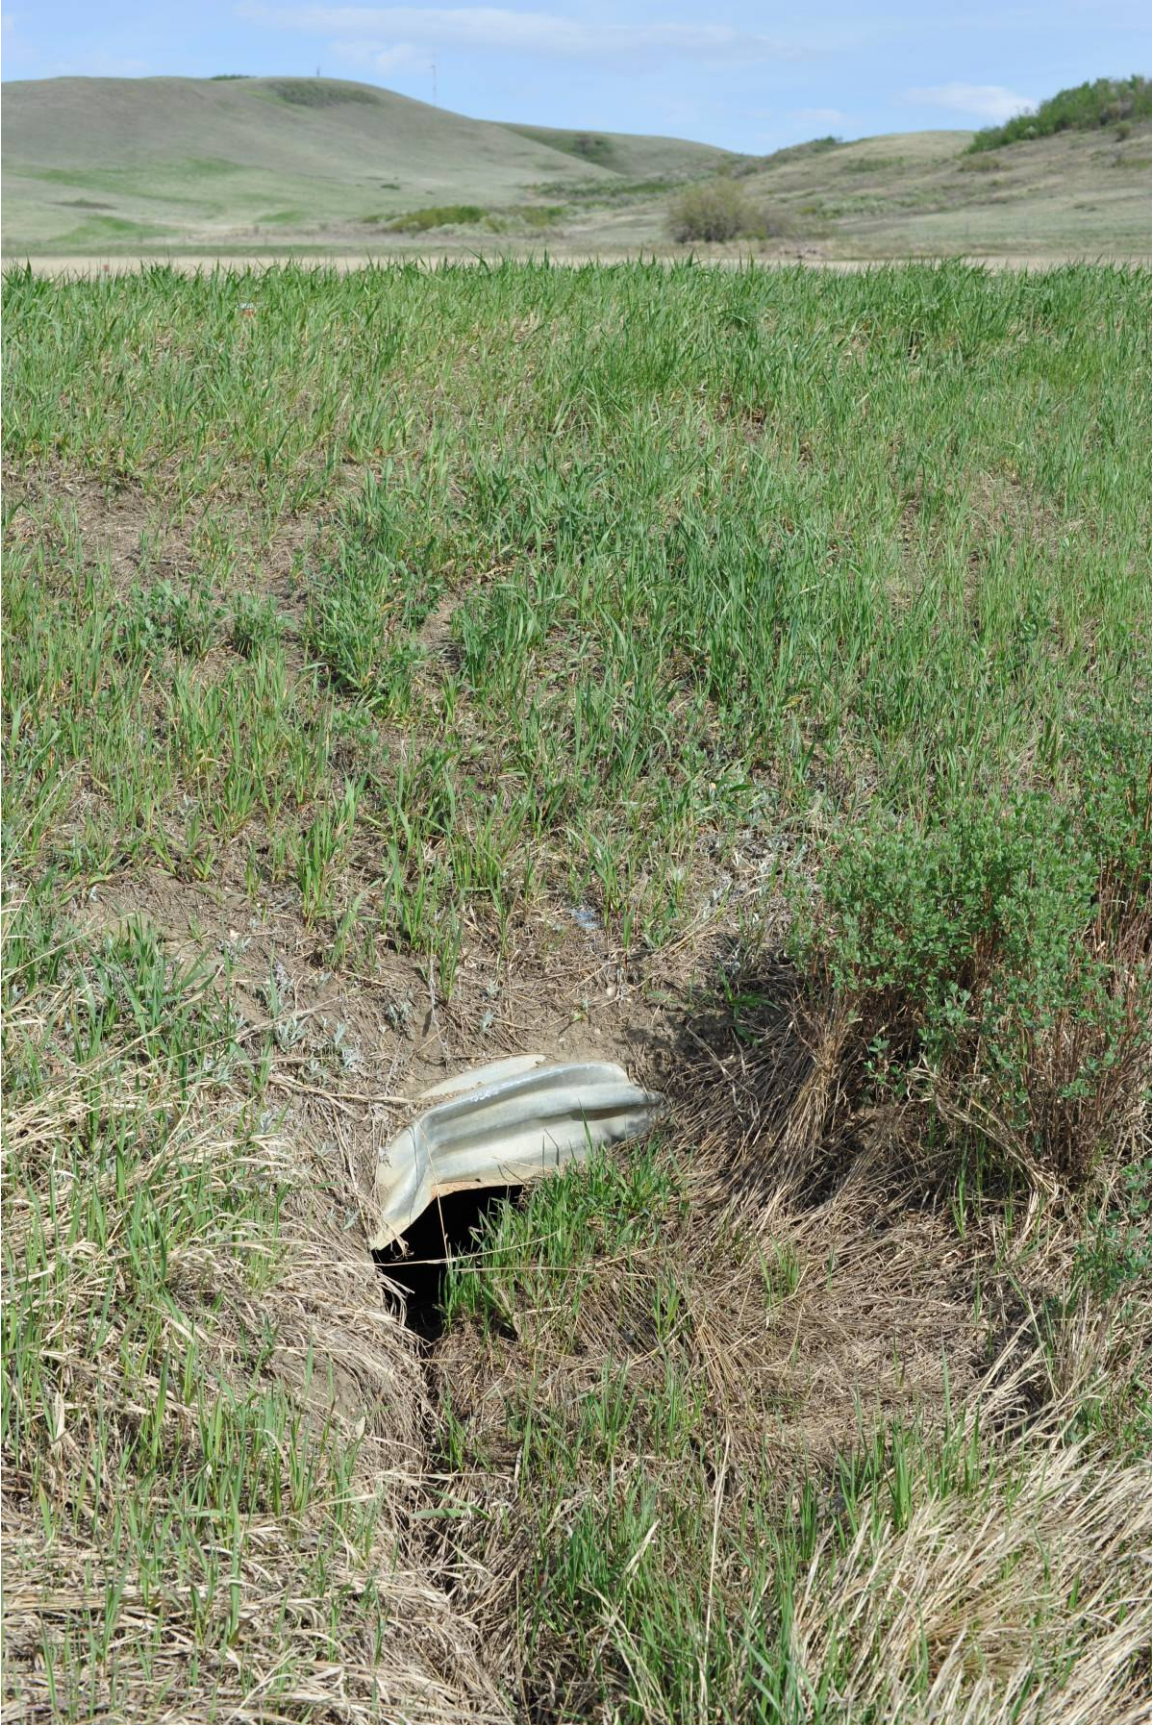
- Despite a number of full width patches, the road surface is highly uneven and a 70 km/hr speed restriction is in effect. The greatest dip is located at the south end of the site and is adjacent to a large bulge in the east ditch slope.
- Deep cracks were observed in the highway surface
- The ditch vegetation was relatively dense and indicative of wet soil conditions.
- A single culvert was located and discharges to the west. The downstream end was blocked with soil and vegetation.

- The inlet and outlet areas of the culvert should be cleared of vegetation and graded to permit drainage.
- A site investigation should be conducted to determine the subsurface conditions of the road, including soil type and groundwater levels. It is recommended that about 6 standpipes to a depth of about 6 m to 8 m be installed along alternate sides of the shoulder of the highway. The cost of this investigation is estimated to be about [REDACTED] as shown in Table 1. As part of this investigation, an existing data review will be undertaken including a review of historical air photographs and Department records. The work will be summarized in a brief letter report including recommendations for future action.
