**CENTRAL REGION  
GEOHAZARD RISK ASSESMENT  
SITE INSPECTION FORM**

SITE NUMBER AND NAME <b>C28 H53:06</b>		HIGHWAY & KM 4 km west of Highway 2	PREVIOUS INSPECTION DATE May 23, 2003	INSPECTION DATE <b>May 12, 2004</b>
LEGAL DESCRIPTION NW 4-43-26-W4	NAD 83 COORDINATES* N 5839575 E 317020		RISK ASSESMENT PF: 9 CF: 1 TOTAL: <b>9</b>

LAST READING DATE:	
PRIMARY SITE ISSUE: Ditch Erosion/Frost Heave	
APPROXIMATE DIMENSIONS: Ditch erosion length about 80 m, frost heave about 3 m wide across road	
DATE OF ANY REMEDIAL ACTION: Drains in 1980's, gravel in frost heave area in 1999

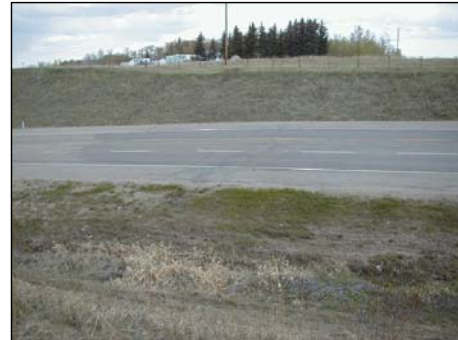
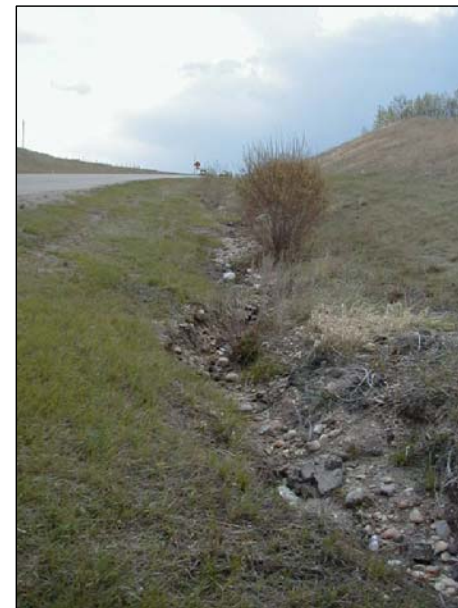
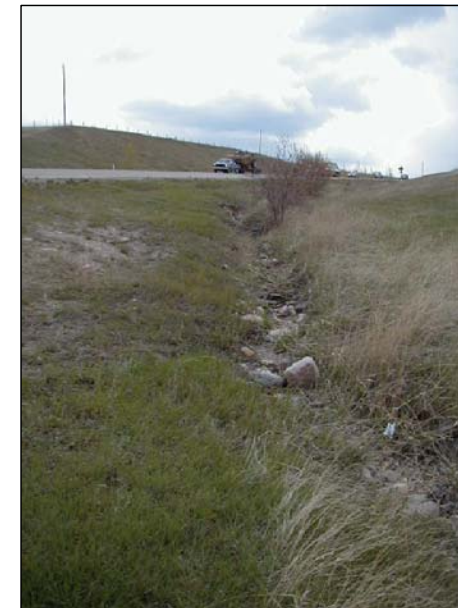
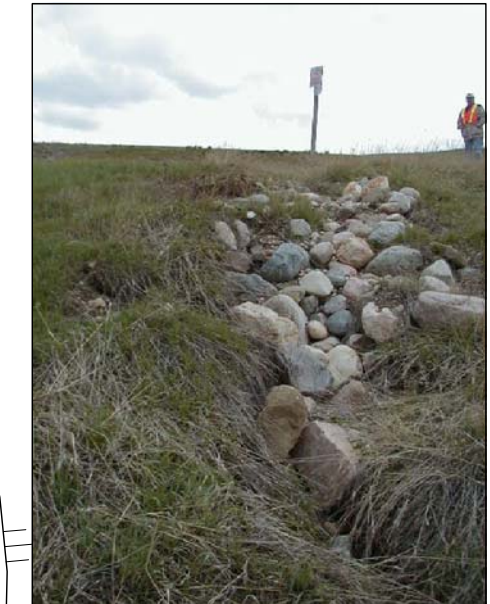
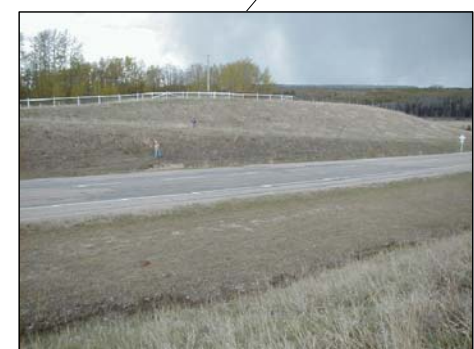
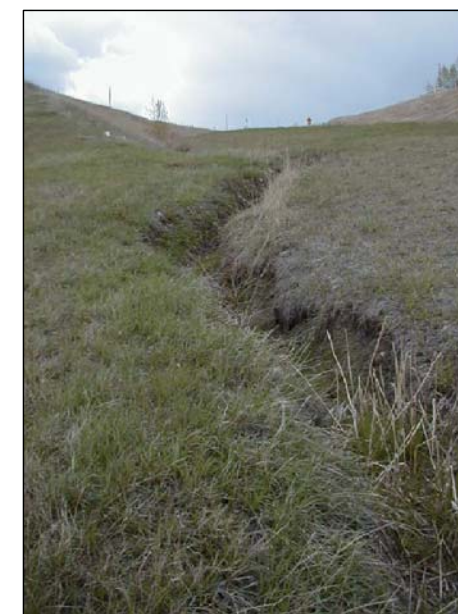
<b>COMMENTS</b>
Refer to attached photos, figures and recommendations
*Coordinates of ditch erosion Frost Heave coordinates: N5839650, E317215

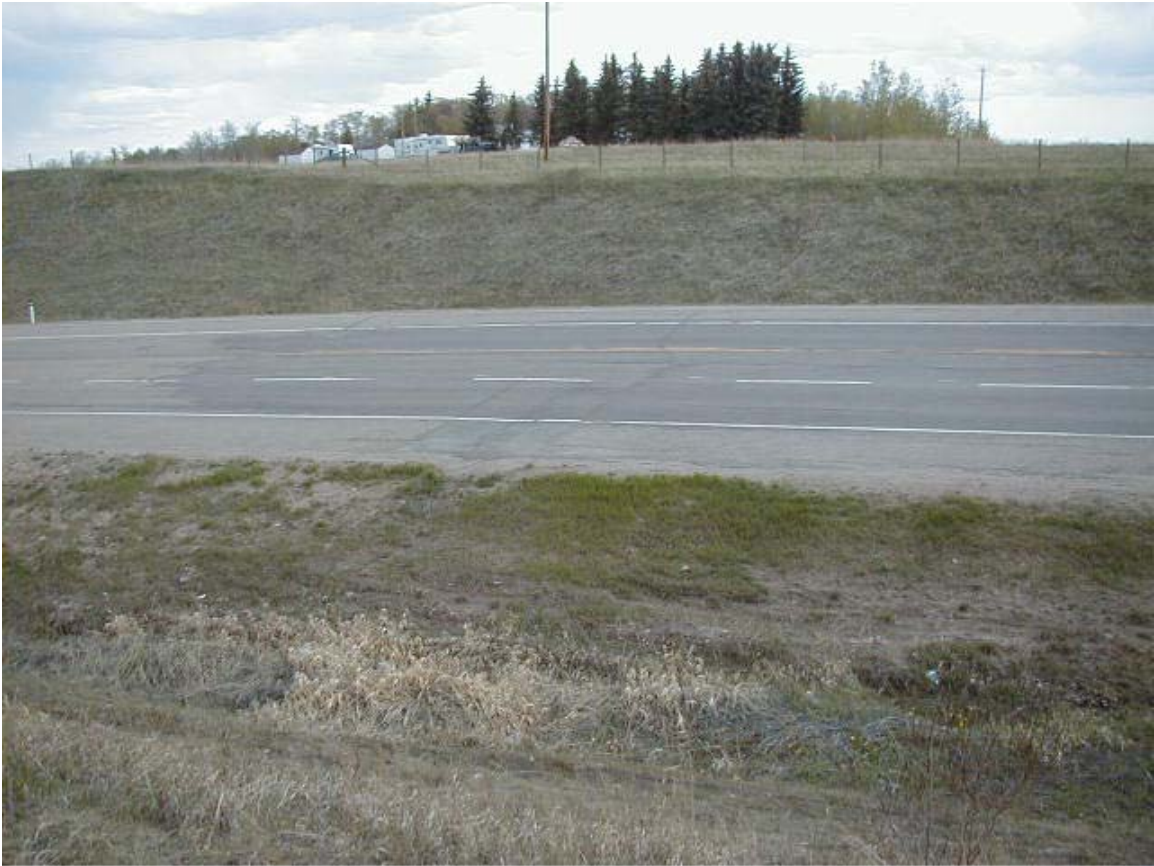
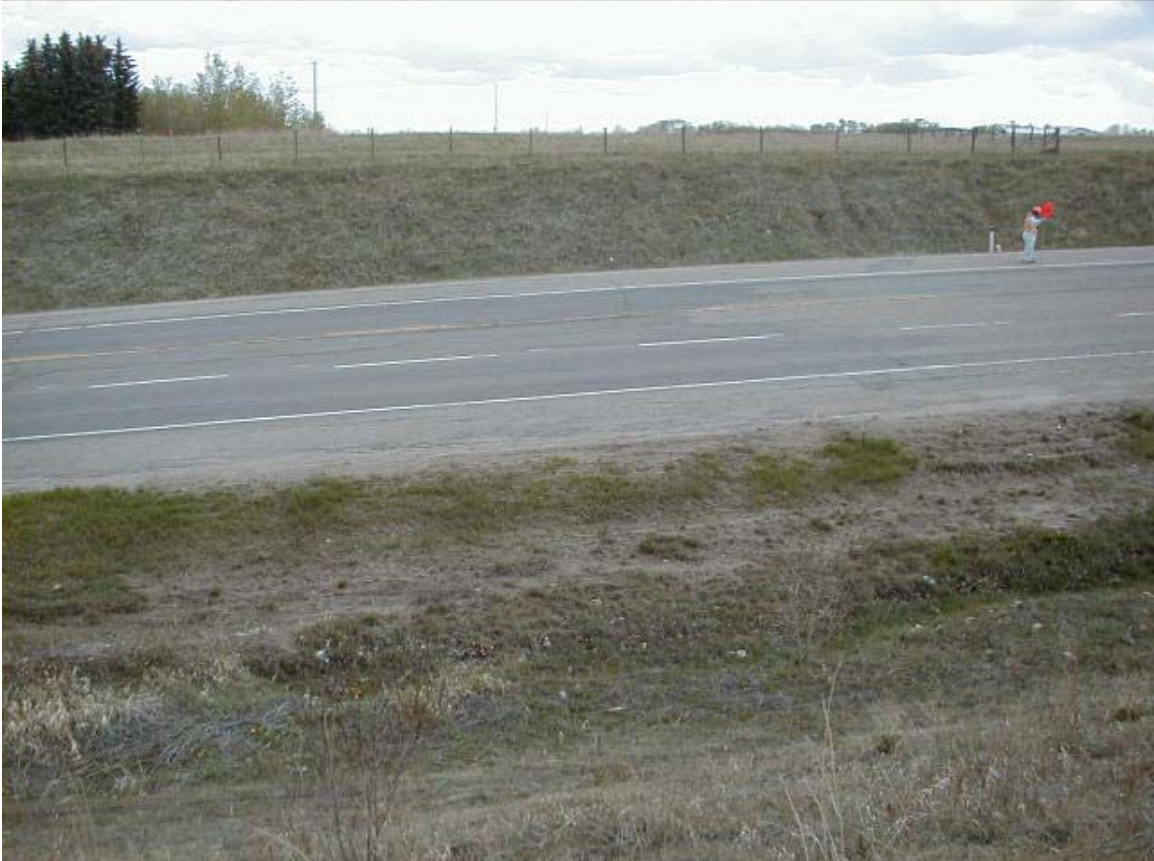
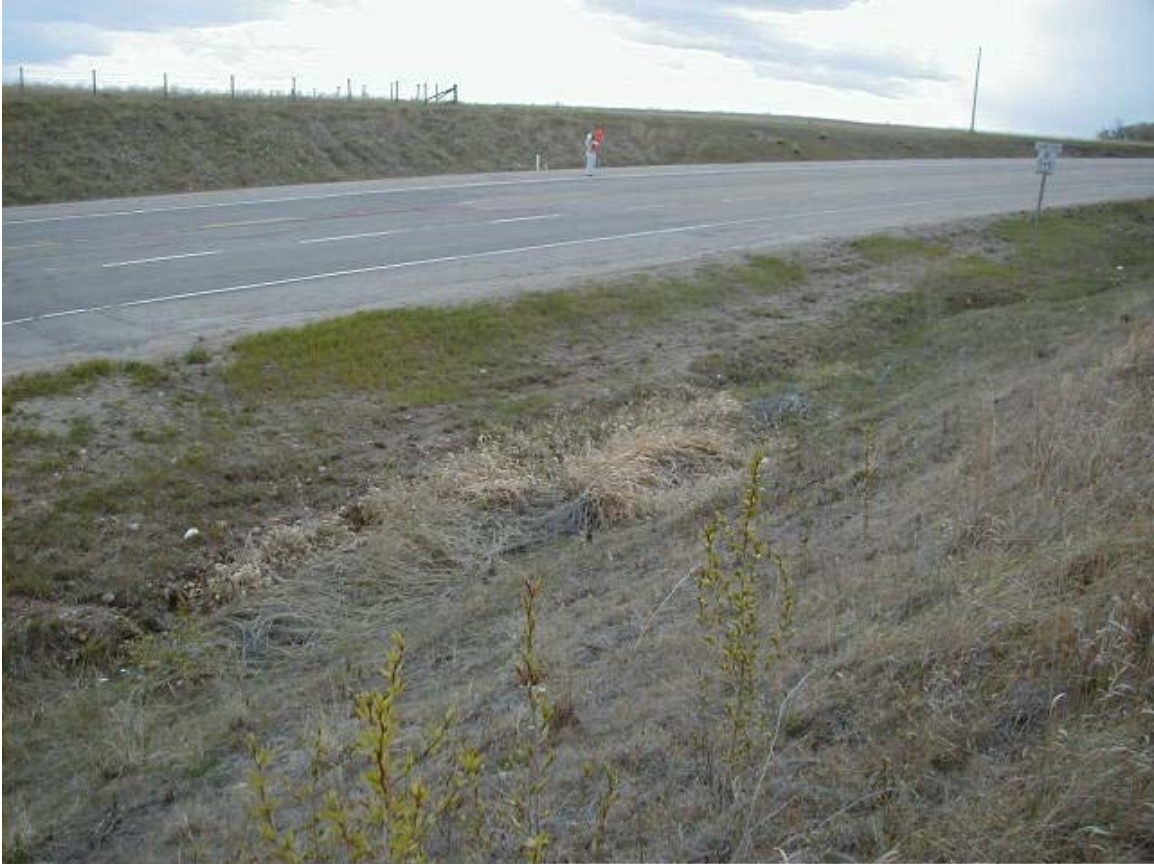
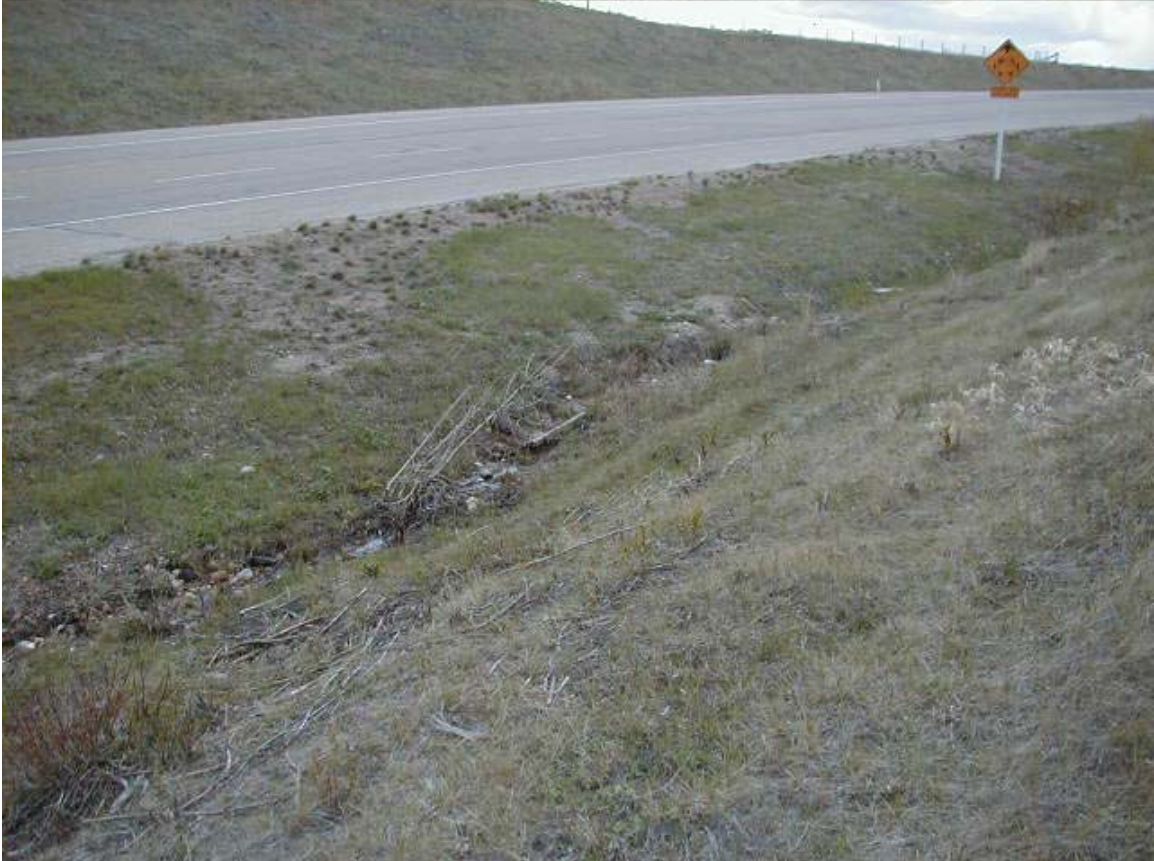
In the winter of 2002/03, a car slid off the highway and became entrapped in the ditch erosion to the southwest of the frost heave area. The total length of the erosion is about 80 m. It is recommended that the erosion area close to the highway edge over a length of about 25 m be remediated with a "Tri-Lock" block approach and delivered in a future overlay project.
