**CENTRAL REGION
GEOHAZARDS RISK ASSESMENT
SITE INSPECTION FORM**

SITE NUMBER AND NAME C26 H585:02		HIGHWAY & KM 18.98-20.19	PREVIOUS INSPECTION DATE May 21, 2003	INSPECTION DATE May 18, 2004
LEGAL DESCRIPTION	NAD 83 COORDINATES Refer to individual sites		RISK ASSESMENT PF: 9 CF: 2 TOTAL: 18

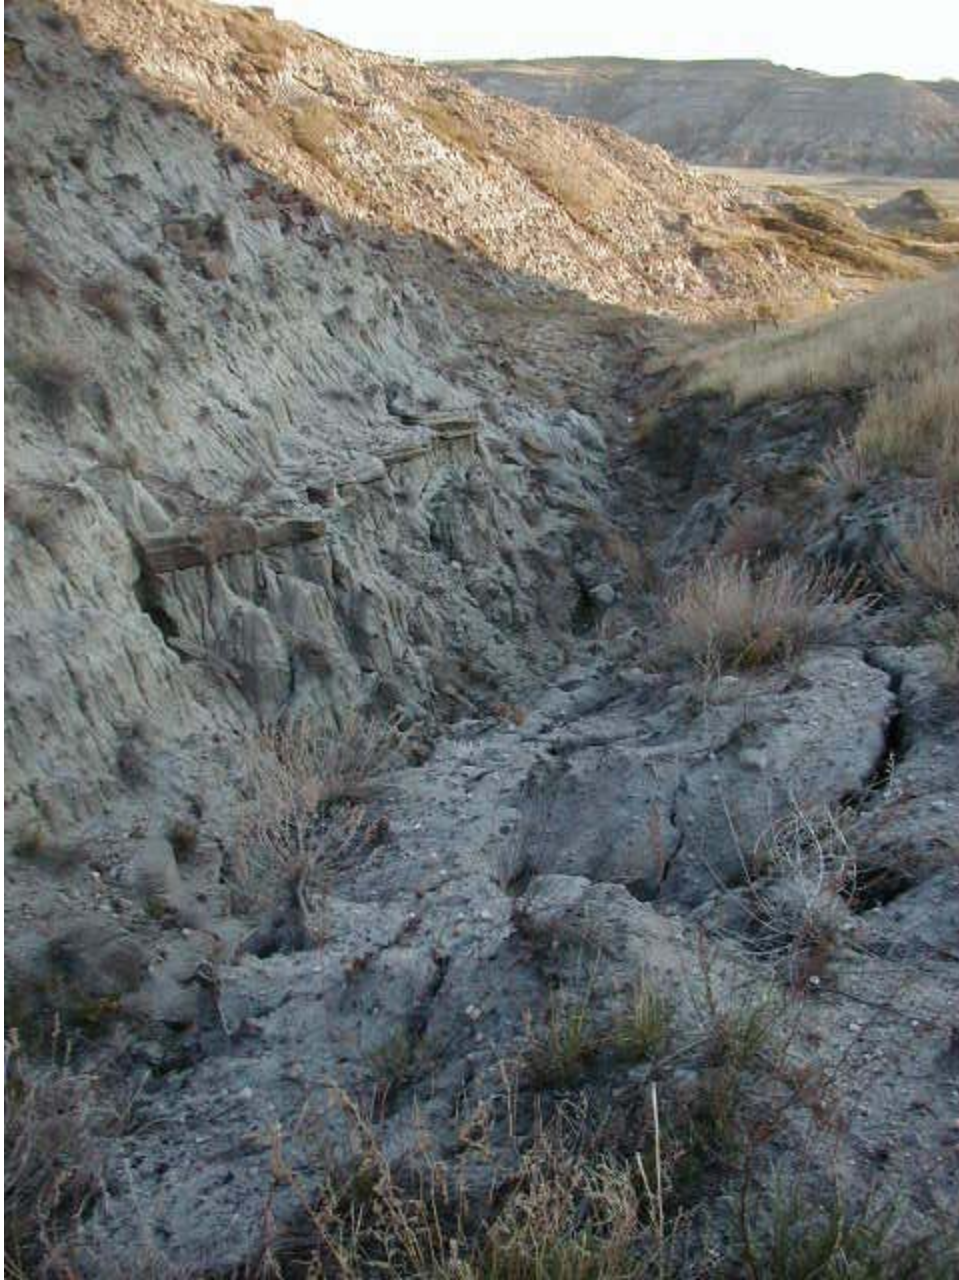
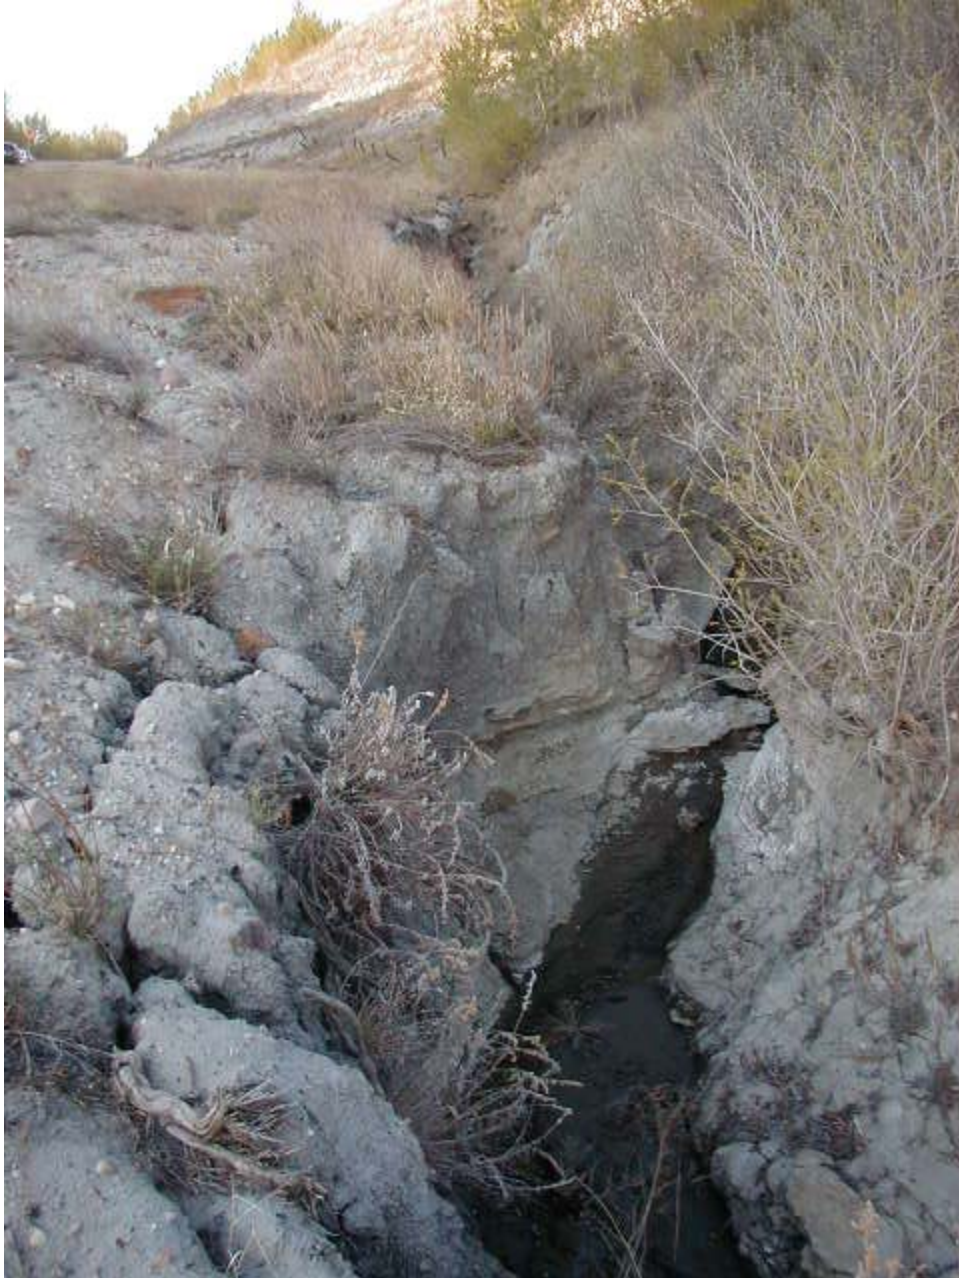
A large erosion ditch has been formed by a spring in the valley slope. The spring has been observed to flow year-round. Some slumping was observed in the erosion channel sides, however, the ditch is currently outside the clear zone of the highway.

Spring area and slumped material in ditch

It is recommended that the rate and extent of the erosion be observed to determine the required remedial work. It is likely that the required remediation will involve the infilling of the eroded ditch with a “hard” protective layer as the potential for good vegetation growth would appear poor. It is considered that this site is relatively low priority.
