SITE NUMBER AND NAME: C030 Slide and Erosion Site		HIGHWAY & KM: 734:12, 40.628	PREVIOUS INSPECTION DATE: June 23, 2016	INSPECTION DATE: July 9, 2019
LEGAL DESCRIPTION: SW 29-33-8-W5	NAD 83 COORDINATES: UTM Northing Easting 11 5745765 629598		RISK ASSESSMENT: PF: 1 CF: 1 TOTAL: 1	
AVERAGE ANNUAL DAILY TRAFFIC (AADT): 100 (southbound) & 60 (northbound) (Ref No. 51280)			CONTRACT MAINTENANCE AREA (CMA): 18

NOTES: 1. HORIZONTAL DATUM: NAD83 2. GRID ZONE: UTM Zone 12N 3. IMAGE SOURCE: Bing Maps, Microsoft Corporation 2019	CLIENT 	PROJECT CENTRAL REGION GEOHAZARD RISK MANAGEMENT PROGRAM
		TITLE Site Plan C030 Hwy 734:12, km 40.628
SCALE 1:1,000	PROJECT No. A05115A02	FIG No. 1

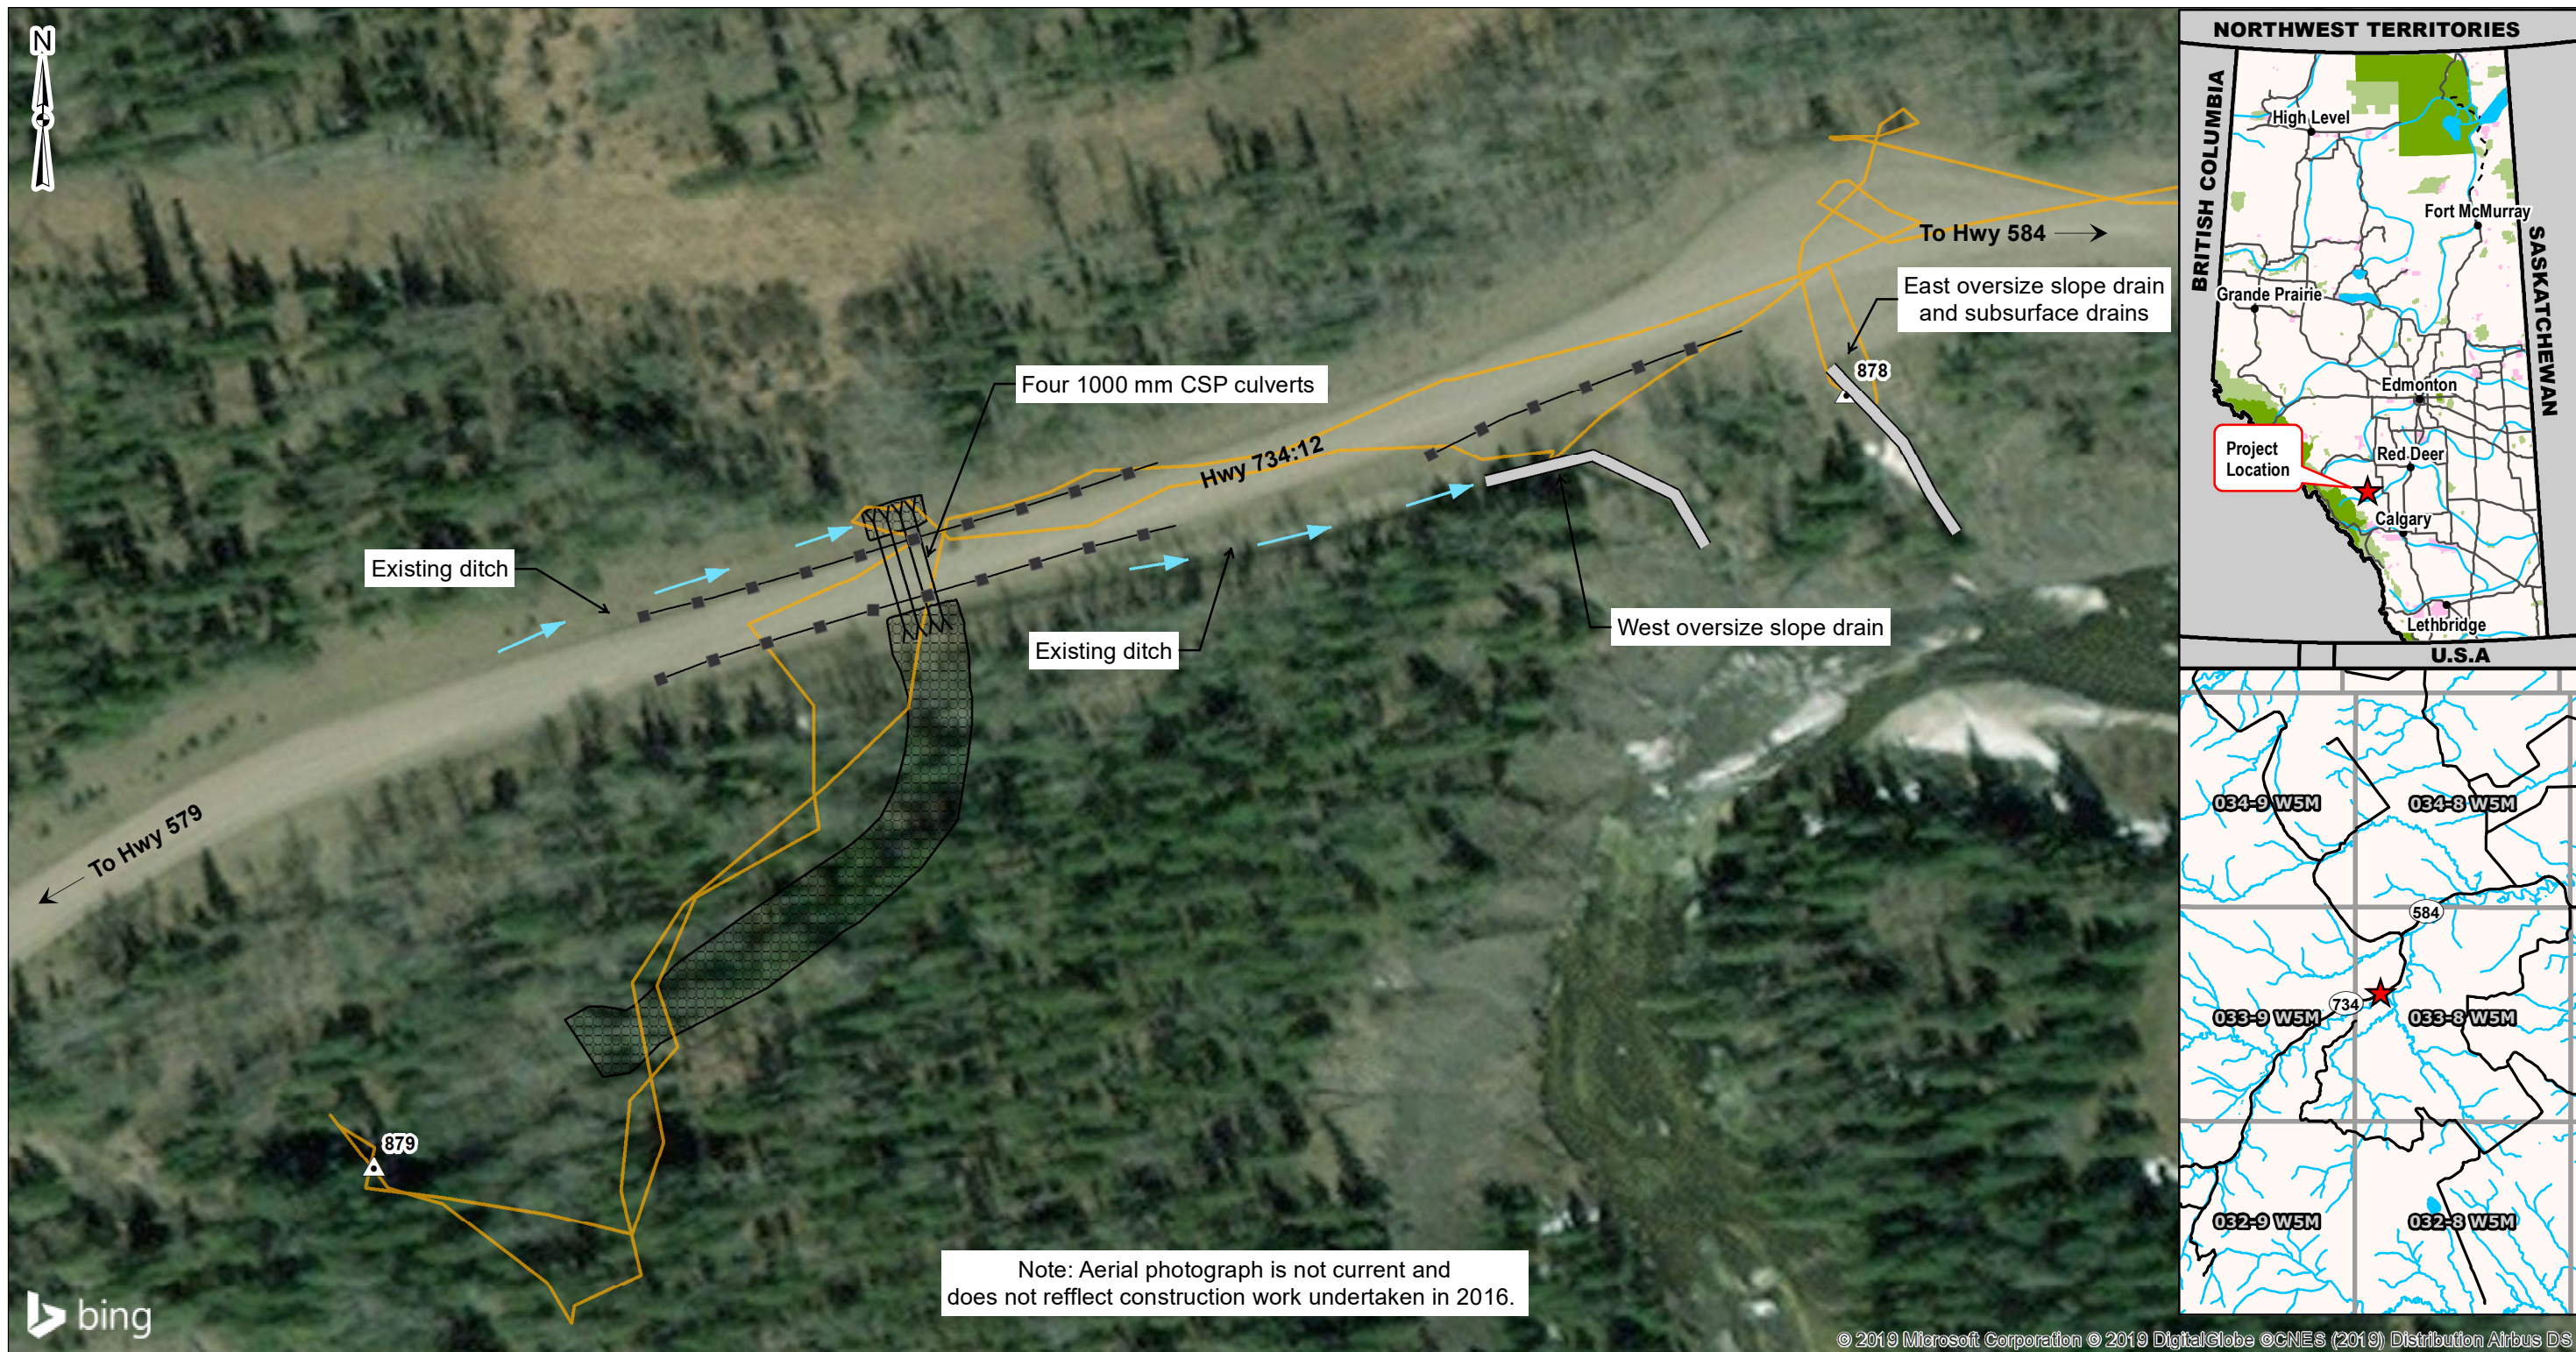
Water was observed to be flowing through the forested area and over the river valley slope downstream of the armoured outlet channel (waypoint 879). A landslide that was observed in 2017 where the water flows over the crest of the valley slope does not appear to have worsened.
