**CENTRAL REGION  
GEOHAZARD RISK ASSESMENT  
SITE INSPECTION FORM**

SITE NUMBER AND NAME <b>C20 H771:02 Pavement</b>		HIGHWAY & KM	PREVIOUS INSPECTION DATE May 23, 2003	INSPECTION DATE <b>May 12, 2004</b>
LEGAL DESCRIPTION SW 3-41-1-W5	NAD 83 COORDINATES N 5820026 E 698635	RISK ASSESMENT PF: 9 CF: 1 TOTAL: <b>9</b>

## 1. SITE C20: H771:02 PAVEMENT DISTRESS

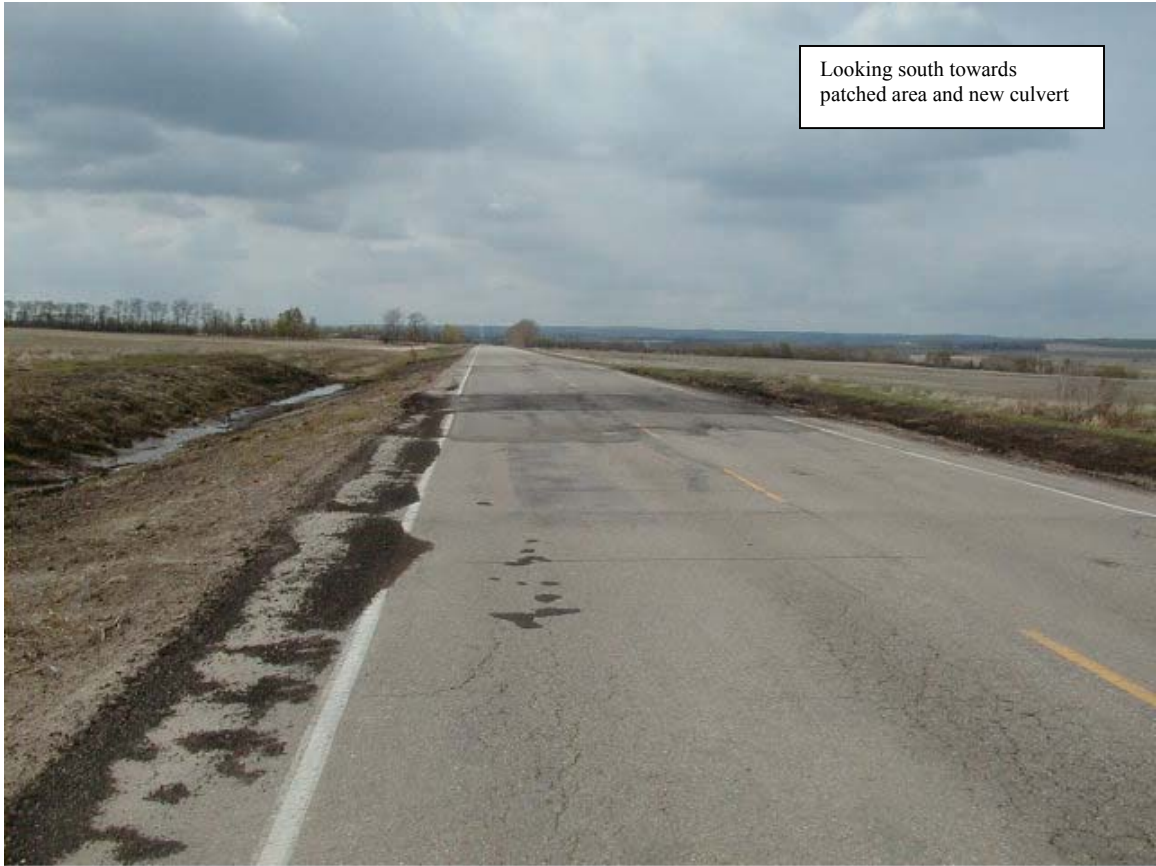
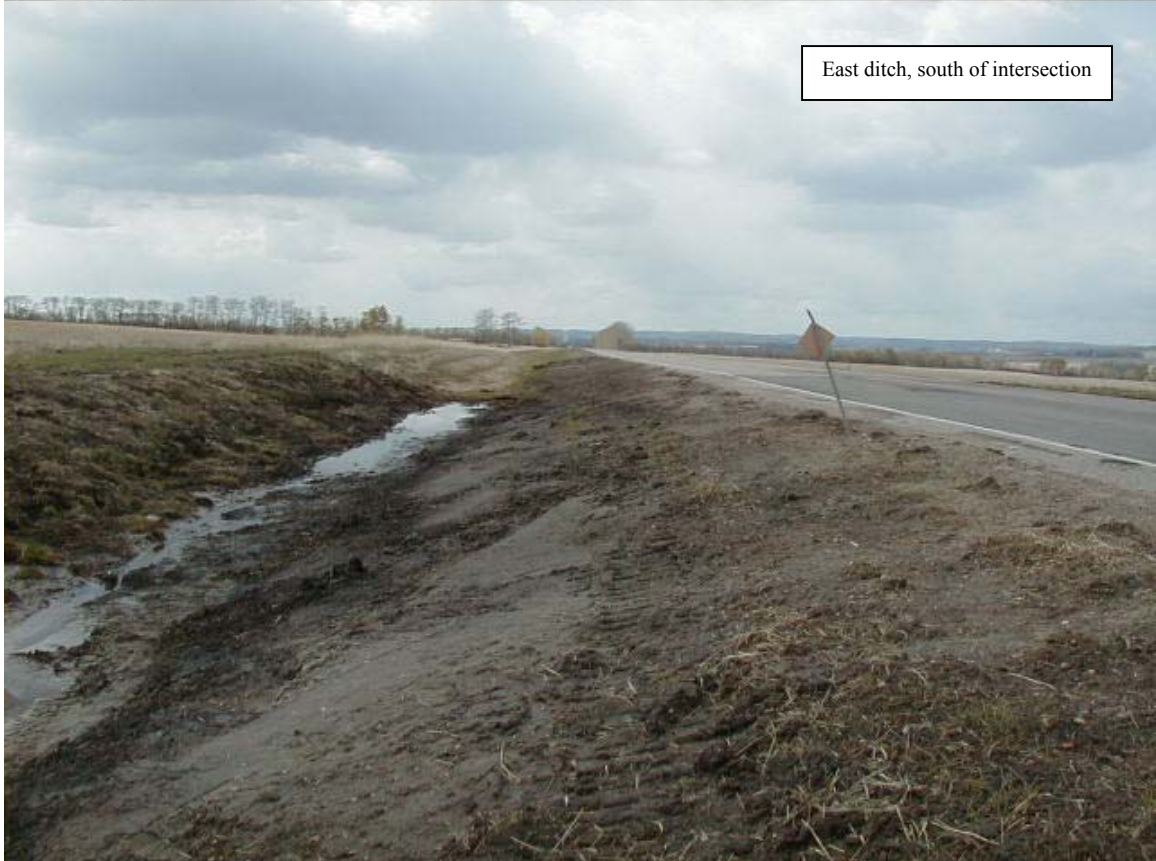
Over the last winter significant frost heave was observed south of the intersection in the area of the new culvert. Due to the granular fill around the new culvert, the culvert area did not heave to the same extent and resulted in a dangerous dip in the highway. The dip was patched and then trimmed off as the heave disappeared in the spring.

To remediate the frost heave area, a material replacement program is required with appropriate material tapering to prevent sharp humps and dips. However, to determine the extent of the heaving areas, it is recommended that the section be monitored over the next winter. It is proposed to undertake an elevation survey this summer and again in February 2005.
