SITE NUMBER AND NAME C063 Frost Heave		HIGHWAY & KM 11:12, 24.734	PREVIOUS INSPECTION DATE Feb 28, 2018	INSPECTION DATE Feb 21, 2019
LEGAL DESCRIPTION NE 24-38-1 W5	NAD 83 COORDINATES: UTM Northing Easting 11 5796735 703911		RISK ASSESSMENT PF: 8 CF: 3 TOTAL: 24	
AVERAGE ANNUAL DAILY TRAFFIC (AADT): 16,180 (west) & 16,420 (east) (Ref. No. 70000488)			CONTRACT MAINTENANCE AREA (CMA): 19

PROJECT CENTRAL REGION GEOHAZARD RISK MANAGEMENT PROGRAM		
TITLE C063 - Site Inspection Hwy 11:12, km 24.734		
SCALE 1:2,500	PROJECT No. A05115A02	FIG No. 1

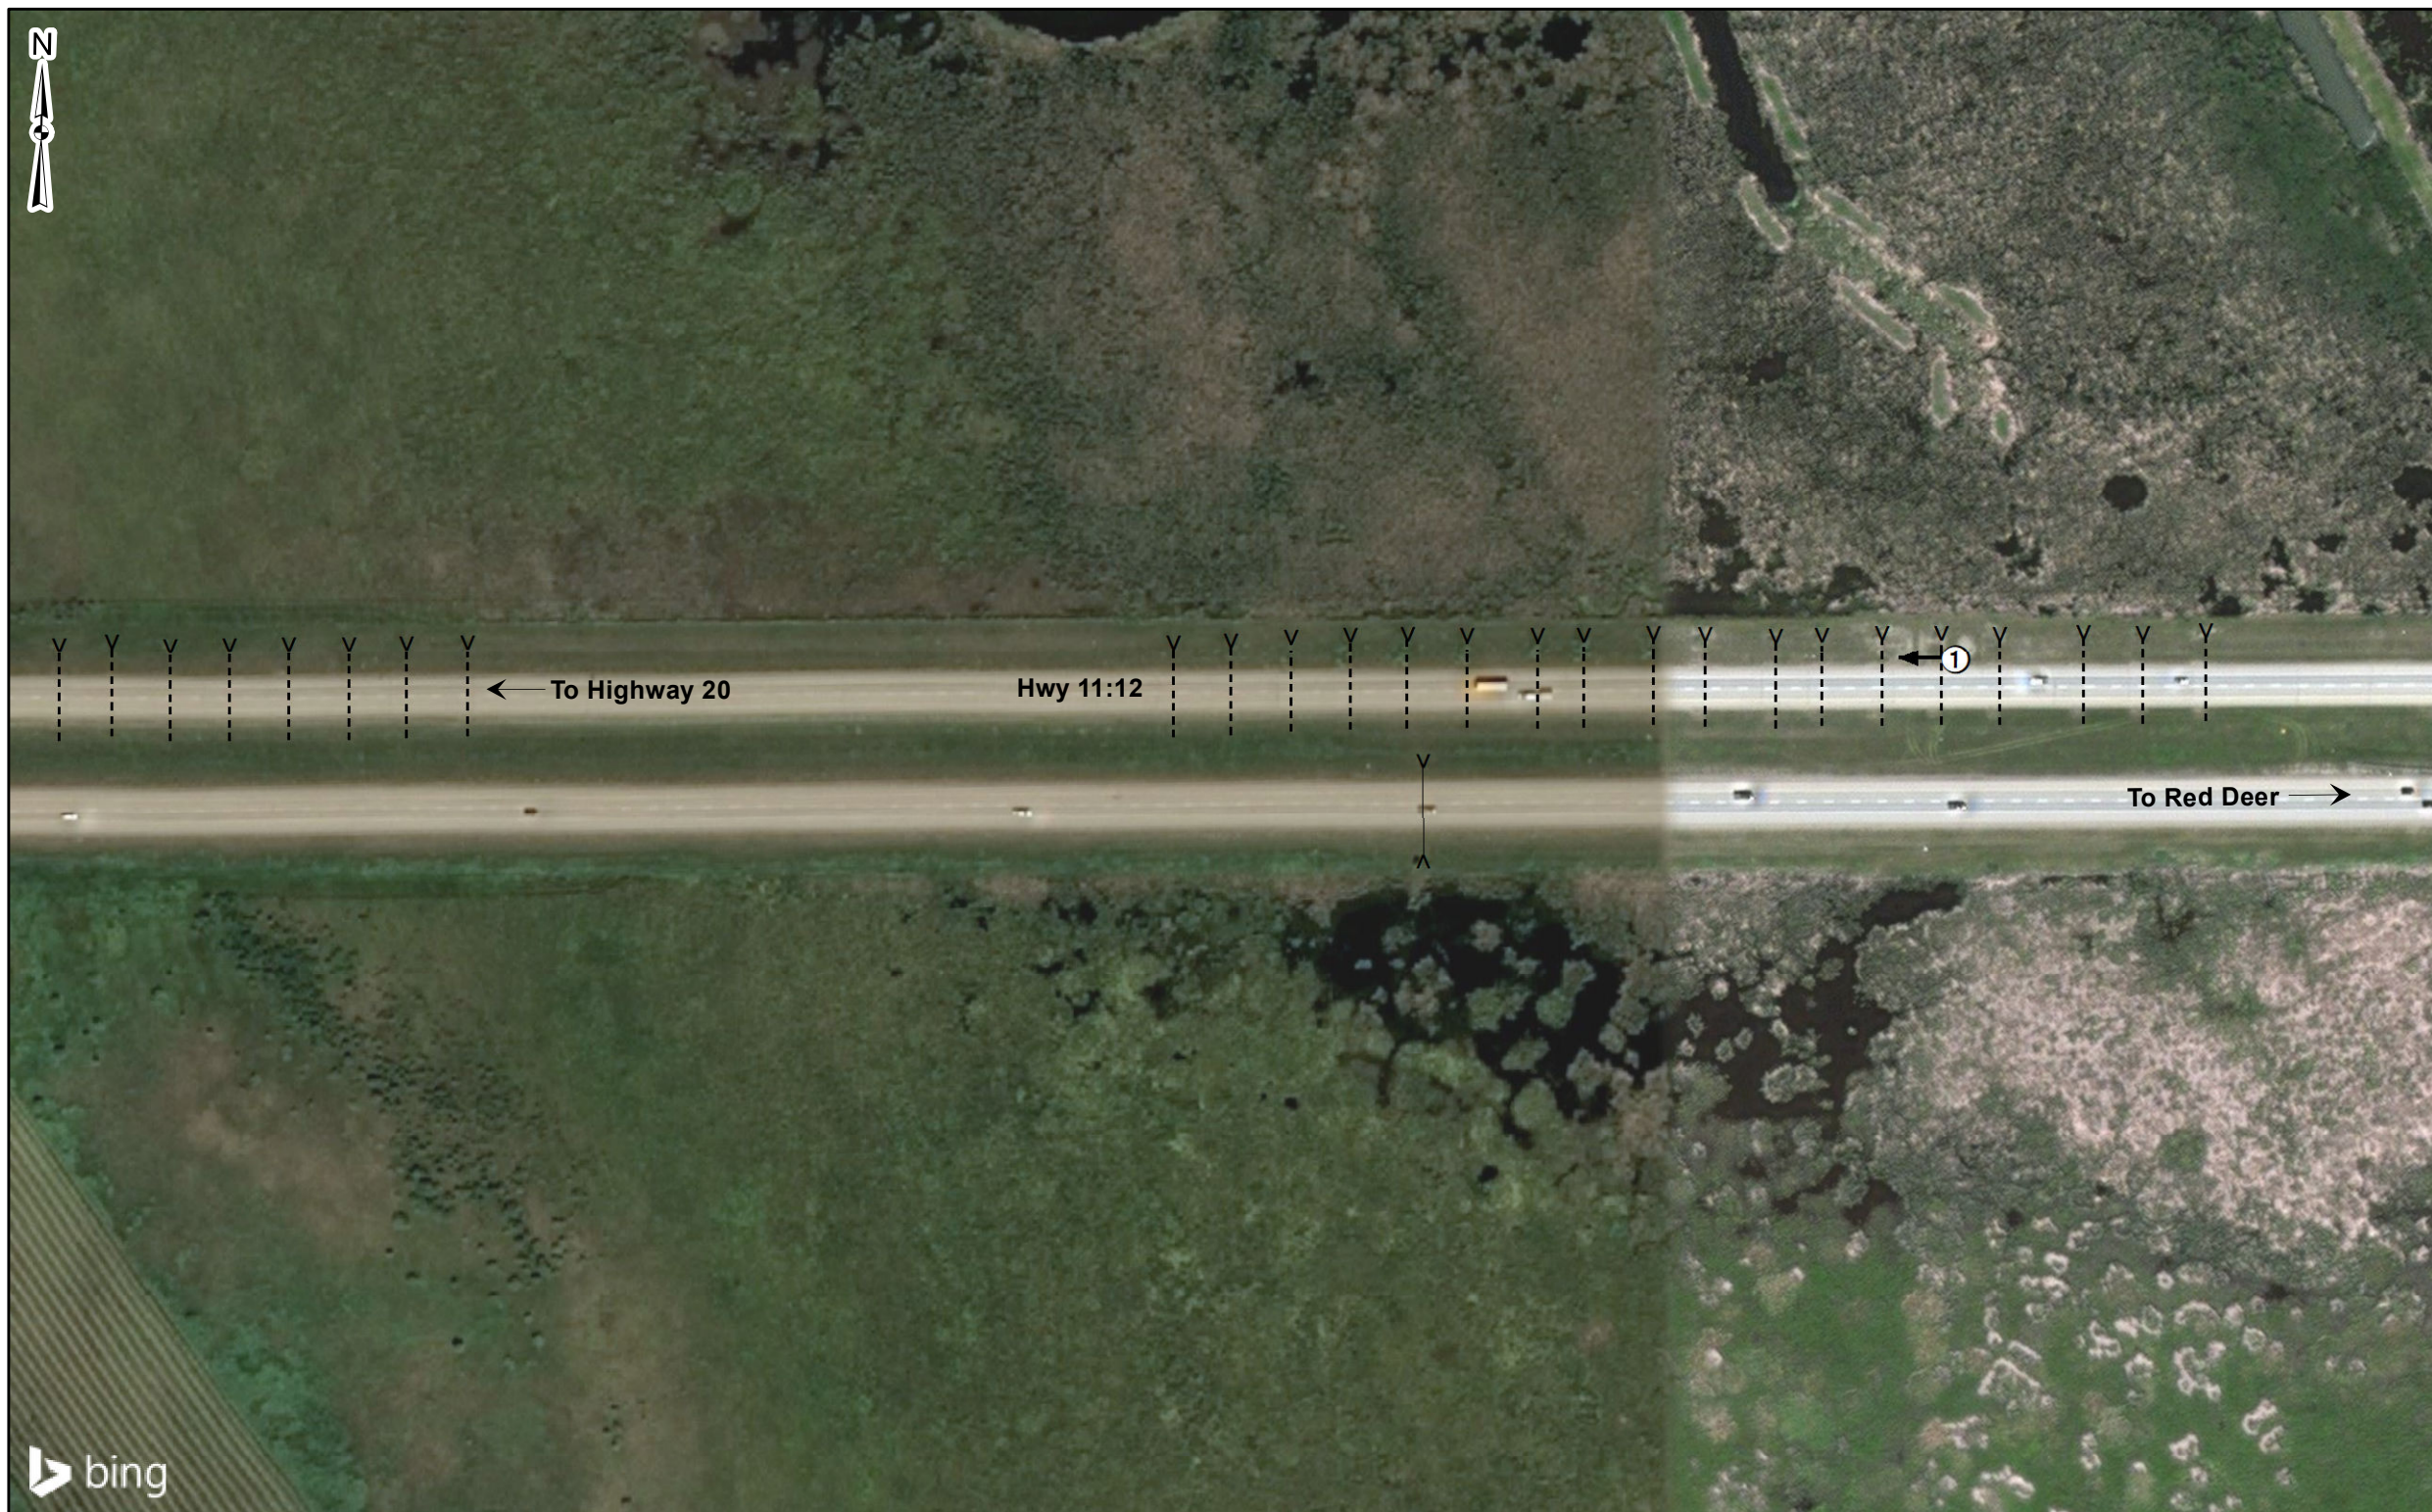
COMMENTS
Frost heaving on the highway appears to occur at the drain backfill locations. Frost heaving was observed to be worse than in the previous year; with the west section heaving more than the east section.
The site will be repaired in Spring 2019 as detailed in Alberta Transportation Tender TND0019153.
