January 11, 2019

Alberta Transportation
4th Floor, Provincial Building
4920 51 Street
Red Deer, Alberta
T4N 6K8

**CON0017608 Central Region GRMP Instrumentation Monitoring
Site C070; H27:10, km 18.932 and 33.102 West and East Slides
Section C – 2018 Fall Readings
Second Draft**

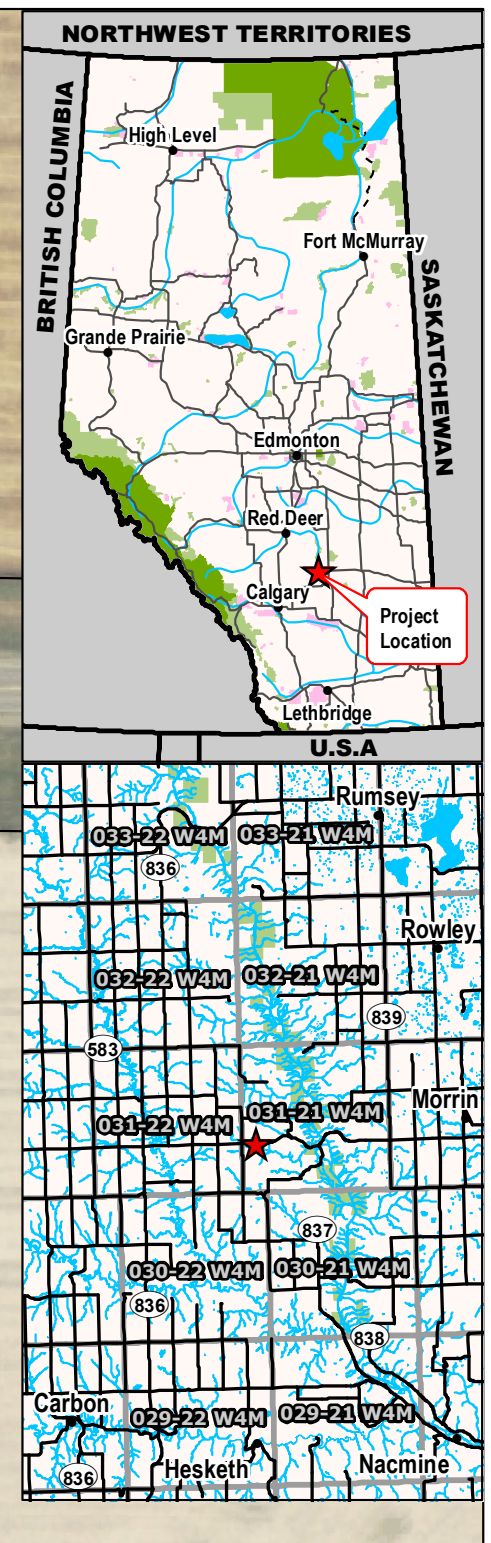
PROJECT CENTRAL REGION GEOHAZARD RISK MANAGEMENT PROGRAM		
TITLE Site Plan C070 - West Slide Hwy 27:10, km 18.932		
SCALE 1:1,200	PROJECT No. A05115A02	FIG No. 2

The upper movements being recorded in SI17-C70W-01 and SI17-C70E-01 appear to be occurring within the previously failed embankment fill, and in the failed material that was pushed upslope to create an access ramp and pad for the drilling rig.

Both sites should be repaired and drainage improvements implemented to limit the potential for future instability (e.g., lateral expansion of the slide along the highway embankment, or retrogression of the backscarp onto the highway) and impacts on the adjacent farmland.

Repair options for both sites are currently being assessed by KCB and Alberta Transportation, and may include the excavation and reconstruction of the slopes with geosynthetic reinforced fill, with subsurface drainage.
