<b>SITE NUMBER AND NAME:</b> C070 West and East Slides		<b>HIGHWAY &amp; KM:</b> 27:10, 18.932 & 33.102	<b>PREVIOUS INSPECTION DATE:</b> June 13 & 14, 2017	<b>INSPECTION DATE:</b> June 13, 2018
<b>LEGAL DESCRIPTION:</b> 02-18-031-21 W4M 15-07-031-21 W4M 02-16-031-20 W4M	<b>NAD 83 COORDINATES:</b> UTM    Northing    Easting 12      5723837    363877 12      5723487    377005		<b>RISK ASSESSMENT:</b> PF: 9    CF: 4    TOTAL: 36 PF: 9    CF: 4    TOTAL: 36	
<b>AVERAGE ANNUAL DAILY TRAFFIC (AADT):</b> 1790 (west) & 1850 (east) (Ref No. 108260 is between both sites)			<b>CONTRACT MAINTENANCE AREA (CMA):</b> 20

**PRIMARY SITE ISSUE:** Two shallow slope failures in the highway embankment fill that are triggered by surface water flowing onto the slide area during periods of heavy or prolonged rainfall, and a high groundwater table. The West Slide and East Slide are located on the south (eastbound lane) and north (westbound lane) side of Hwy 27, respectively. Both slides have reached the edge of pavement, and the west slide has undermined the guardrail.

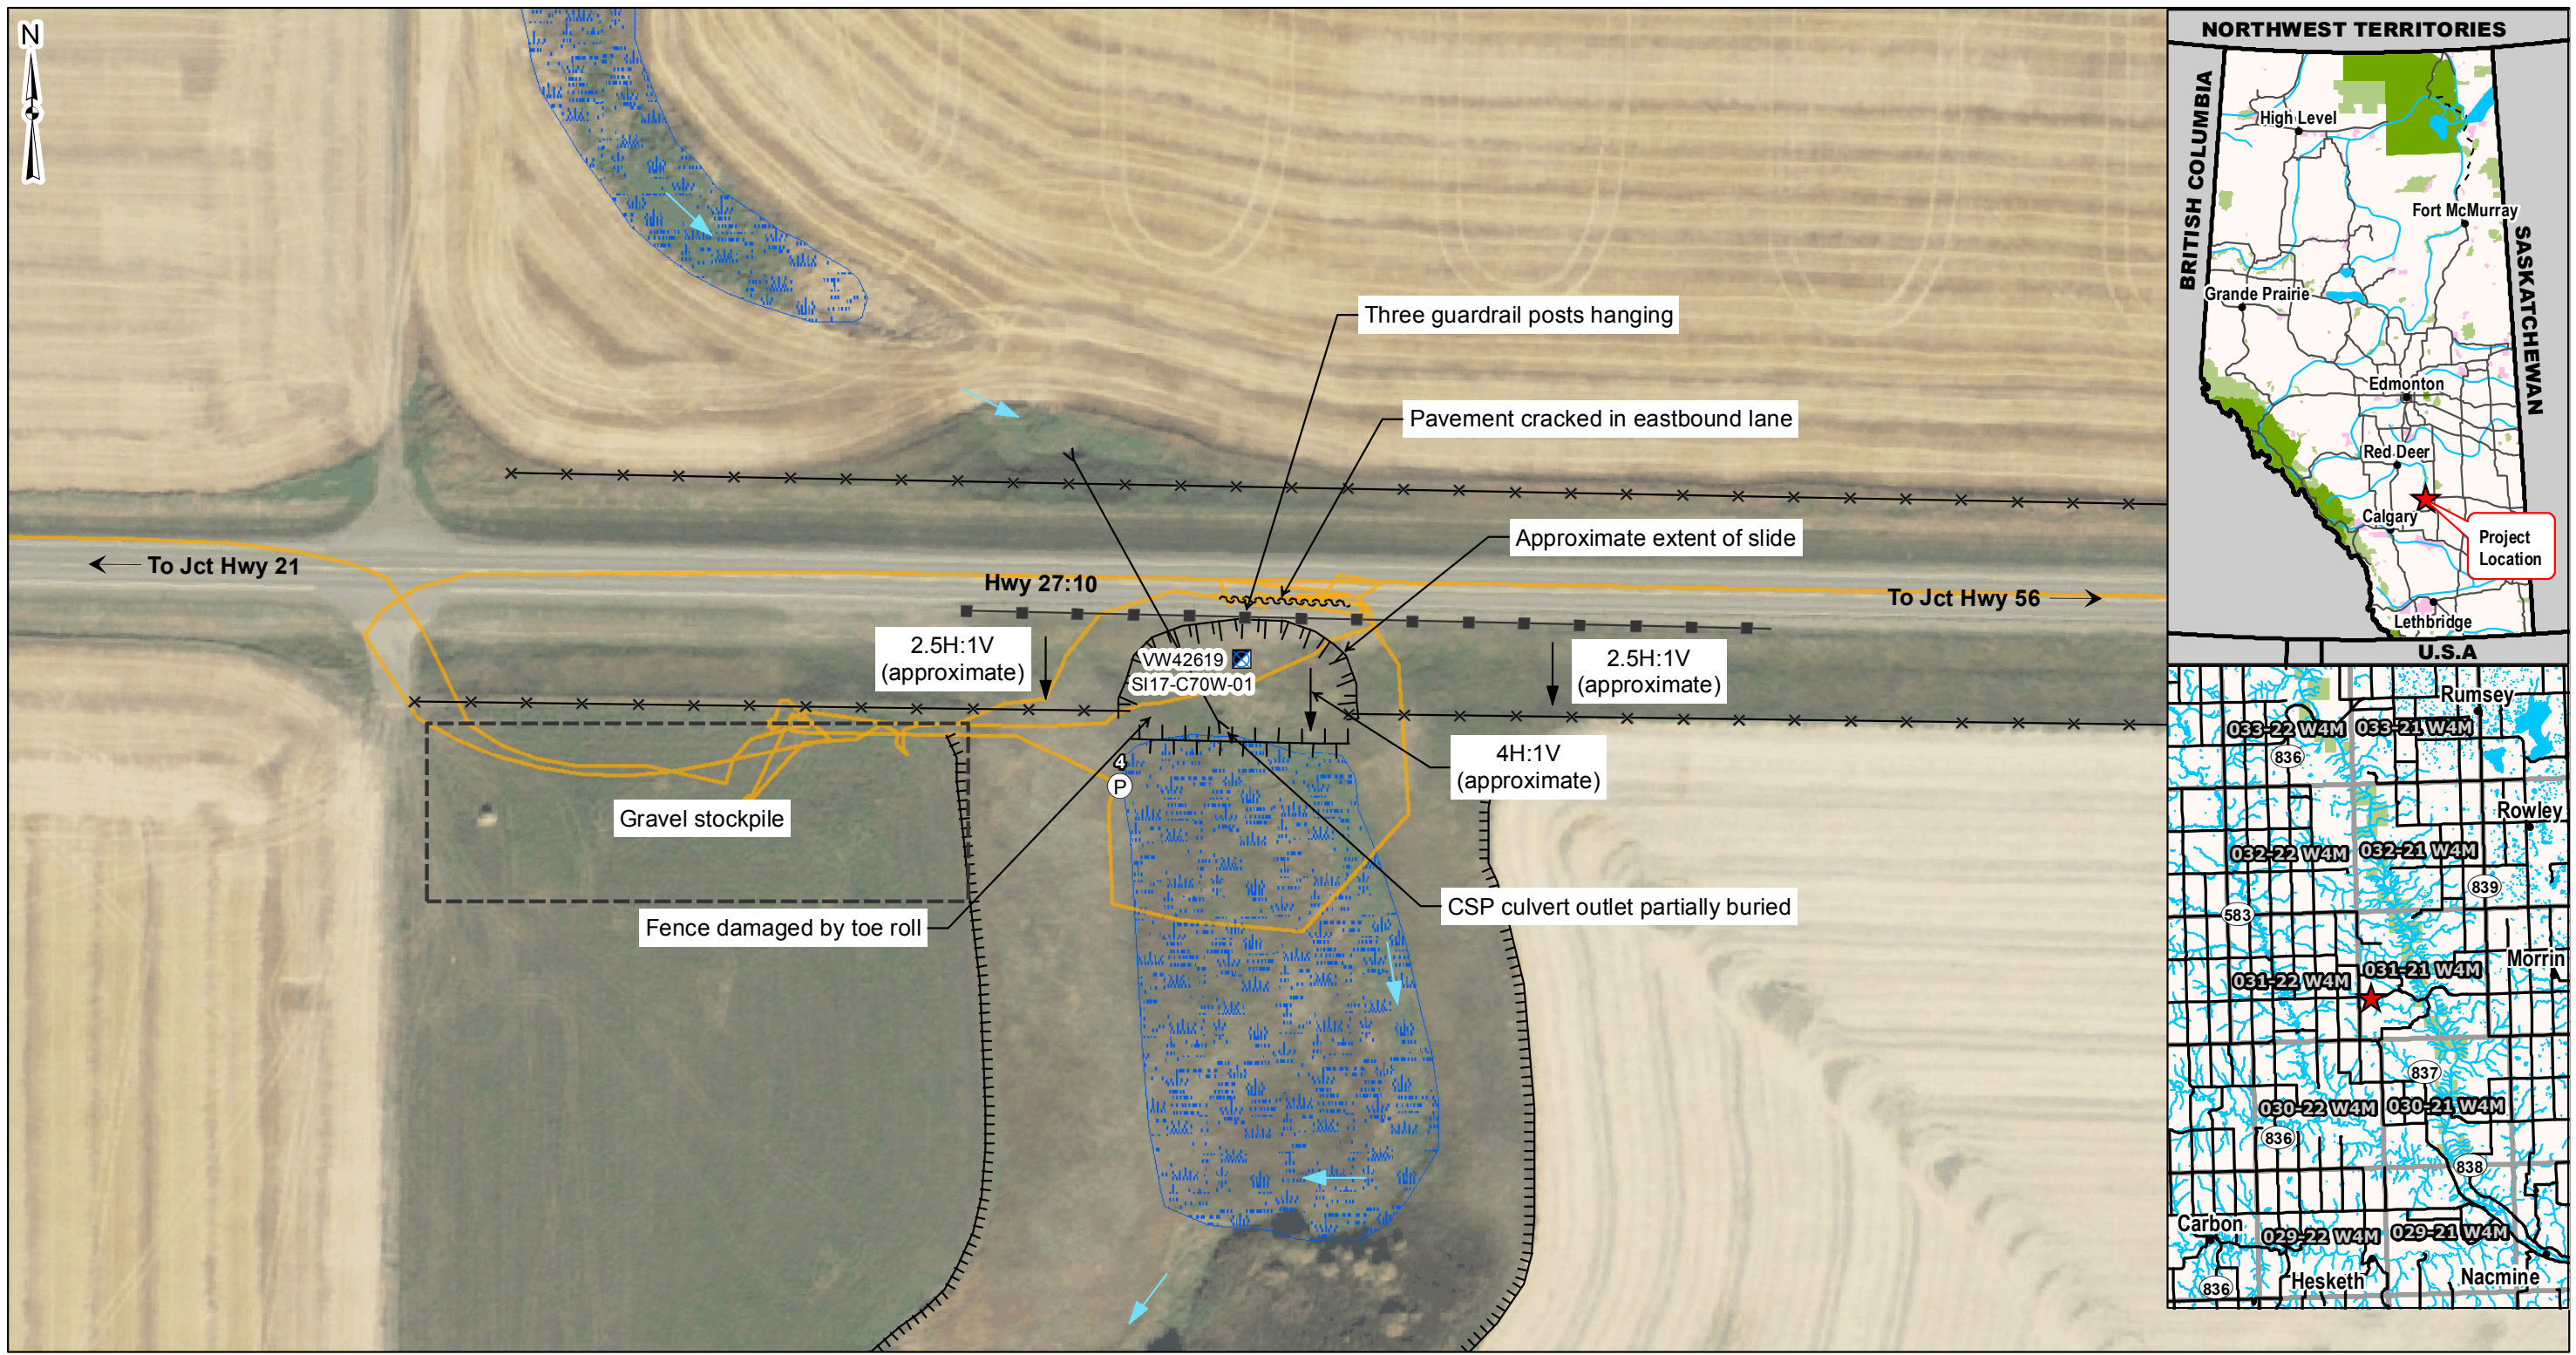
PROJECT	CENTRAL REGION GEOHAZARD RISK MANAGEMENT PROGRAM	
TITLE	Site Plan C070 - West Slide Hwy 27:10, km 18.932	
SCALE	PROJECT No.	FIG No.
1:1,200	A05115A02	2

- Slide area has become well vegetated with numerous cracks along the slope
- CNRL gas well access road to the north of the slide area has been reclaimed and seeded, with some fill removed.
- Slide has widened towards the west by 1.5 to 2.0m
- Slide head scarp is approximately 1.7 m high at edge of pavement (waypoint 702)

ITEM	CONDITION EXISTS		DESCRIPTION AND LOCATION	NOTICABLE CHANGE FROM LAST INSPECTION	
	YES	NO		YES	NO
			<ul style="list-style-type: none"> <li>Between the 2017 inspection and Spring 2018 instrument readings, the instruments (VWP and SI) at the site were struck by a vehicle and destroyed.</li> </ul>		
			<p>At the West Slide:</p> <ul style="list-style-type: none"> <li>No discernable movement observed since inspection in 2017</li> <li>Three guardrail posts remain unsupported and the south edge of pavement continues to be impacted (approximately 0.3 m of asphalt lost)</li> </ul>		
			<p>KCB and AT discussed the idea of using material from existing stockpile at C070W located southwest of the slide area for the scheduled repairs at C070E and C070W. The pad could also be used to stockpile waste material from both sites.</p>		
			<p>Based on instrumentation data collected and visual observations, the slides appear to be rotational-embankment failures caused by placing poor quality and/or compacted fill beneath the slopes of the embankment, as well as poor foundation preparation. In addition to poor quality fill, the slide movements are likely exacerbated by poor surface drainage.</p>

<p>Repair of both sites is expected to be completed in Fall 2018 as part of the works included in the Alberta Transportation Tender TND0019153. The repair will involve excavating the failed slopes and backfilling with geosynthetic reinforced gravel fill with a shear key.</p>
