SITE NUMBER AND NAME: C062 Back Slope Failure North of Vermillion Dam		HIGHWAY & KM: 41:20, 2.889	PREVIOUS INSPECTION DATE: June 24, 2020	INSPECTION DATE: June 29, 2021
LEGAL DESCRIPTION: 16-31-050-06 W4M	NAD 83 COORDINATES: UTM Northing Easting 12 5912662 509163		RISK ASSESSMENT: PF: 9 CF: 3 TOTAL: 27	
Average Annual Daily Traffic (AADT): 3070 (north) (Ref No. 997074)			CONTRACTOR MAINTENANCE AREA (CMA): 512

PROJECT CENTRAL REGION GEOHAZARD RISK MANAGEMENT PROGRAM		
TITLE Site Plan C062 - Back Slope Failure North of Vermilion Dam Hwy 41:02, km 2.889		
SCALE 1:1,500	PROJECT No. A05116A02	FIG No. 1

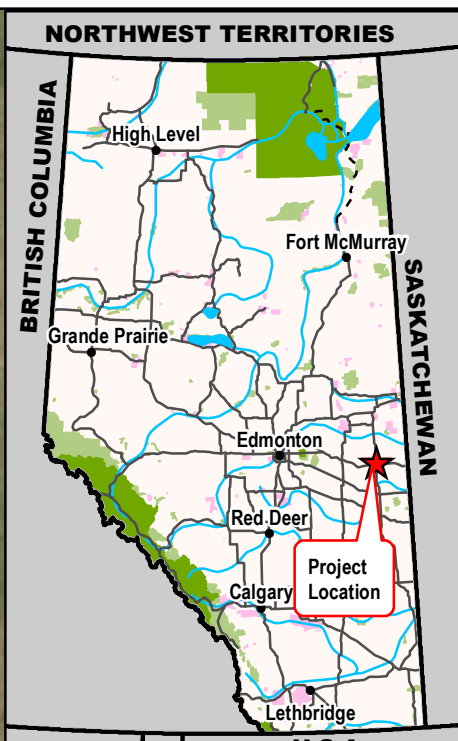
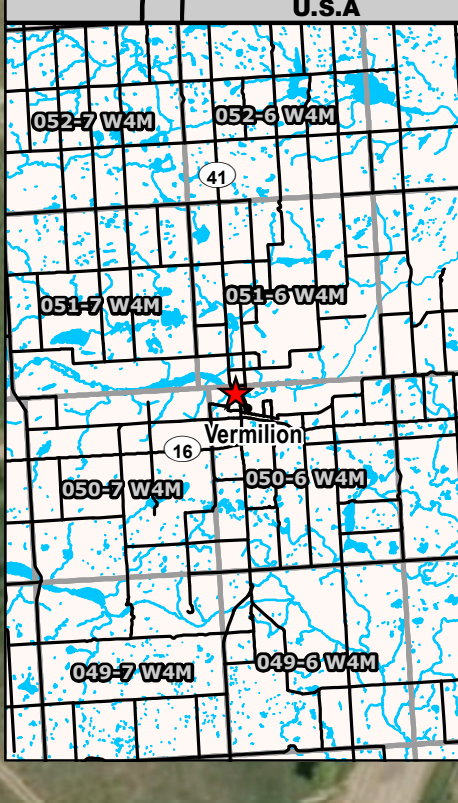
COMMENTS
Slide area extends along the crest of the back slope to the river valley slope south of the power poles. Bench on river valley slope is located at the previous Hwy 41 alignment, before it was realigned across Vermillion Dam in 1981.
Since the 2020 inspection, the toe roll of the slide appears to have deformed further into the ditch. However, due to the height of the vegetation, the amount of movement was difficult to determine.
Cracking was observed in 2020 on the river valley slope (southeast of Waypoint 0060) and directly north of the outlet channel from the Vermillion Dam spillway. The grass on the backslope and river valley slope is approximately 2 ft high (0.6 m) and may be obscuring other slide features.
The backscarp has extended further to the southwest (past Waypoint 0060) as further settlement was observed near the power poles and on the slope below the power poles. The settlement/cracking observed was

approximately 0.3 m wide by 0.5 m deep. A sinkhole approximately 1 m long and 0.3 m wide was observed during the June 2021 inspection, near the cracking that was observed in 2020 (WP0060).

A tension crack was observed on the downslope bench created during the geotechnical investigation completed in April 2018 (bench constructed in March 2018). The tension crack was approximately 25 mm wide in June 2020 and was not found in June 2021 due to tall vegetation.
