**CON0022160 Central Region GRMP Instrumentation Monitoring
Site C079; H53:12, km 0.684; Hwy 53 East of Battle River Slide
Section C – 2025 Fall Readings**

Site Plan
C079 – H53 East of Battle River Slide
Hwy 53:12

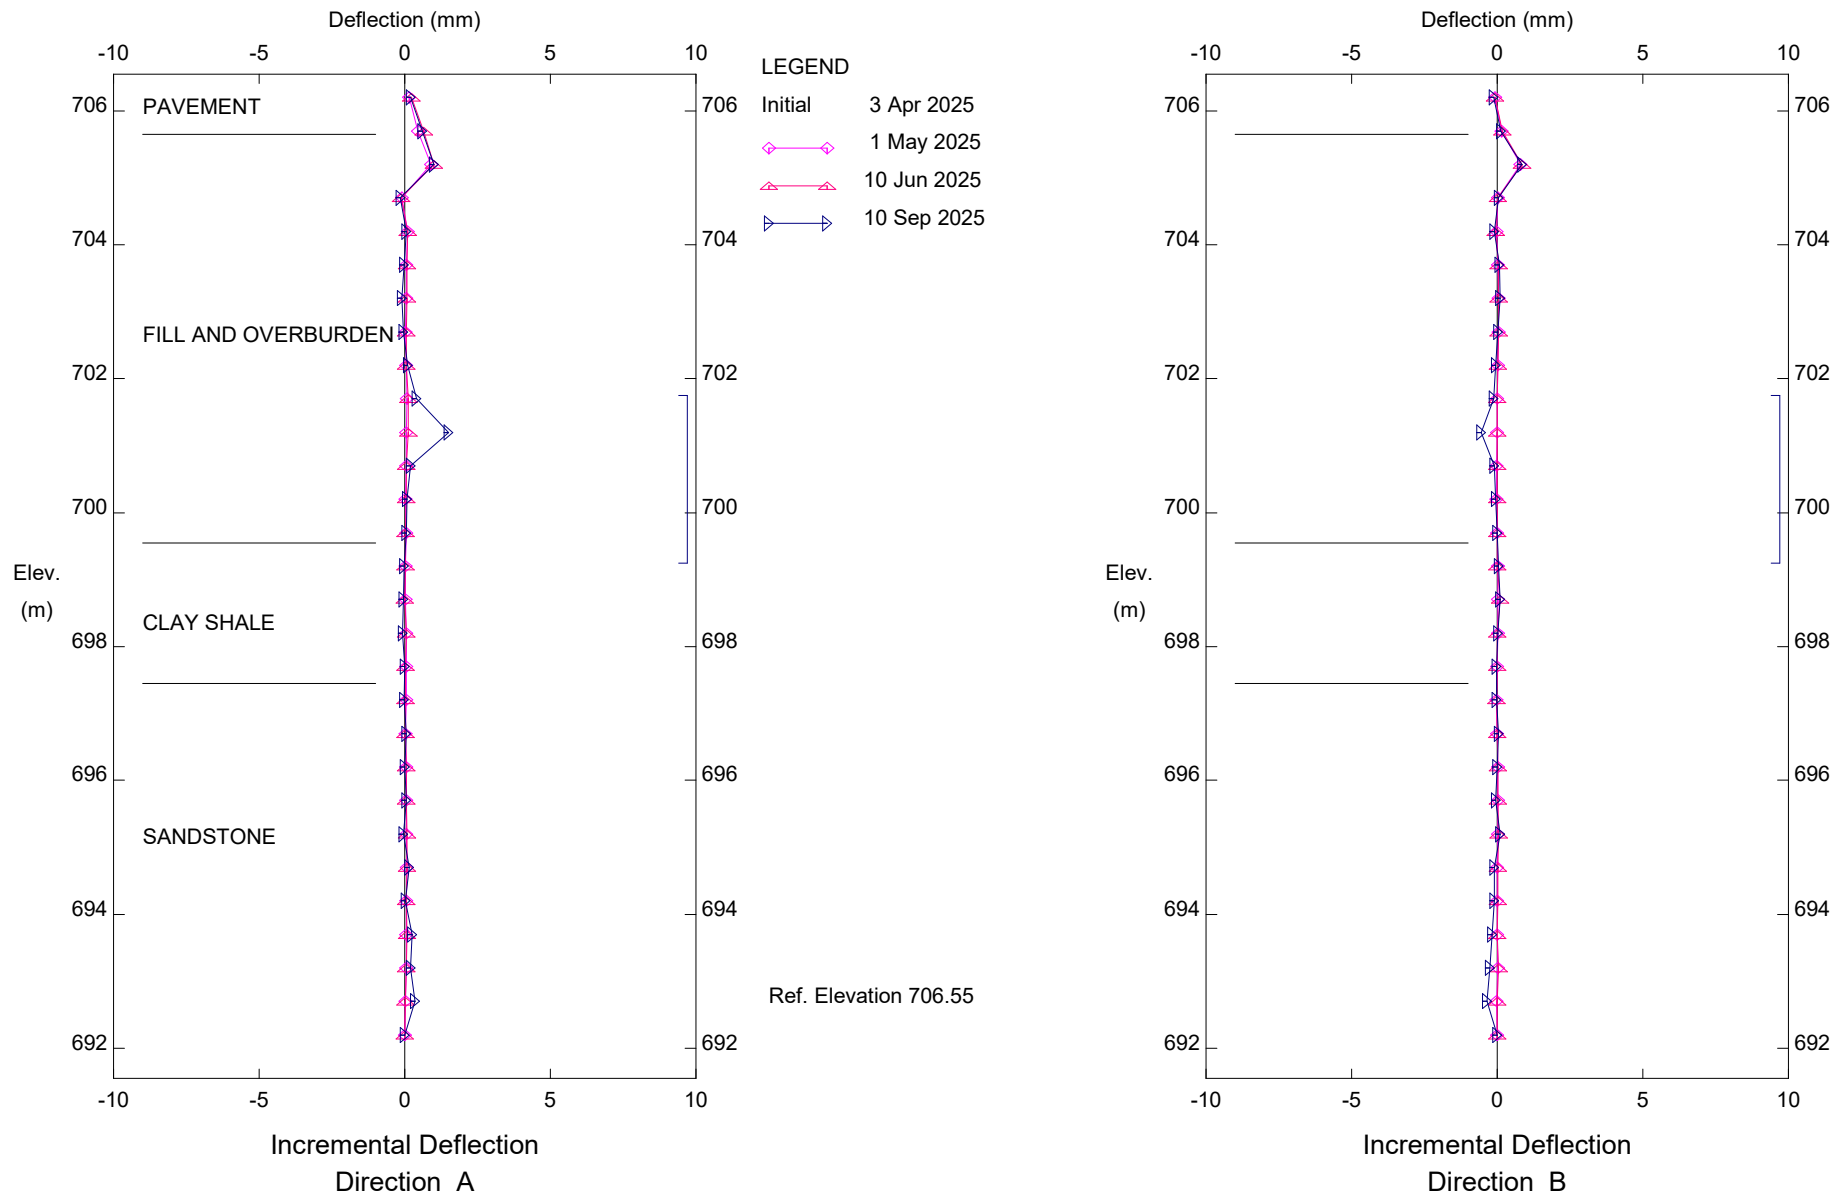
H53 East of Battle River Slide, Inclinometer SI25-01
Alberta Transportation

The shallow movement recorded in top 2 m of SI25-C079-01 may be attributed to a soft zone of embankment fill or foundation material (e.g., poorly compacted fill or in-situ material that should have been sub-excavated during construction) where no recovery was observed during drilling (from approximately 1.5 m to 3.0 m below ground surface). The deeper zone of movement from approximately 5 m to 6 m below ground surface is approximately 1.5 m above the top bedrock (clay shale) and close to the elevation of a minor scarp observed on the highway embankment slope during the 2025 Section B Inspection. The deeper movement is recorded near a relatively soft zone observed during drilling (high plastic silt with some sand).
