October 7, 2020

Alberta Transportation  
4th Floor, Provincial Building  
4920 51 Street  
Red Deer, Alberta  
T4N 6K8

**CON0017608 Central Region GRMP Instrumentation Monitoring  
Site C025; H569:02. km 18.469 Western Monarch Slide  
Section C – 2019 Fall Readings**

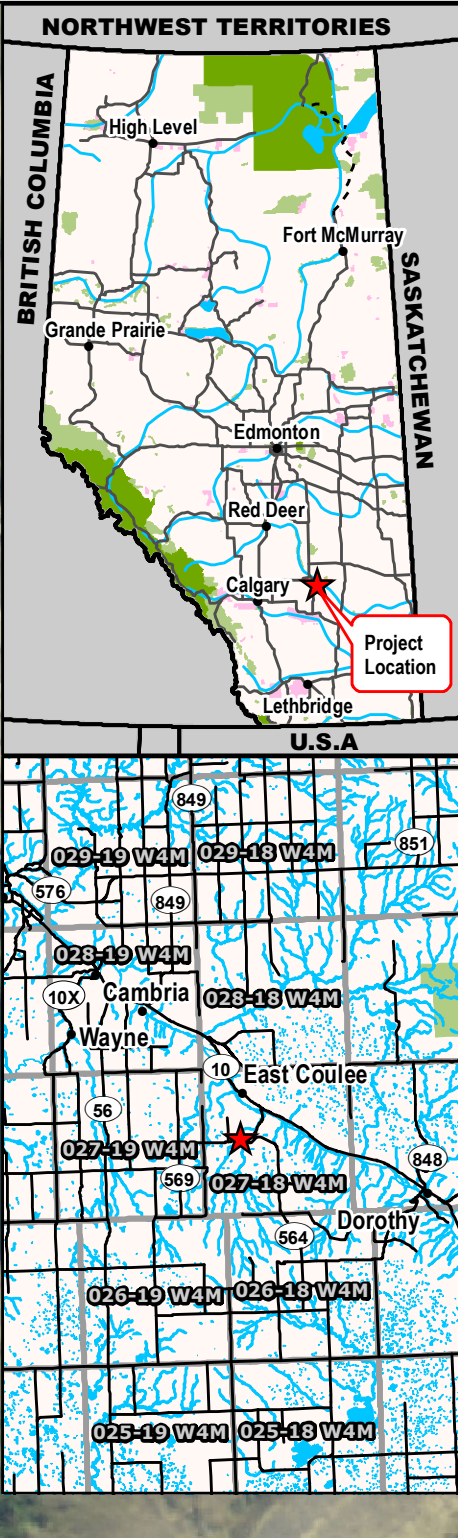
**BH17-C25-01**  
SI17-C25-01 (inoperable)  
VW42616  
VW42617 (inoperable)

Scarp located approximately 2 m from guardrail

SI04-02 (inoperable)

Approximate extent of slide

Water ponded upstream of slide

Slide blocking creek
