SITE NUMBER AND NAME: <b>C058-I, -II, &amp; -III Sinkholes</b>		HIGHWAY & KM: 570:02, 8.3, 9.2, 9.8	PREVIOUS INSPECTION DATE: July 10, 2019	INSPECTION DATE: <b>June 24, 2021</b>
LEGAL DESCRIPTION: 10-08-027-17 W4M	NAD 83 COORDINATES: UTM Northing Easting <b>C058-I</b> 12 5683470 405475 <b>C058-II</b> 12 5683845 404934 <b>C058-III</b> 12 5684148 404224		RISK ASSESSMENT: PF: 8 CF: 5 TOTAL: 40 PF: 8 CF: 5 TOTAL: 40 PF: 8 CF: 5 TOTAL: 40	
AVERAGE ANNUAL DAILY TRAFFIC (AADT): 510 (west) & 360 (east) (Ref No. 116220 & 997198)			CONTRACT MAINTENANCE AREA (CMA): 521

SUMMARY OF SITE INSTRUMENTATION:  There is no instrumentation at the C058 site.  LAST READING DATE: N/A	INSPECTED BY: Chris Gräpel (KCB) James Lyons (KCB) Roger Skirrow (AT) Tony Penney (AT)
PRIMARY SITE ISSUE: Settlement of Hwy 570 due to the presence of dispersive-soil voids beneath the highway surface.	
APPROXIMATE DIMENSIONS: Numerous soil voids along a 1.5 km stretch of Hwy 570.	
DATE OF ANY REMEDIAL ACTION: May 3, 2010 – remediated using foam injection; May 29, 2015 – excavated (deep) and reconstructed with gravel fill and a culvert; unknown – sinkholes in ditch backfilled; speed reduction signs to 50 km/h and hazard mar

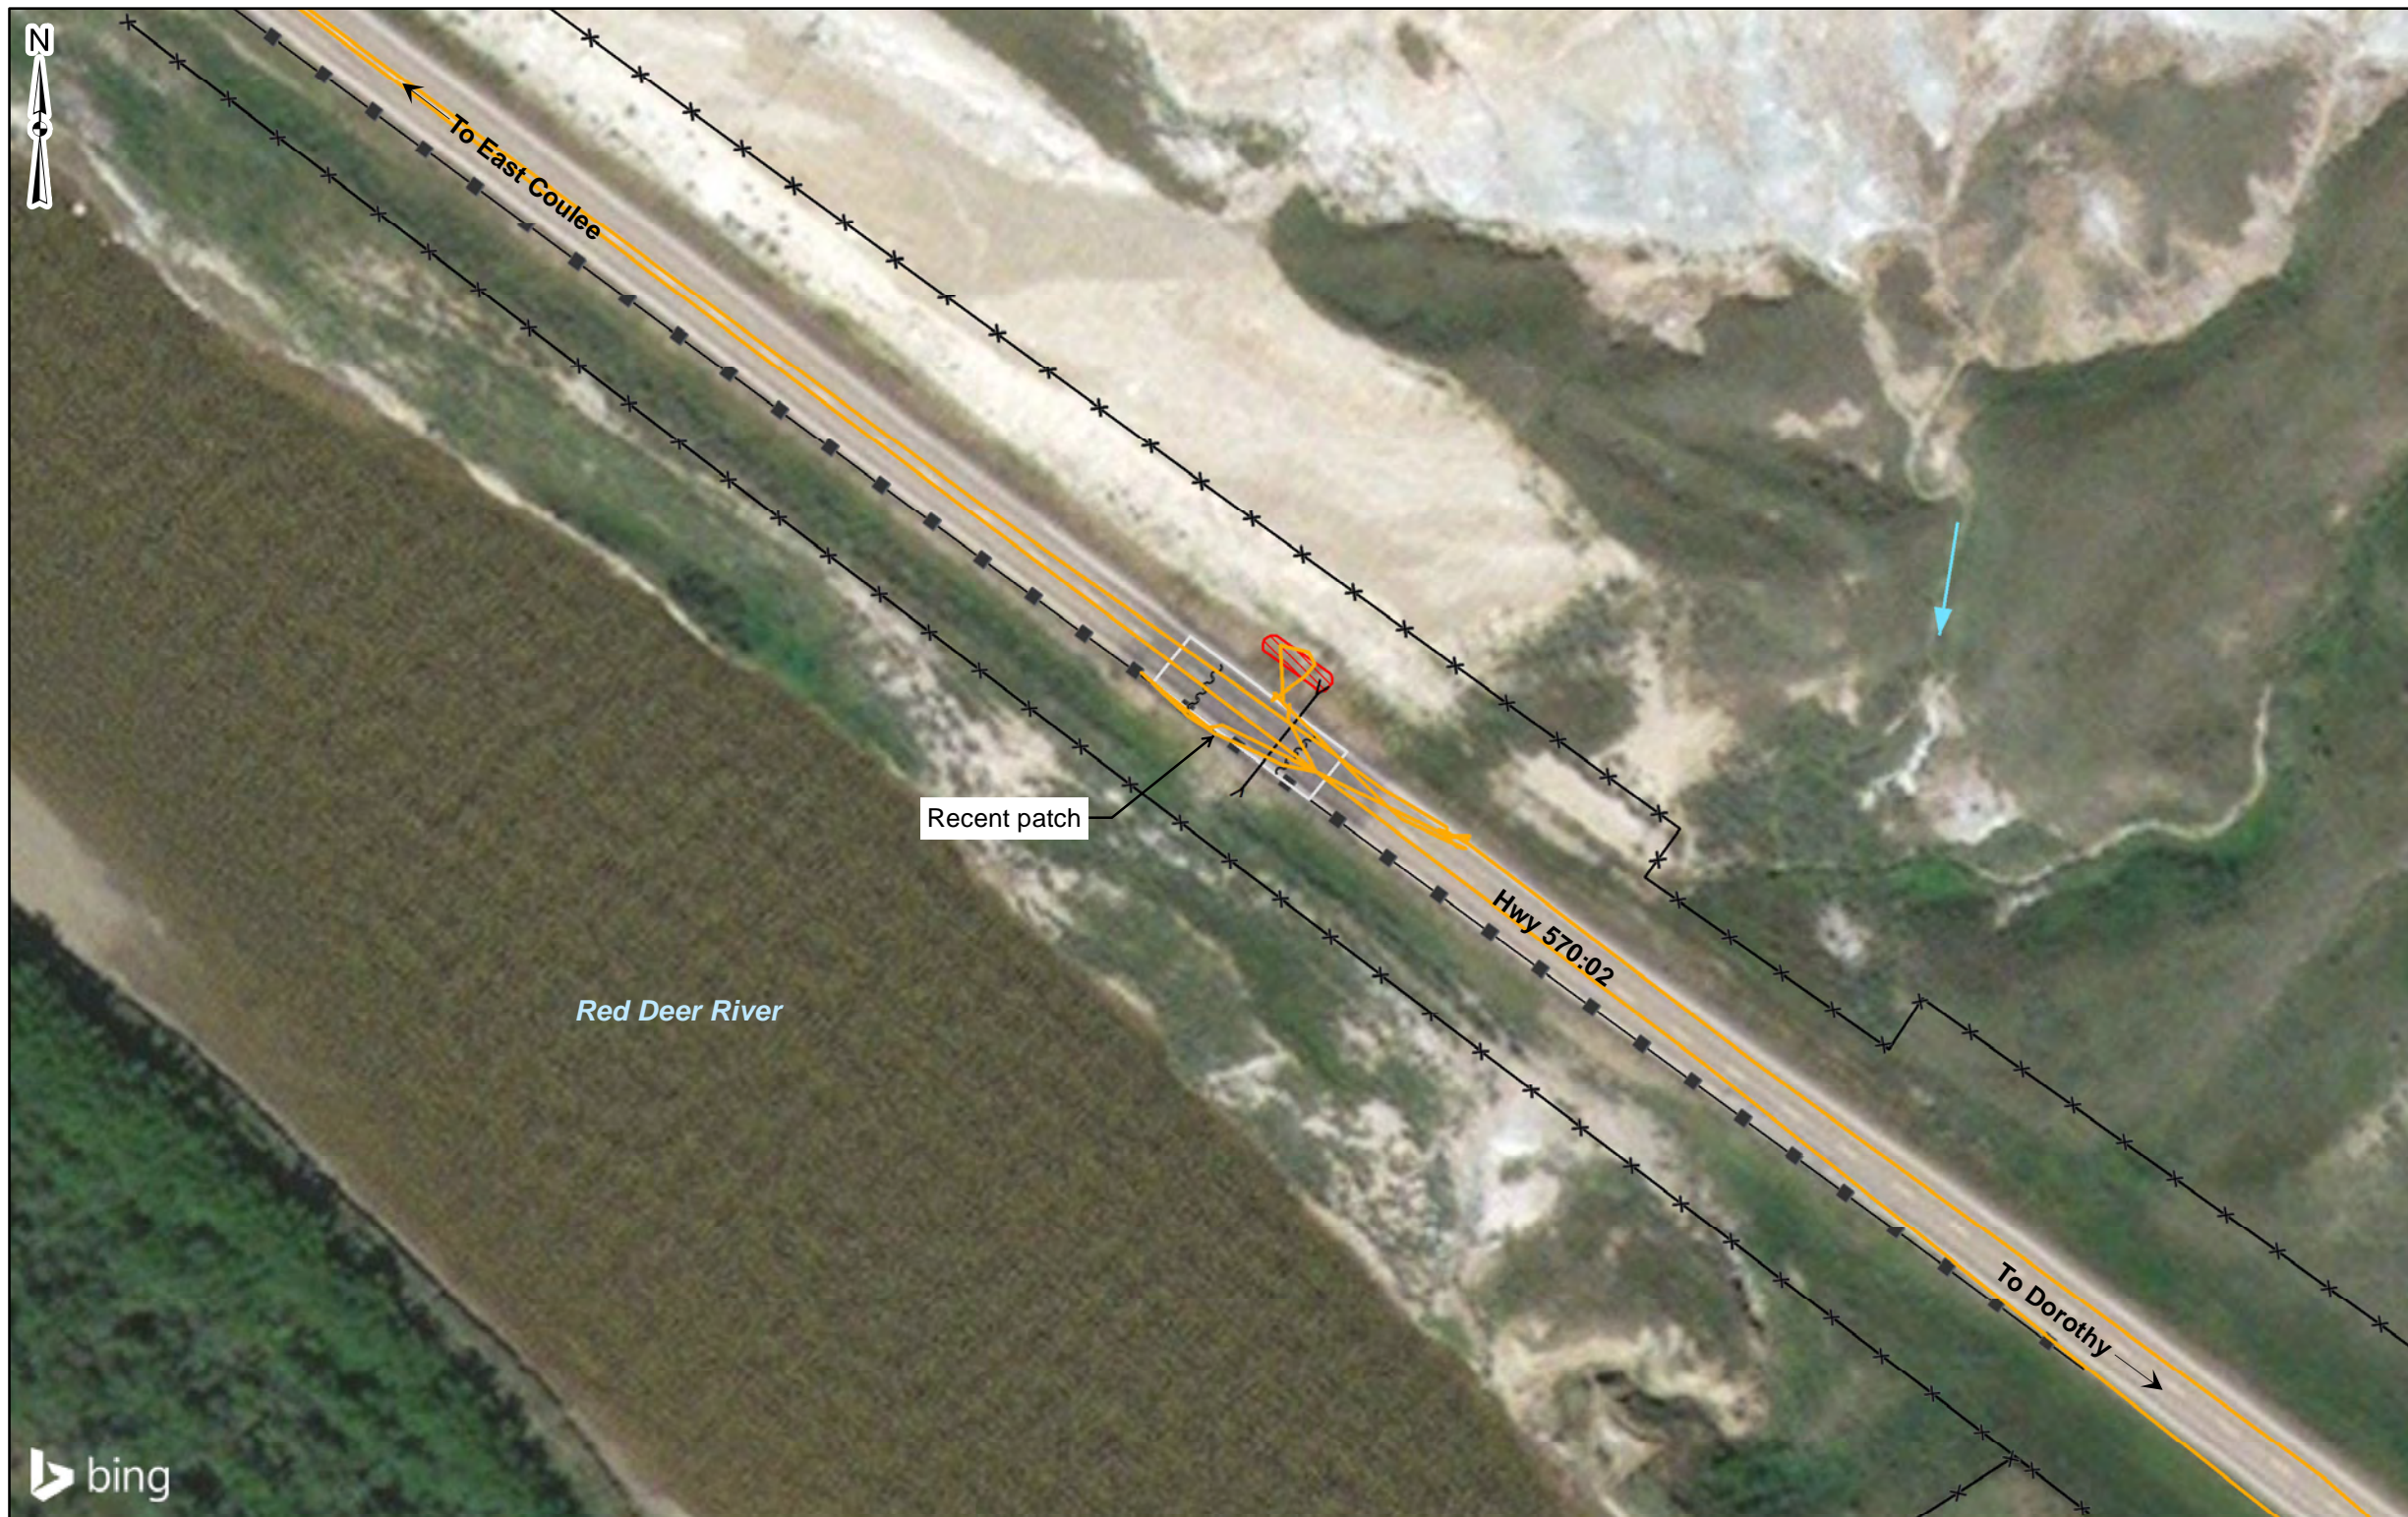
<b>COMMENTS</b>
C058-I: <ul style="list-style-type: none"> <li>Pavement has been recently patched in both lanes. A small sinkhole (0.3 to 0.5 m in diameter) has formed on the north edge of the pavement (Waypoint 21). The sinkhole is located across the highway diagonally from a dip in the pavement surface on the south side of the highway indicating the presence of a void.</li> </ul>

- A sinkhole at the culvert inlet (north of the highway) was filled with 4 m<sup>3</sup> of grout in October 2018. The grout is intact and has not subsided since 2018.

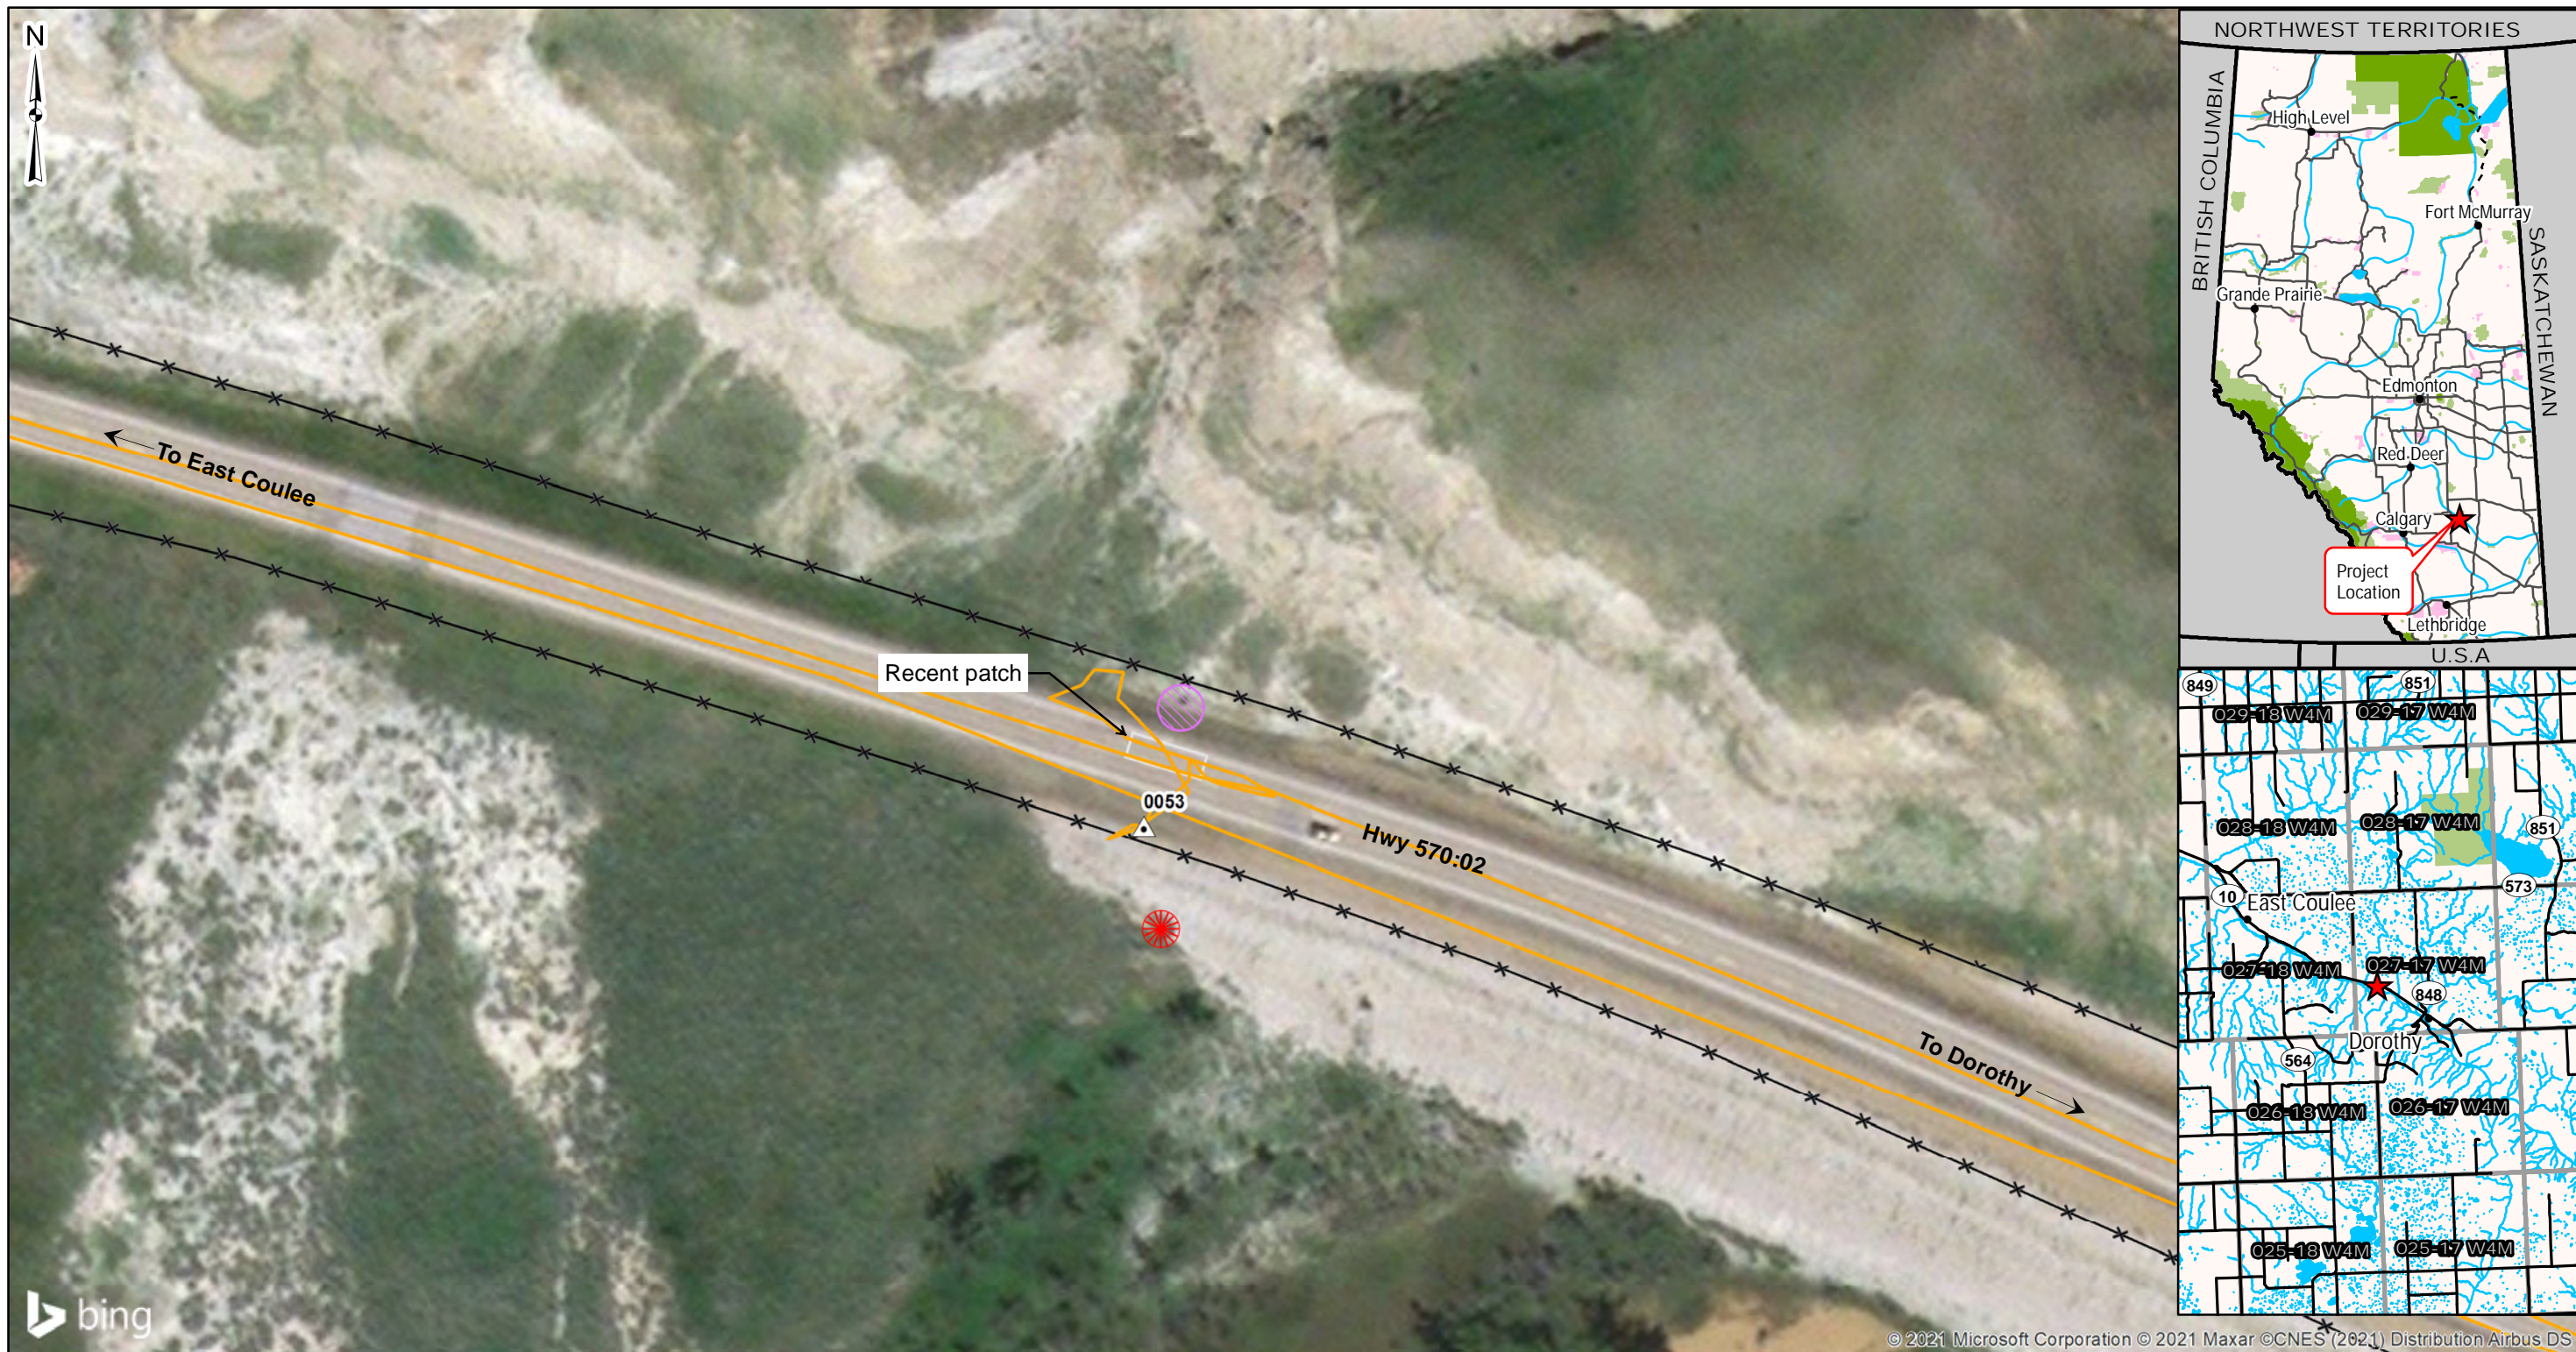
PROJECT CENTRAL REGION GEOHAZARD RISK MANAGEMENT PROGRAM		
TITLE Site Plan C058-III Hwy 570:02, km 8.3		
SCALE 1:1,000	PROJECT No. A05116A02	FIG No. 1

- North (westbound lane) of highway recently patched where sinkhole was observed during 2018 inspection.
- A sinkhole in the north ditch was filled with grout in 2018. The grout appeared to be heaving from groundwater pressure during the 2018 inspection. The grout cap and sinkhole are now buried with soil deposits and gravel fill.

- During the 2018 inspection, the MCI identified two sinkholes marked with 2x4 posts were full of water following filling of the sinkhole with grout (Waypoint 687), indicating that the void had been plugged. When dispersive voids re-opened beneath the road, the MCI could see the water in the holes dropped, indicating that void filling/plugging efforts had failed. The ground around the posts has since been covered in sediment, obscuring observations of groundwater

- Two large sinkholes were found near the toe of the embankment on the south side of the highway during the 2018 inspection (Waypoint 691 and 692). Sinkhole at Waypoint 691 does not appear to have expanded since 2018 inspection.
