SITE NUMBER AND NAME: C058 Erosion and Sinkholes	HIGHWAY & KM: 570:01, 8.3, 9.2, 9.8	PREVIOUS INSPECTION DATE: June 26, 2023	INSPECTION DATE: June 10, 2025
LEGAL DESCRIPTION: 10-08-27-17 W4M	NAD 83 COORDINATES: UTM Northing Easting C058-1 12 5683470 405475 C058-2 12 5683845 404934 C058-3 12 5684148 404224	RISK ASSESSMENT: C058-1: PF: 8 CF: 5 TOTAL: 40 C058-2: PF: 8 CF: 5 TOTAL: 40 C058-3: PF: 8 CF: 5 TOTAL: 40	
HIGHWAY CLASSIFICATION NUMBER: 3		CONTRACT MAINTENANCE AREA (CMA): 521	
AVERAGE ANNUAL DAILY TRAFFIC (AADT): 500 (west) & 400 (east) (Ref No. 116220 & 997198)

SUMMARY OF SITE INSTRUMENTATION: There is no instrumentation at the C058 site. LAST READING DATE: N/A	INSPECTED BY: Chris Gräpel (KCB) James Lyons (KCB) Tony Penney (TEC) Chris Newman (TEC) Imram Mehmood (TEC)
PRIMARY SITE ISSUE: Settlement of Hwy 570:01 due to the presence of dispersive-soil voids beneath the highway surface.	
APPROXIMATE DIMENSIONS: Numerous subsurface voids along an approximate 1.5 km stretch of Hwy 570:01.	
DATE OF ANY REMEDIAL ACTION: May 3, 2010 – remediated using foam injection; May 29, 2015 – excavated (deep) and reconstructed with gravel fill and a culvert; unknown – sinkholes in ditch backfi

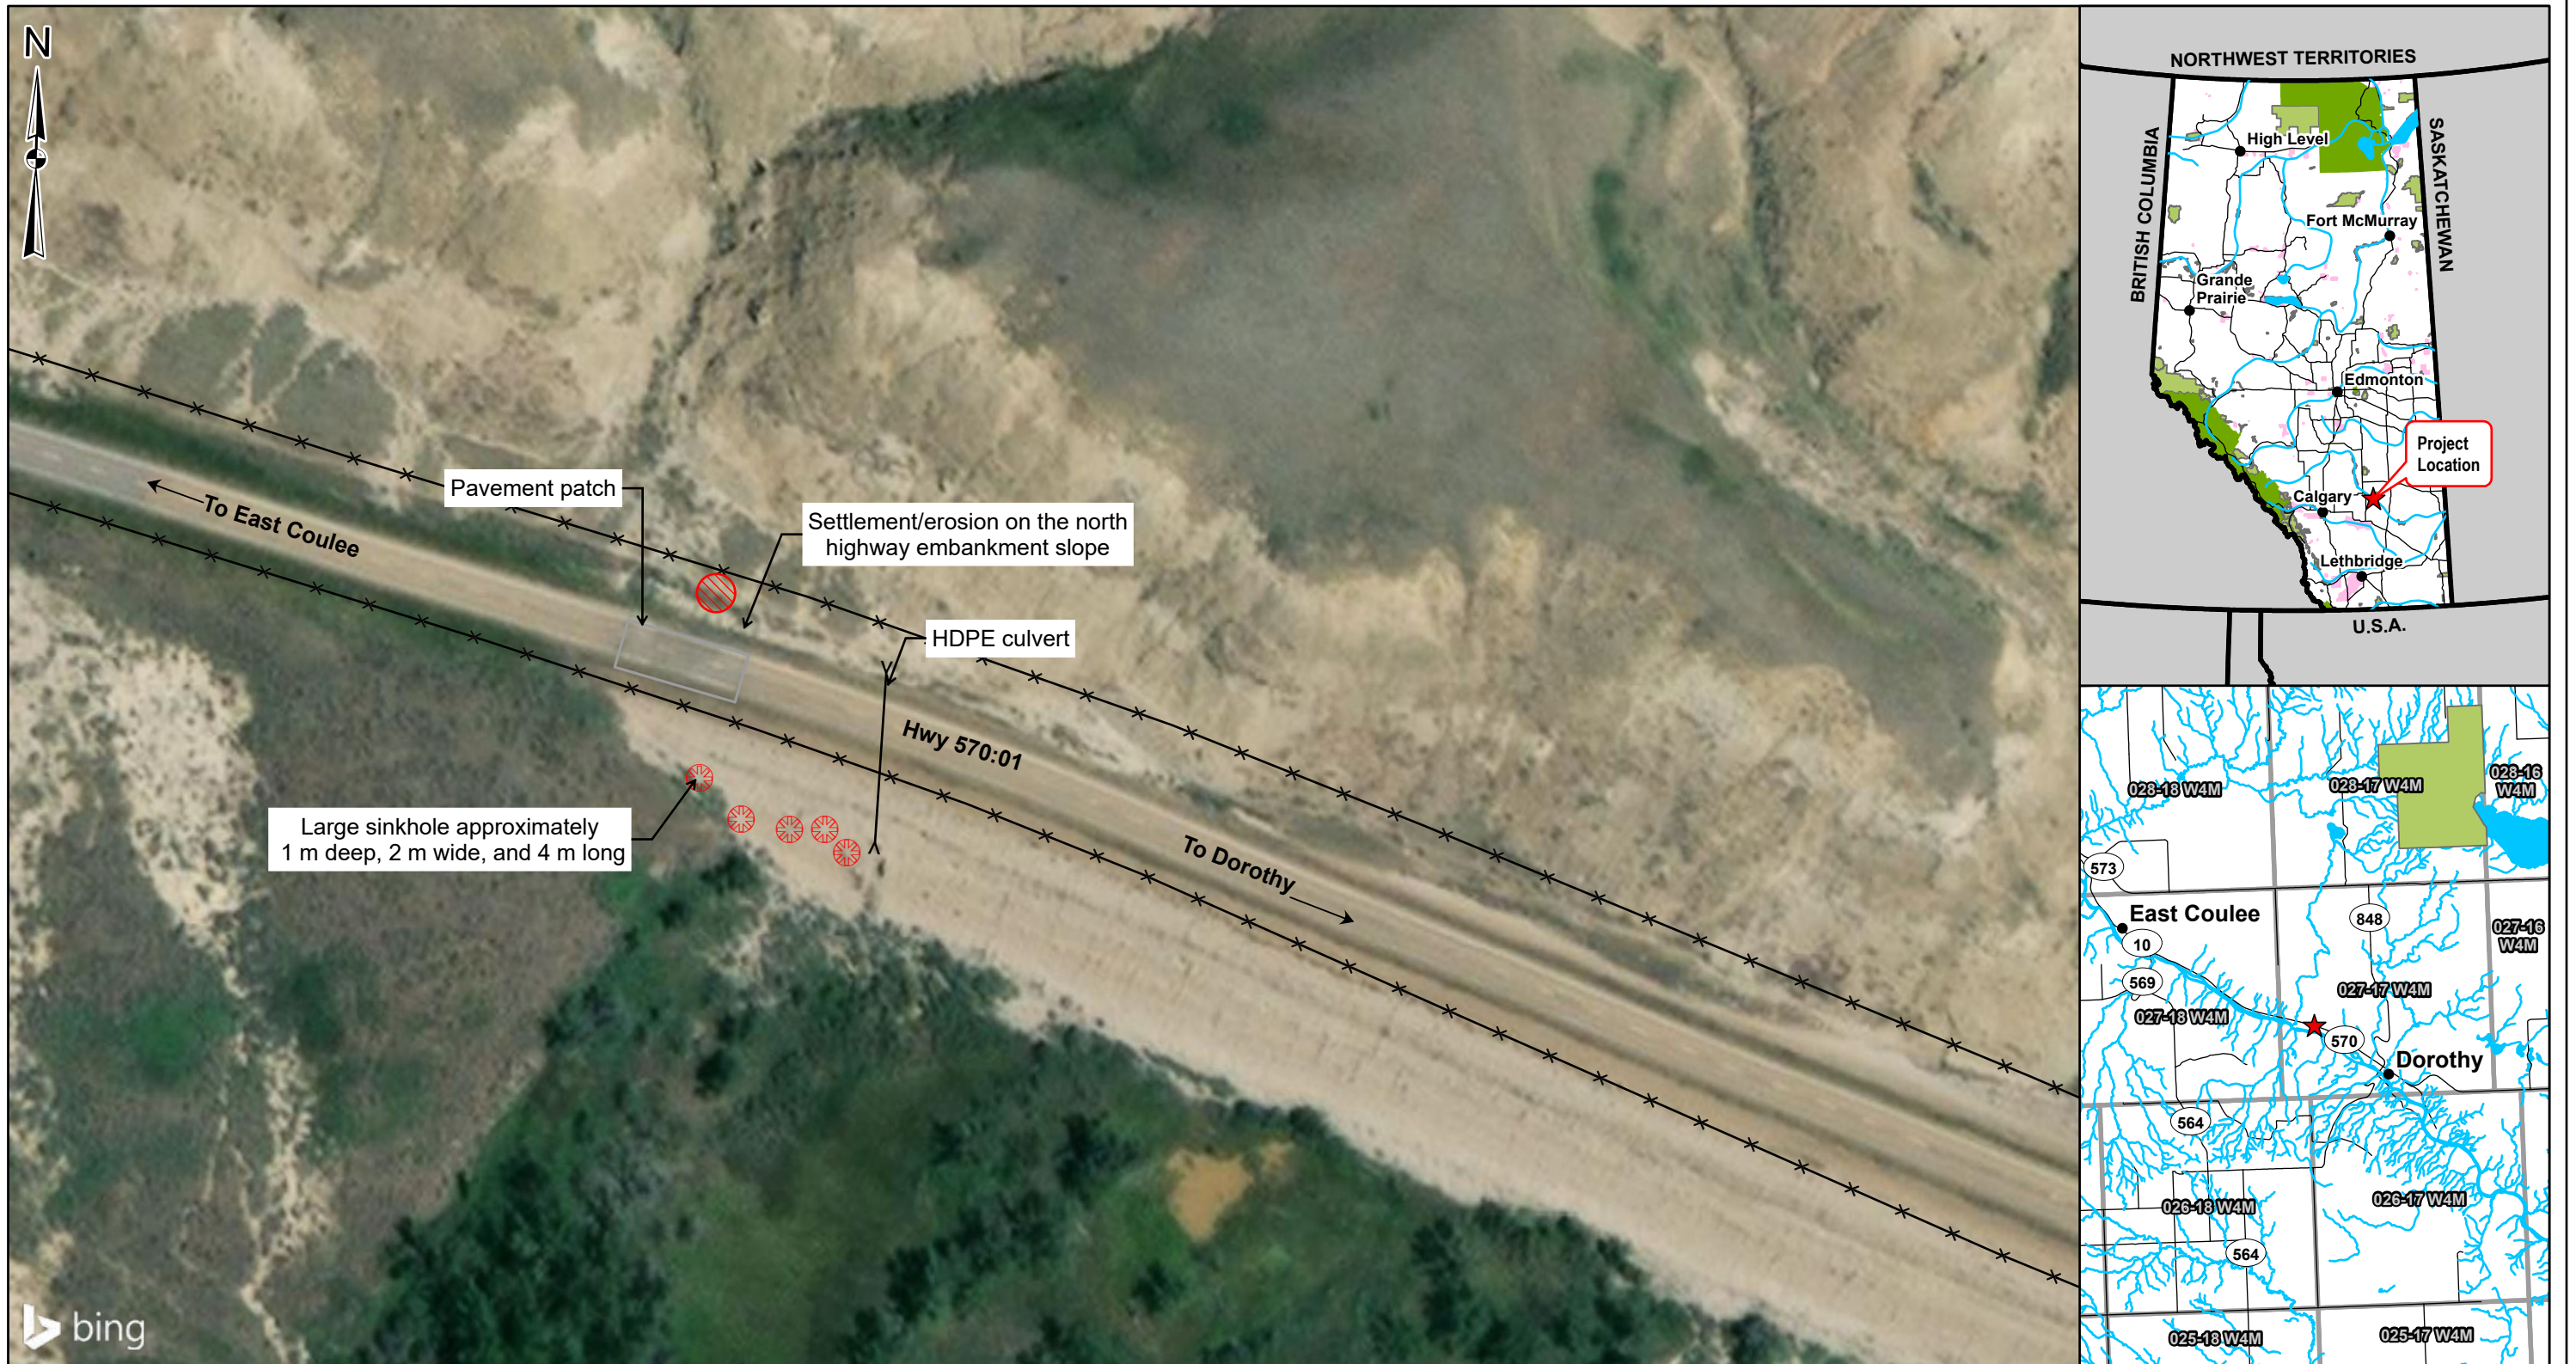
- A large sinkhole was located at the toe of the south highway embankment slope (first observed during the 2018 inspection) (Photo 12). The sinkhole did not appear to have enlarged significantly since the 2023 inspection.
