Klohn Crippen Berger

Alberta Transportation

Hwy 570:01, km 8.8 (Near Dorothy) Call-Out Report

October 2022

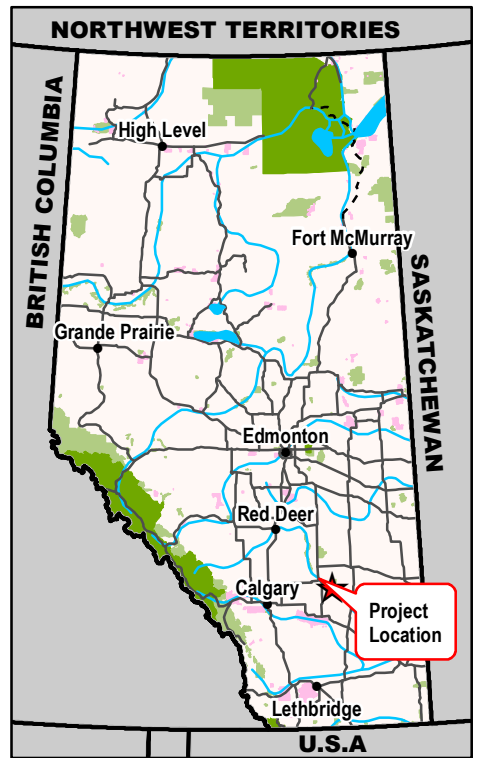
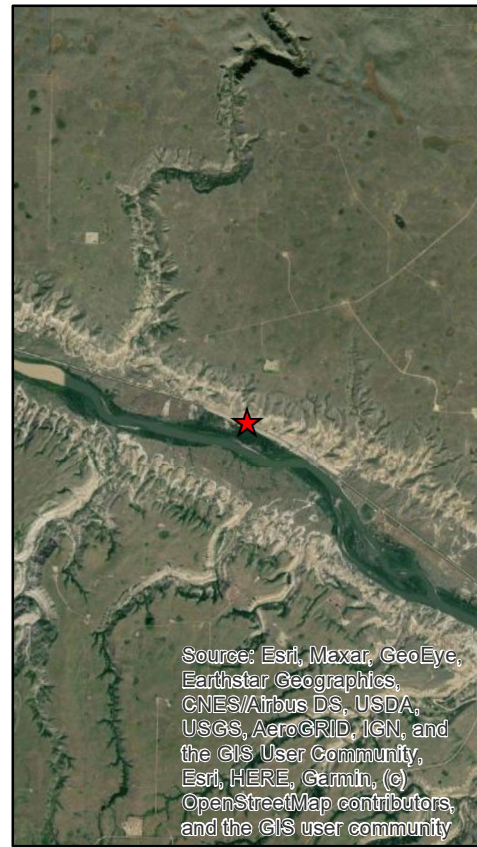
Review of historic air photos obtained from Alberta Environment and Parks (see Figure 2 and 3) indicates that
