SITE NUMBER AND NAME: C017-I, -II, and -III Truckstop Slide	HIGHWAY & KM: 575:04, 26.631 to 26.050	PREVIOUS INSPECTION DATE: June 10, 2020	INSPECTION DATE: June 23, 2021
LEGAL DESCRIPTION: C017-I 04-26-29-21 W4M C017-II 01-27-29-21 W4M C017-III 01-27-29-21 W4M	NAD 83 COORDINATES: UTM Northing Easting 12 5707574 370869 12 5707733 370415 12 5707738 370340	RISK ASSESSMENT: PF: 4 CF: 3 TOTAL: 12 PF: 7 CF: 4 TOTAL: 28 PF: 10 CF: 4 TOTAL: 40	
AVERAGE ANNUAL DAILY TRAFFIC (AADT): 800 (east) and 870 (west) (Ref No. 105240 & 106230)		CONTRACT MAINTENANCE AREA (CMA): 517

SUMMARY OF SITE INSTRUMENTATION: One slope inclinometer (SI) and two vibrating wire piezometers (VWPs) were installed in fall 2020 at C017-III. LAST READING DATE: June 12, 2021	INSPECTED BY: Chris Gräpel (KCB) James Lyons (KCB) Roger Skirrow (AT) Tony Penney (AT)
PRIMARY SITE ISSUE: C017 – I: a shallow embankment slope failure on the north side (eastbound lane) of Hwy 575; C017 – II: an erosion gully that has formed downslope of a culvert outlet on the north side of Hwy 575; and C017 – III: a moderately deep-seated slide (5 to 6 m deep based on an SI installed in 2019) on the north side of Hwy 575 where the highway crosses

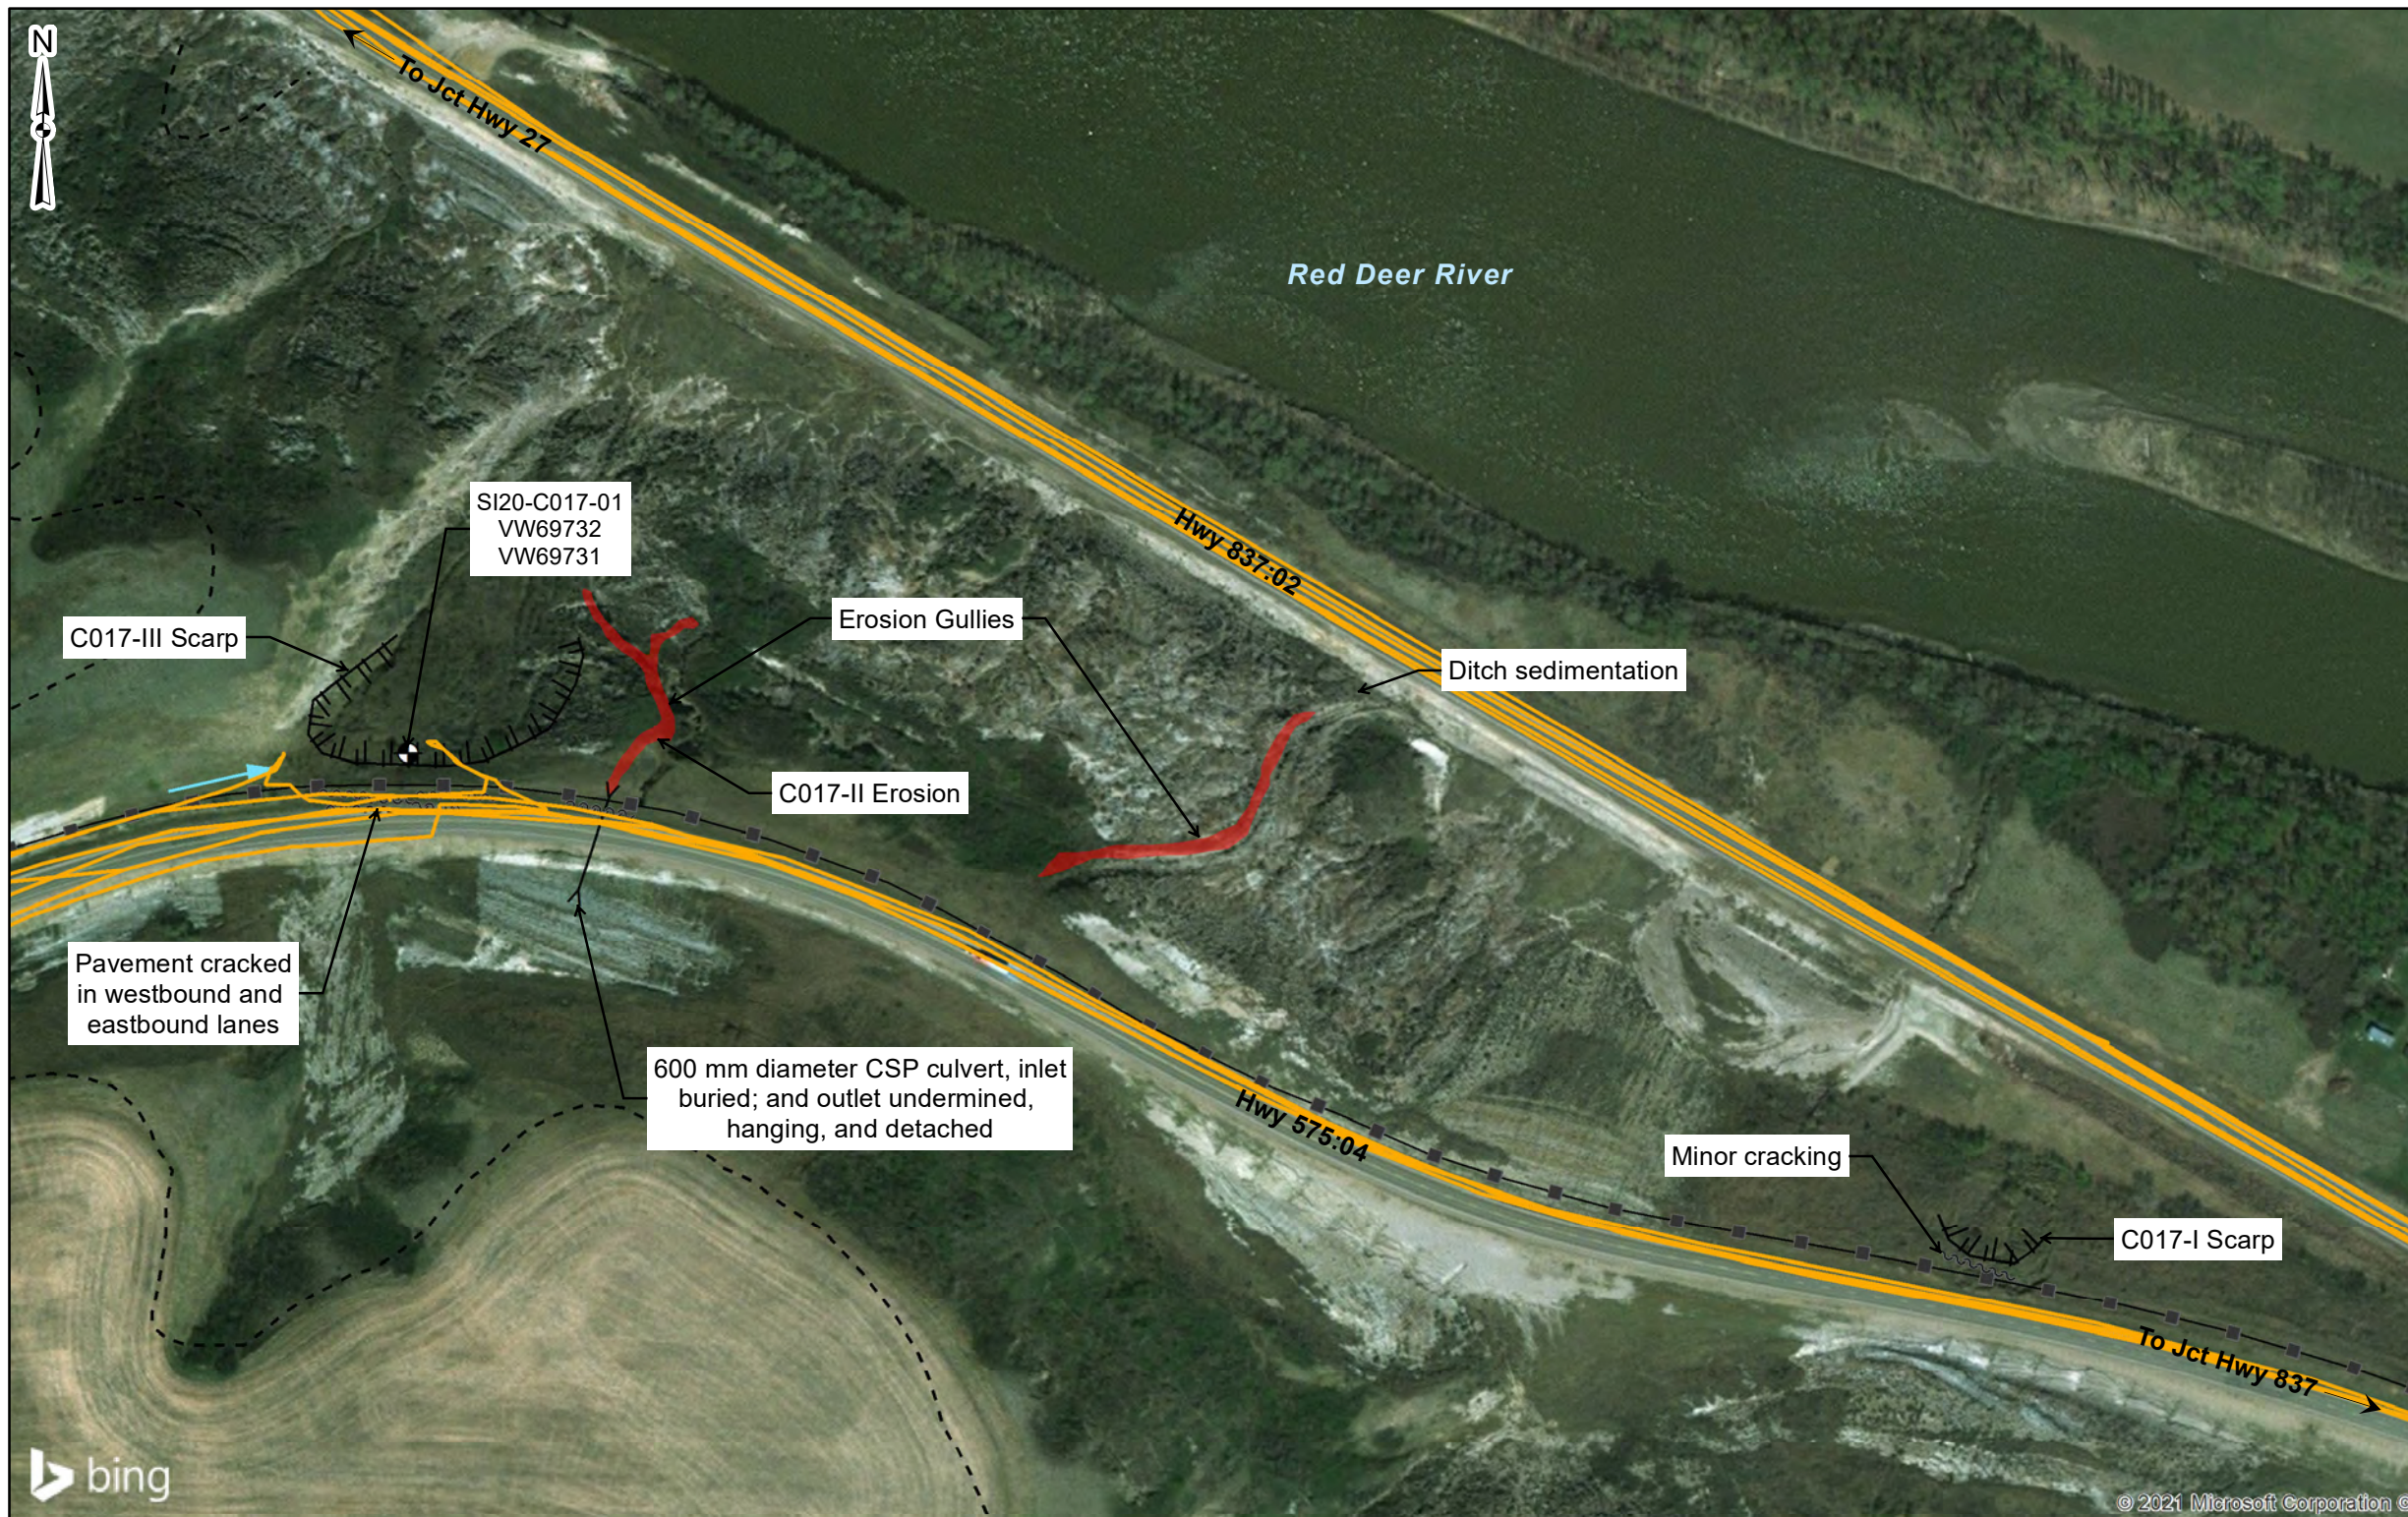
- Slide expansion was observed in 2021, near the north end of the backscarp, where an erosion gully approximately 2 m wide and 1.5 m has formed since the 2020 inspection.
- A longitudinal crack was observed between the backscarp and the shoulder of Hwy 575 since the 2020 inspection. Longitudinal cracking in the westbound lane could indicate potential retrogression of the backscarp onto the highway.
- The north ditch is conveying surface water flow over the slide area.
- Ditch erosion in the south (eastbound) ditch between C017-II and C017-III continues worsen, with gullies up to 1.2 m in depth.

- Since the failure plane appears to be approximately 5 m to 6 m below ground surface, the backscarp should be reinforced with soil nails. The slide may continue to move and require additional soil nail stabilization in the future. Like the C017-I site, the soil nail repair could be conducted by working from the highway surface. An additional borehole should be drilled in the westbound lane to assess ground conditions for a soil nail repair. Surface water flows from the ditch north of the slide should be re-routed to the toe of the slope with an intake structure installed in the ditch bottom, a buried pipe from the intake structure to the toe of the slope, and energy dissipating structure at the pipe outlet.
