July 15, 2024

**CON0022160 Central Region GRMP Instrumentation Monitoring  
Site C017-3; H575:04, km 26.631 Truckstop Slide  
Section C – 2024 Spring Readings**

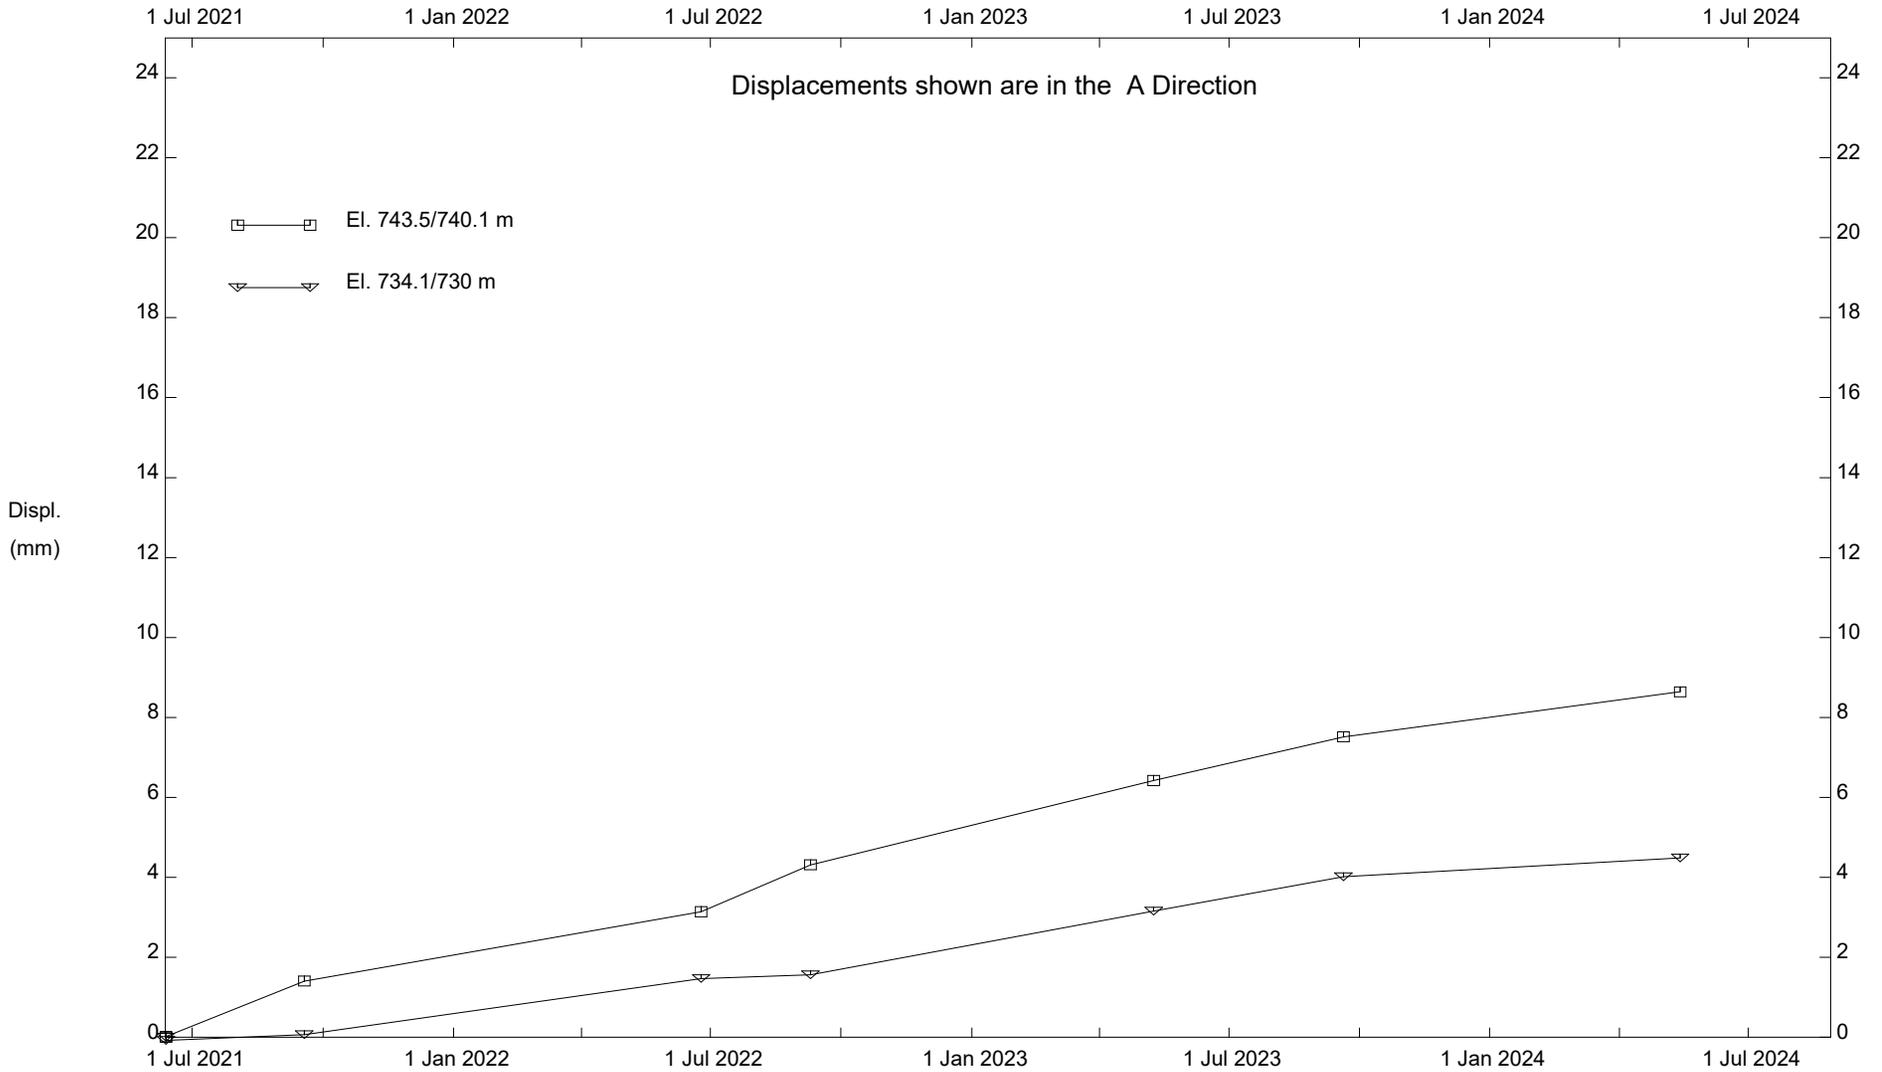
C017-III; H575:04; Truckstop Slide, Inclinator SI20-01

Based on the stratigraphy encountered during the 2020 drilling investigation, the upper and lower zones of movement recorded in SI20-C017-01 appear to be occurring in a soft zone in the embankment fill (silty clay and sand) and in the underlying foundation material (sandy silt), respectively.

An overall relatively slow rate of movement (approximately 3 mm/year) has been recorded in the SI since June 2021, excluding an increased rate of movement (approximately 6 mm/year) recorded in fall 2022 after wet weather in June and July 2022. Increased movement may occur in response to periods of heavy or prolonged rainfall or freshet infiltration, resulting in a higher groundwater level.
