July 15, 2025

Alberta Transportation and Economic Corridors
4th Floor, Provincial Building
4920 – 51st Street
Red Deer, Alberta
T4N 6K8

CON0022160 Central Region GRMP Instrumentation Monitoring
Site C048-1; H575:04, km 14.500 Slide West of Carbon Creek
Section C – 2025 Spring Readings

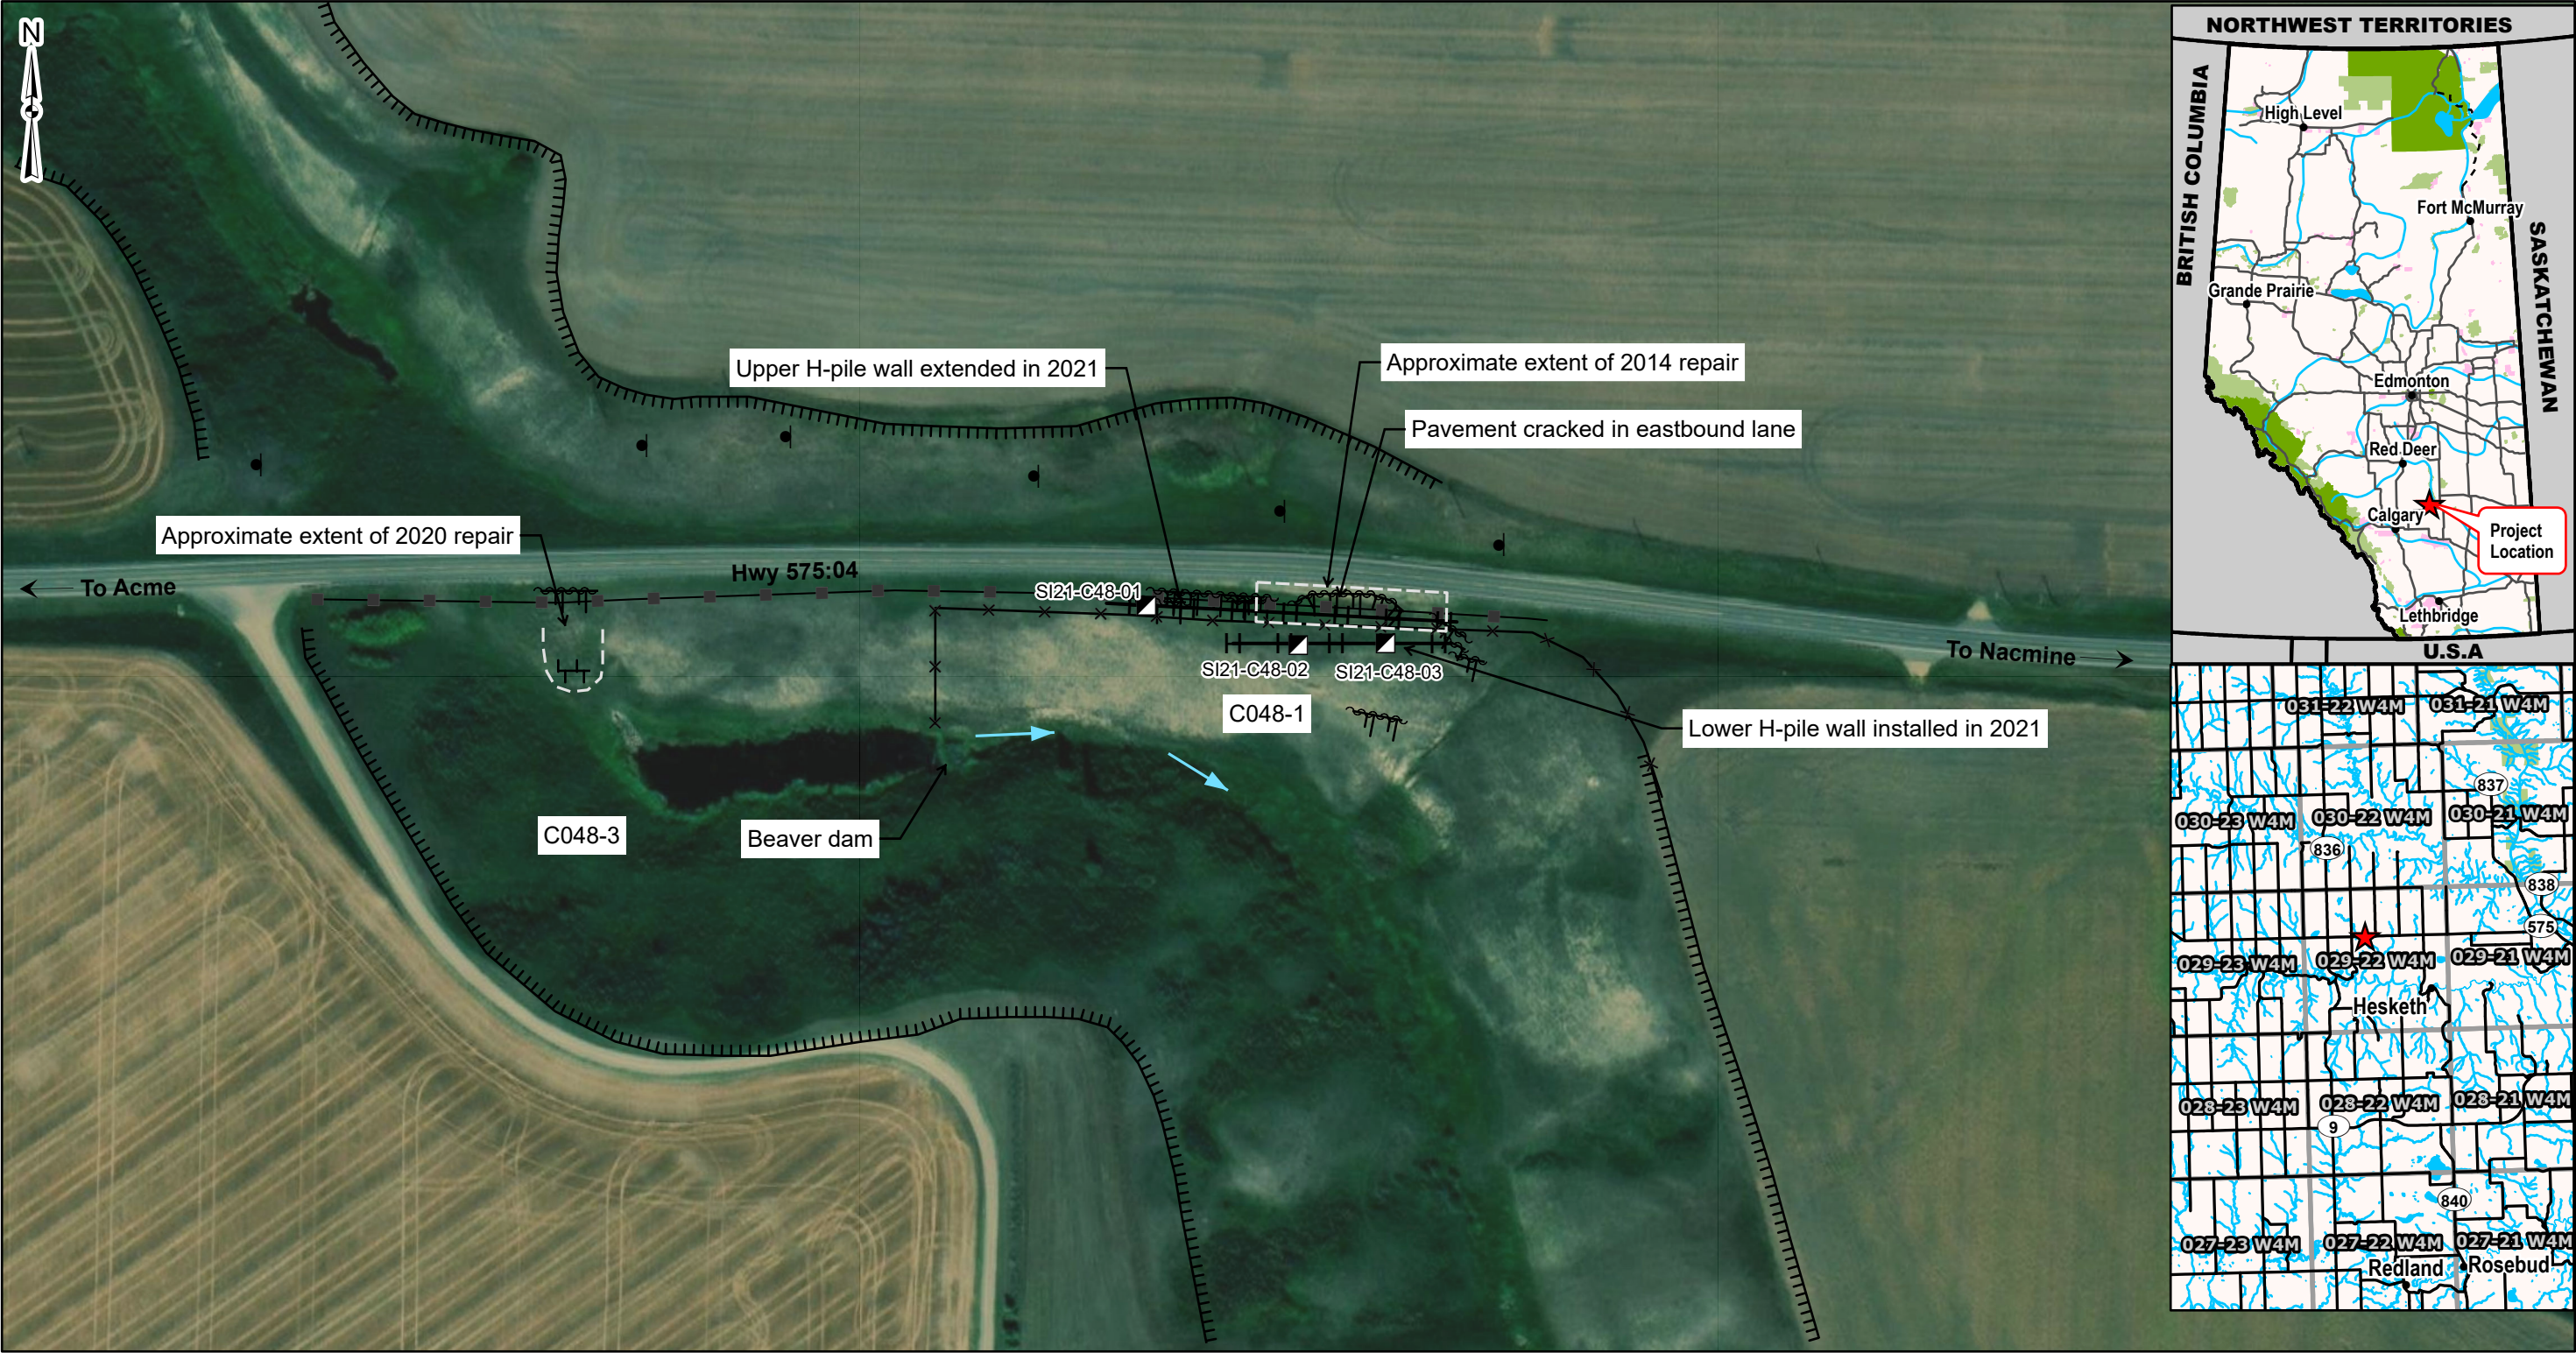
FIGURE

Three slope inclinometers (SIs) (SI21-C48-01 through SI21-C48-03) were read at the C048 site in the Central Region on May 20, 2025 by Evan Hergott, E.I.T. of Klohn Crippen Berger Ltd. (KCB). These instruments were read as part of the Central Region Geohazard Risk Management Program (GRMP). The site is located on Hwy 575:04, km 14.500, approximately 8 km northeast of Carbon, Alberta. The approximate site coordinates are 5707780 N, 358388 E (UTM Zone 12, NAD 83). A site plan is presented in Figure 1.
