July 15, 2025

Alberta Transportation and Economic Corridors
4th Floor, Provincial Building
4920 – 51st Street
Red Deer, Alberta
T4N 6K8

CON0022160 Central Region GRMP Instrumentation Monitoring
Site C065; H585:02, km 16.136 East of Trochu Slides
Section C – 2025 Spring Readings

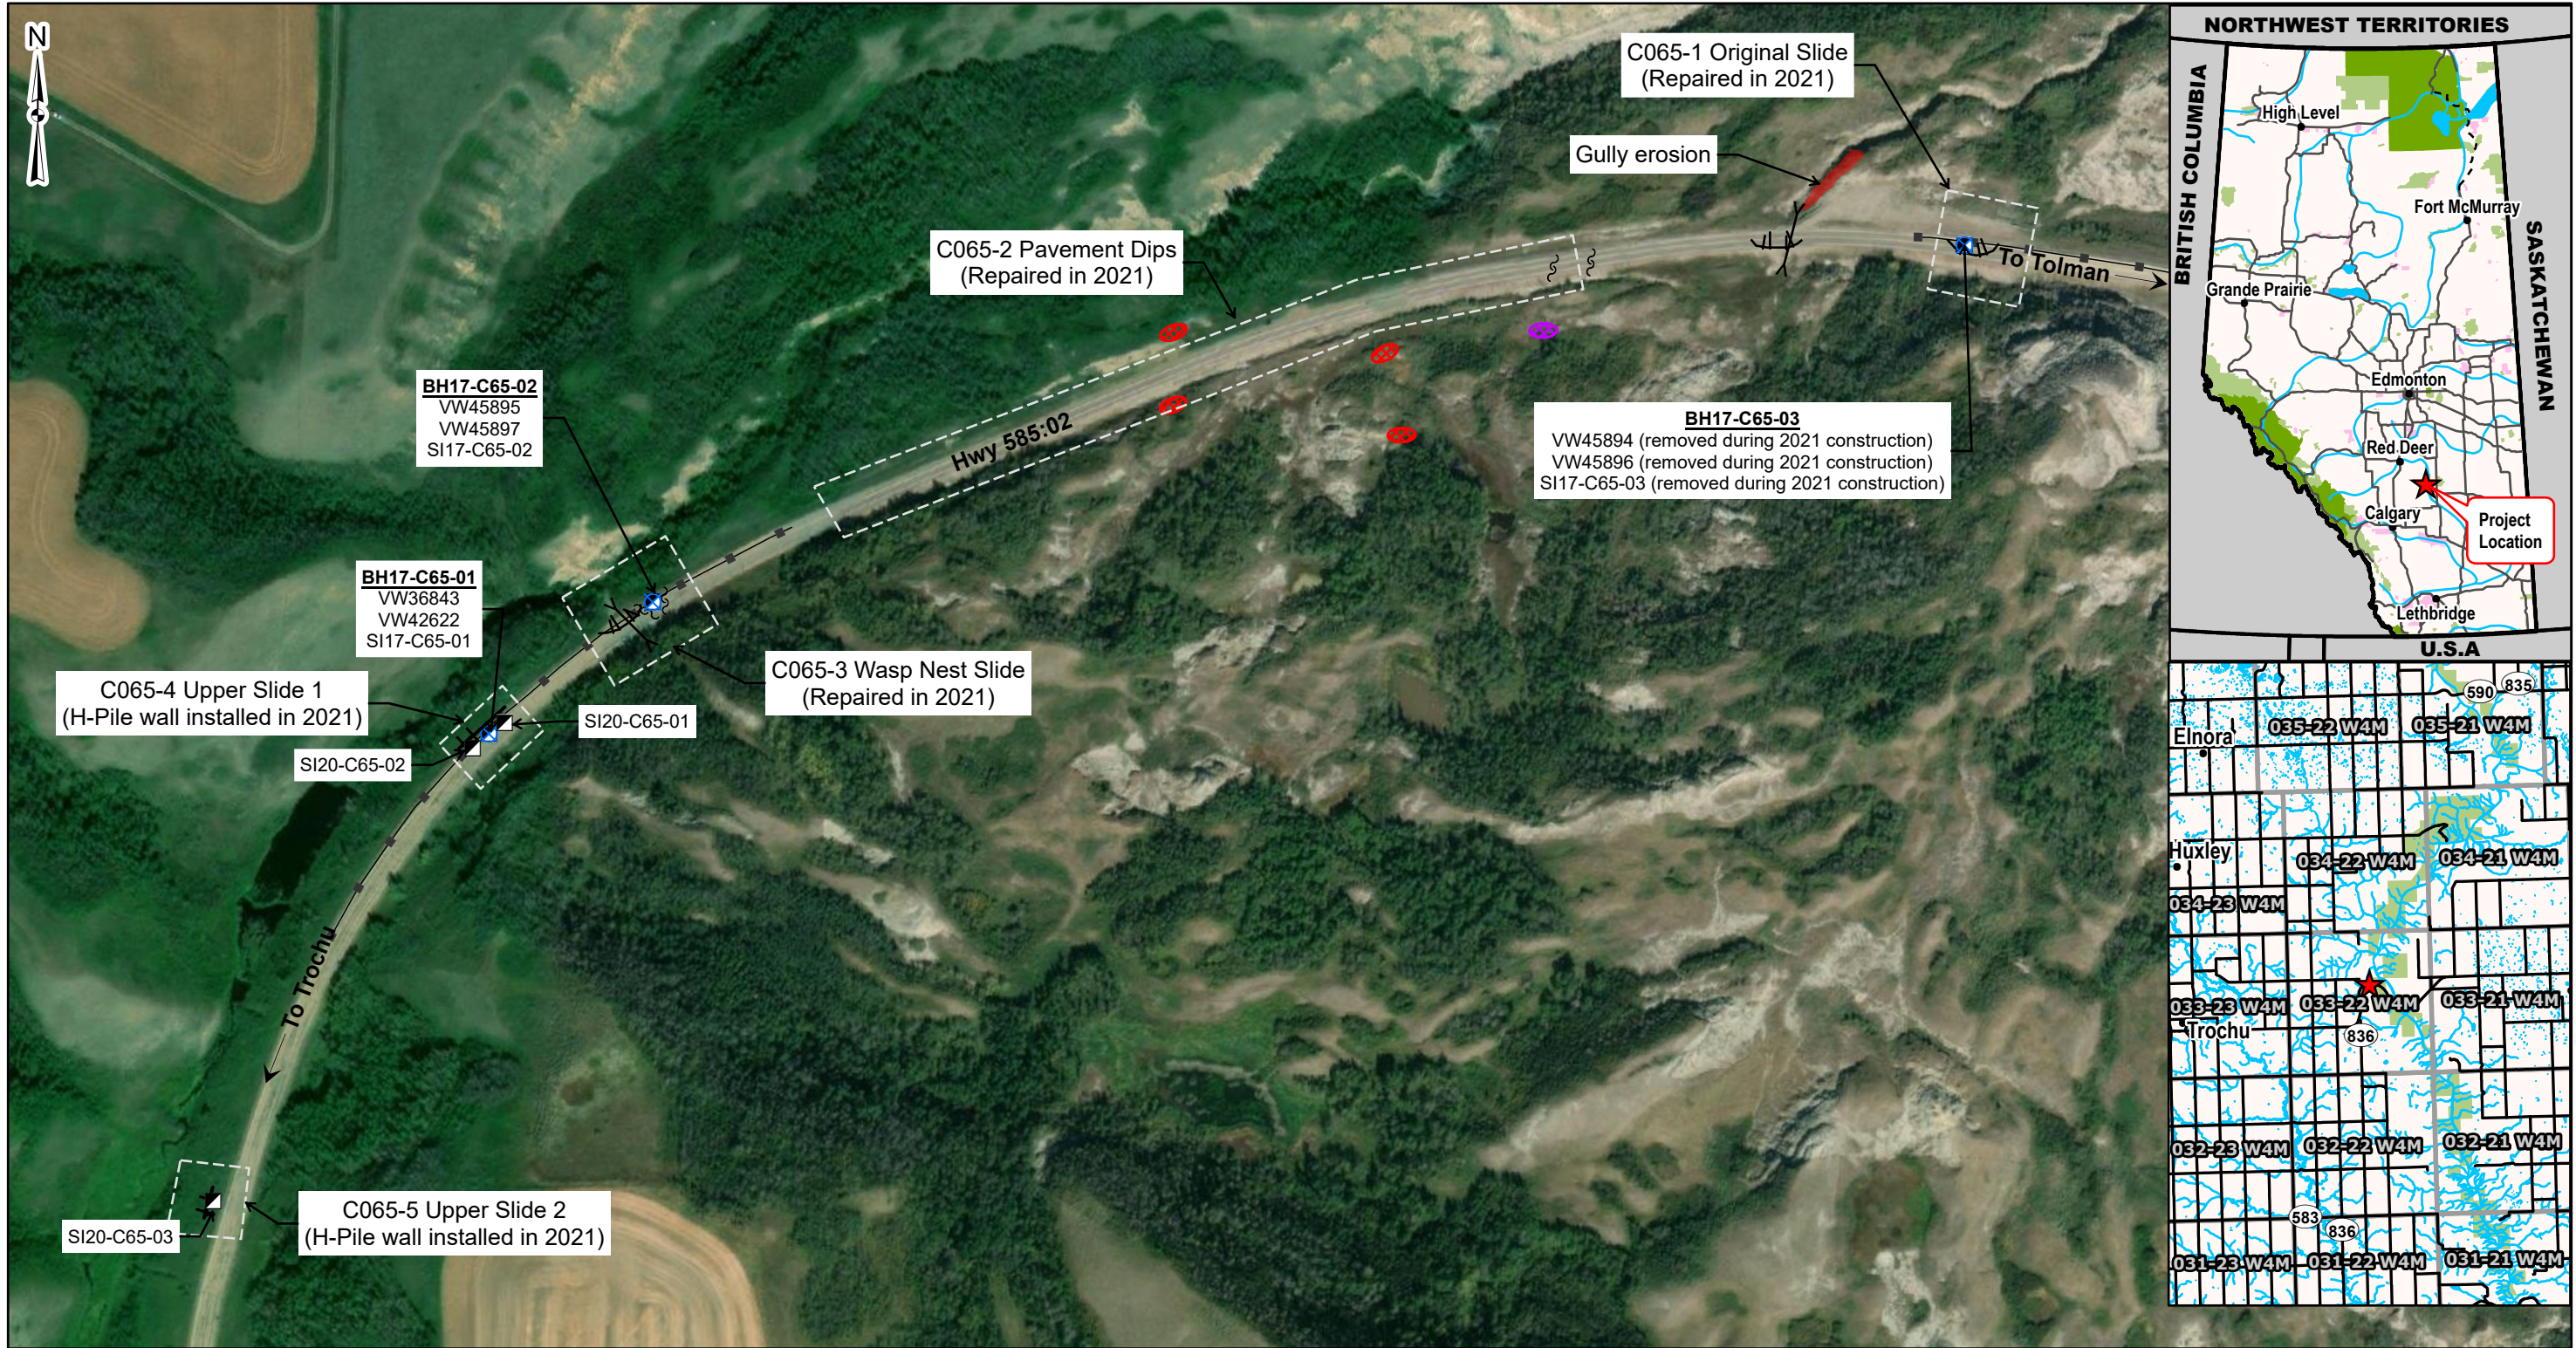
FIGURE

Five slope inclinometers (SIs) (SI17-C65-01 and SI17-C65-02, and SI21-C65-01 through SI21-C65-03) and four vibrating wire piezometers (VWPs) (VW36843, VW42622, VW45895, and VW45897) were read at the C065 site in the Central Region on May 14, 2025 by Tim Hillman, E.I.T., and Kaylee Craplewe (co-op student) of Klohn Crippen Berger Ltd. (KCB). These instruments were read as part of the Central Region Geohazard Risk Management Program (GRMP). The site is located on Hwy 585:02, km 16.136, approximately 13 km east of Trochu, Alberta and 2 km west of the Tolman Bridge, which crosses the Red Deer River. The approximate site coordinates are 5746288 N, 359329 E (UTM Zone 12, NAD 83). A site plan is presented in Figure 1.
