SITE NUMBER AND NAME: C035 Ditch Erosion		HIGHWAY & KM: 590:04, 20.104	PREVIOUS INSPECTION DATE: June 9, 2020	INSPECTION DATE: June 24, 2021
LEGAL DESCRIPTION: 04-28-035-21 W4M 13/14/15/16-21-035-21 W4M 01-28-035-21 W4M	NAD 83 COORDINATES: UTM Northing Easting 12 5765903 365774 12 5765738 367296		RISK ASSESSMENT: PF: 10 CF: 4 TOTAL: 40	
AVERAGE ANNUAL DAILY TRAFFIC (AADT): 680 (east) and 570 (west) (Ref No.103300 & 997156)			CONTRACT MAINTENANCE AREA (CMA): 517

SUMMARY OF SITE INSTRUMENTATION: There is no instrumentation at the C035 site. LAST READING DATE: N/A	INSPECTED BY: Chris Gräpel (KCB) James Lyons (KCB) Roger Skirrow (AT) Tony Penney (AT) Darcy Newton (AT)
PRIMARY SITE ISSUE: Numerous erosion features located along Hwy 590, mainly in the ditches, on either side of the Red Deer River.	
APPROXIMATE DIMENSIONS: The site is approximately 2 km long.	
DATE OF ANY REMEDIAL ACTION: 2020 – The large erosion gully approximately 600 m west of the bridge was backfilled with gravel and Class 1M riprap by the Highway Maintenance Contractor (HMC) in fall 2020.

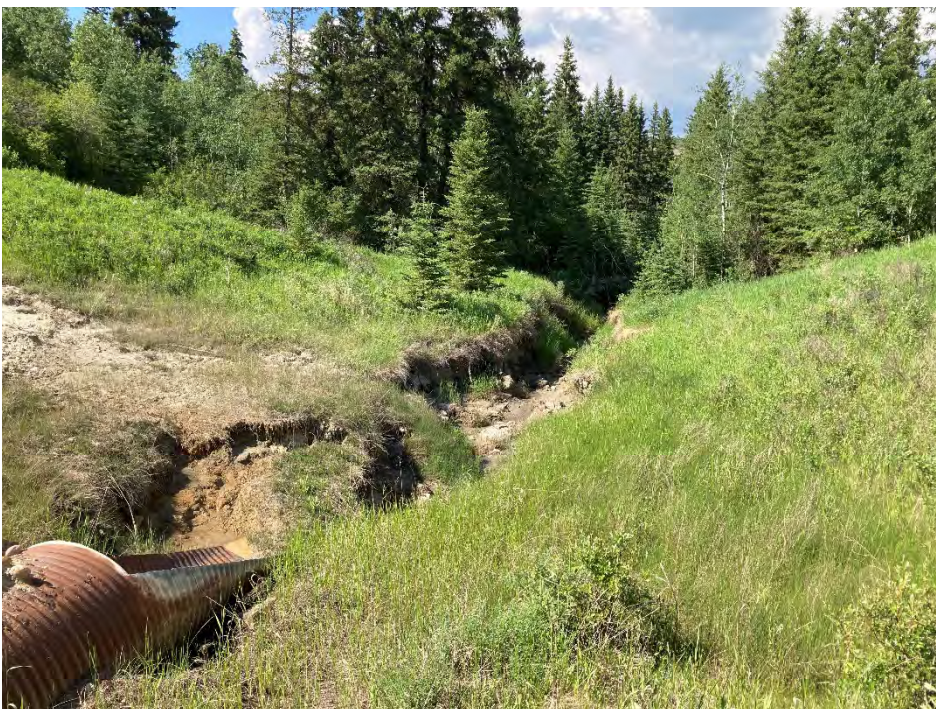
- Erosion gullies beneath the bridge have expanded and retrogressed toward the bridge abutments. The erosion gully is larger than during the 2020 inspection and should be repaired in 2021.

Photo 4 Erosion gully at the east abutment is larger than during the 2020 inspection. Photo taken June 24, 2021 facing west.

Repair options for the erosion gully below bridge abutment:

- In the short term, riprap should be placed in the erosion gully to minimize the potential for enlargement and continued retrogression. This should be repaired by the bridge group, as they have experience completing work around existing creosote timbers and have procedures in place.
