<b>SITE NUMBER AND NAME:</b> C060 Slide East of Blackfalds		<b>HIGHWAY &amp; KM:</b> 597:02, 11.299	<b>PREVIOUS INSPECTION DATE:</b> June 9, 2020	<b>INSPECTION DATE:</b> <b>May 30, 2022</b>
<b>LEGAL DESCRIPTION:</b> 01-16-039-26 W4M 16-09-039-26 W4M	<b>NAD 83 COORDINATES:</b> UTM Northing Easting 12 5802987 317570		<b>RISK ASSESSMENT:</b> PF: 5 CF: 6 TOTAL: 30	
<b>AVERAGE ANNUAL DAILY TRAFFIC (AADT):</b> 1120 (west) & 2910 (east) (Ref No. 97337 & 89330)			<b>CONTRACT MAINTENANCE AREA (CMA):</b> 516

PROJECT CENTRAL REGION GEOHAZARD RISK MANAGEMENT PROGRAM		
TITLE Site Plan C060 - Slide East of Blackfalds Hwy 597:02, km 11.299		
SCALE 1:1,000	PROJECT No. A05116A02	FIG No. 1

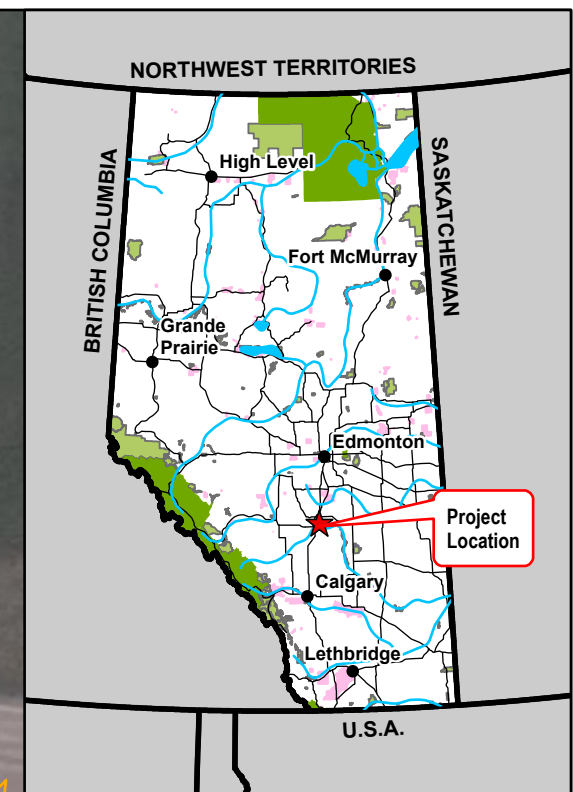
<b>COMMENTS</b>
In March 2017, a geotechnical site investigation was conducted by KCB. Four VWPs and two SIs were installed to monitor groundwater conditions and depth of movement. Since installation, SI17-C60-02 (located at the toe berm crest) has not recorded any discernible movement. SI17-C60-01 is recording movement at the interface between embankment fill and bedrock foundation (approximately 14 mbgs).
The fence north of the highway appears to have settled above (upslope) the slide area (Photo 1).
The pavement appears to have deteriorated (i.e., alligator cracking) in the eastbound and westbound lanes since the pavement patch was completed in 2020 (Photo 1). There is a transverse crack near the east extent of the

pavement patch that extends across both lanes. Pavement cracking could lead to increased infiltration and softening of the highway subgrade.

- Photo 1** Alligator cracking has been regularly observed in both lanes upslope the C060 slide and appears to have worsened since the 2020 inspection. Photo taken May 30, 2022, facing northwest.

- The pavement along the site should be milled and repaved to address pavement cracking. The extent of the pavement patch should be larger than the previous patch to address the new pavement cracking east of the slide.
- In the areas where the pavement deterioration is the most significant (i.e., zone of cracking and pothole near the west extent of the exiting pavement patch) the subgrade should be excavated and replaced with more competent material (e.g., Des. 2 Cl. 40). AT informed KCB that paving may be completed in fall 2022 or 2023.
- The erosion observed at the outlet of the CSP culvert (WP 142) should be repaired by backfilling the eroded areas with riprap (e.g., Class 1M)
