September 12, 2022

Alberta Transportation
4th Floor, Provincial Building
4920 51 Street
Red Deer, Alberta
T4N 6K8

**CON0022160 Central Region GRMP Instrumentation Monitoring
Site C060; H597:02, km 11.299 Slide East of Blackfalds
Section C – 2022 Spring Readings**

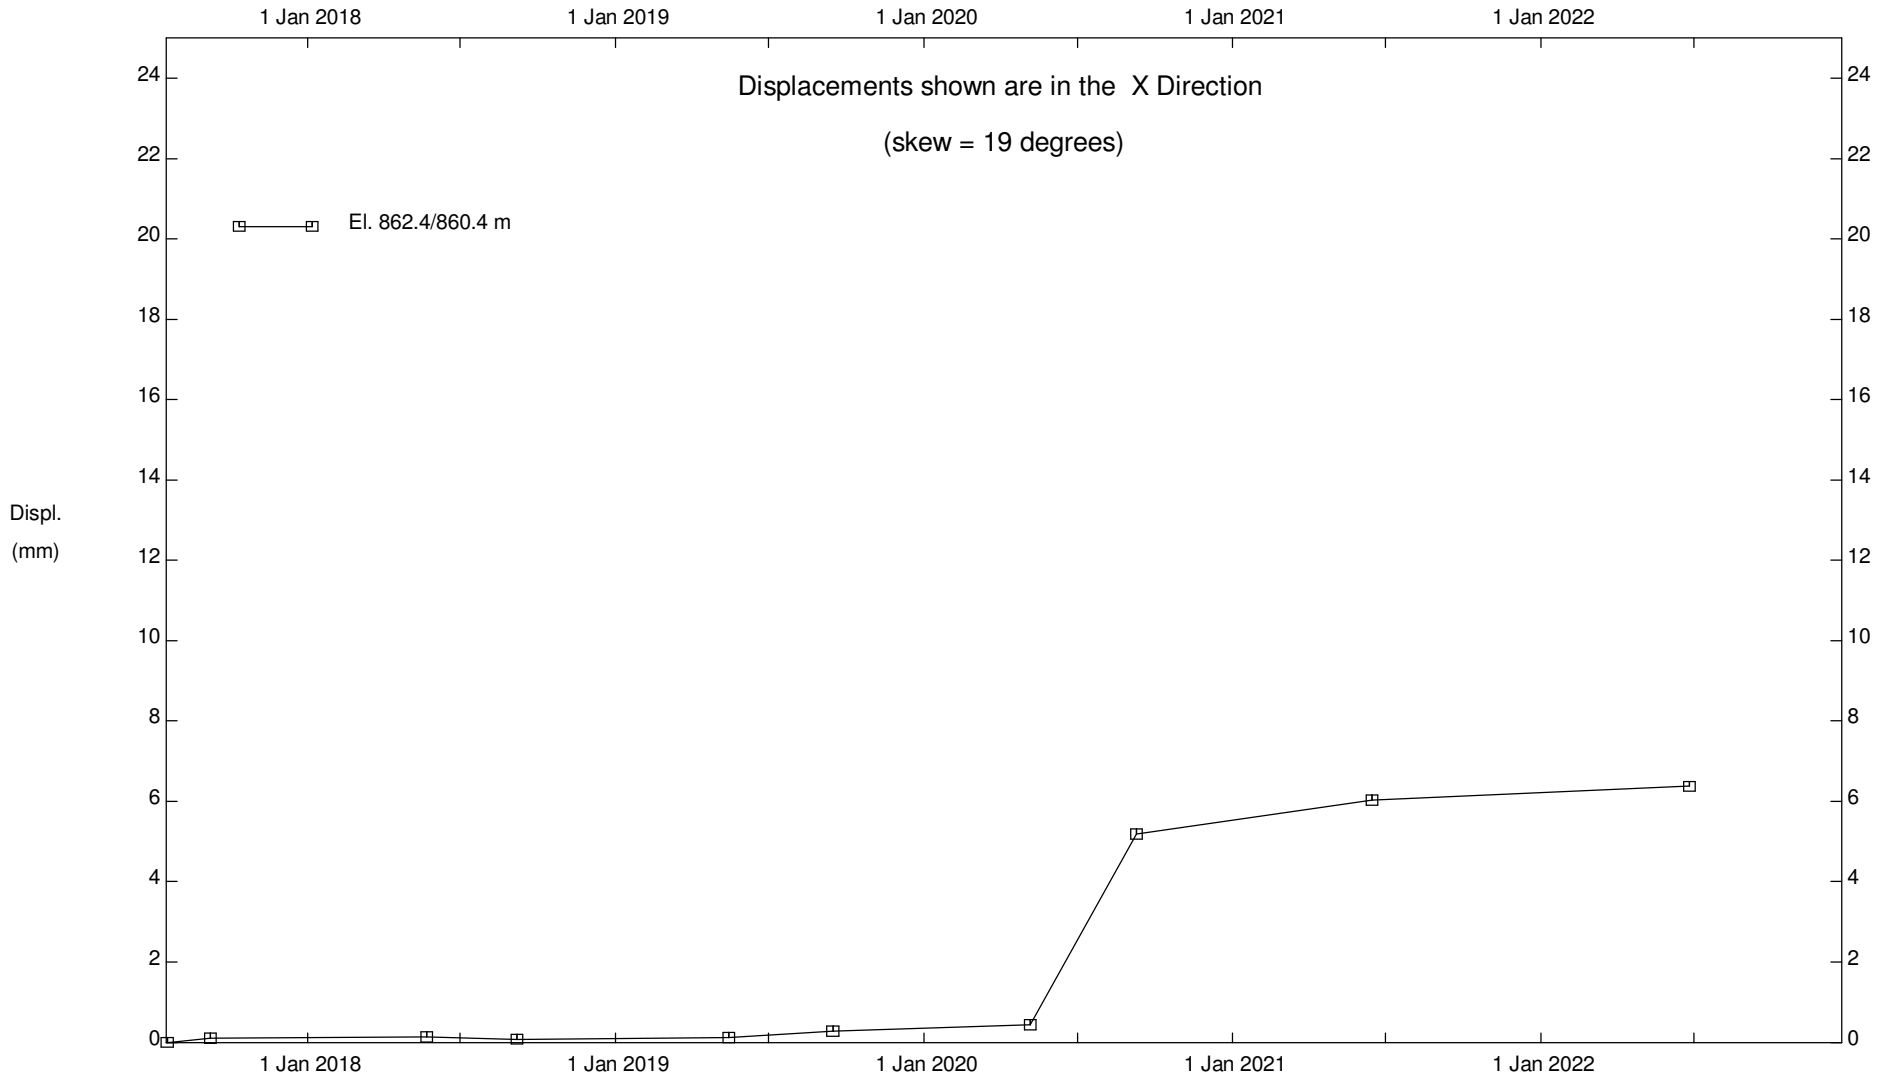
C060; H597:02, Slide East of Blackfalds, Inclinometer S117-C60-02

- the movement recorded in SI17-C60-02 (through toe berm crest) appears to be occurring near the interface between the fill and underlying foundation materials.
