SITE NUMBER AND NAME: <b>C037 – I &amp; II Culverts</b>		HIGHWAY & KM: 734:12, 41.8 & 42.9	PREVIOUS INSPECTION DATE: June 23, 2016	INSPECTION DATE: <b>June 12, 2017</b>
LEGAL DESCRIPTION: 03-29-033-08 W5M	NAD 83 COORDINATES: UTM Northing Easting 11 5746497 630511		RISK ASSESSMENT: PF: 1 CF: 1 TOTAL: 1 PF: 1 CF: 1 TOTAL: 1	
AVERAGE ANNUAL DAILY TRAFFIC (AADT): 160 south (Reference No. 51280)			CONTRACT MAINTENANCE AREA (CMA): 18

NOTES: 1. HORIZONTAL DATUM: NAD83 2. GRID ZONE: UTM Zone 11N 3. IMAGE SOURCE: Bing Maps 2016, Microsoft Corporation. Image dated May 2013	CLIENT 	PROJECT CENTRAL REGION GEOHAZARD RISK MANAGEMENT PROGRAM
		TITLE Site Plan C037-I Culverts Hwy 734:12, km 41.8
SCALE 1:800	PROJECT No. A05115A02	FIG No. 1

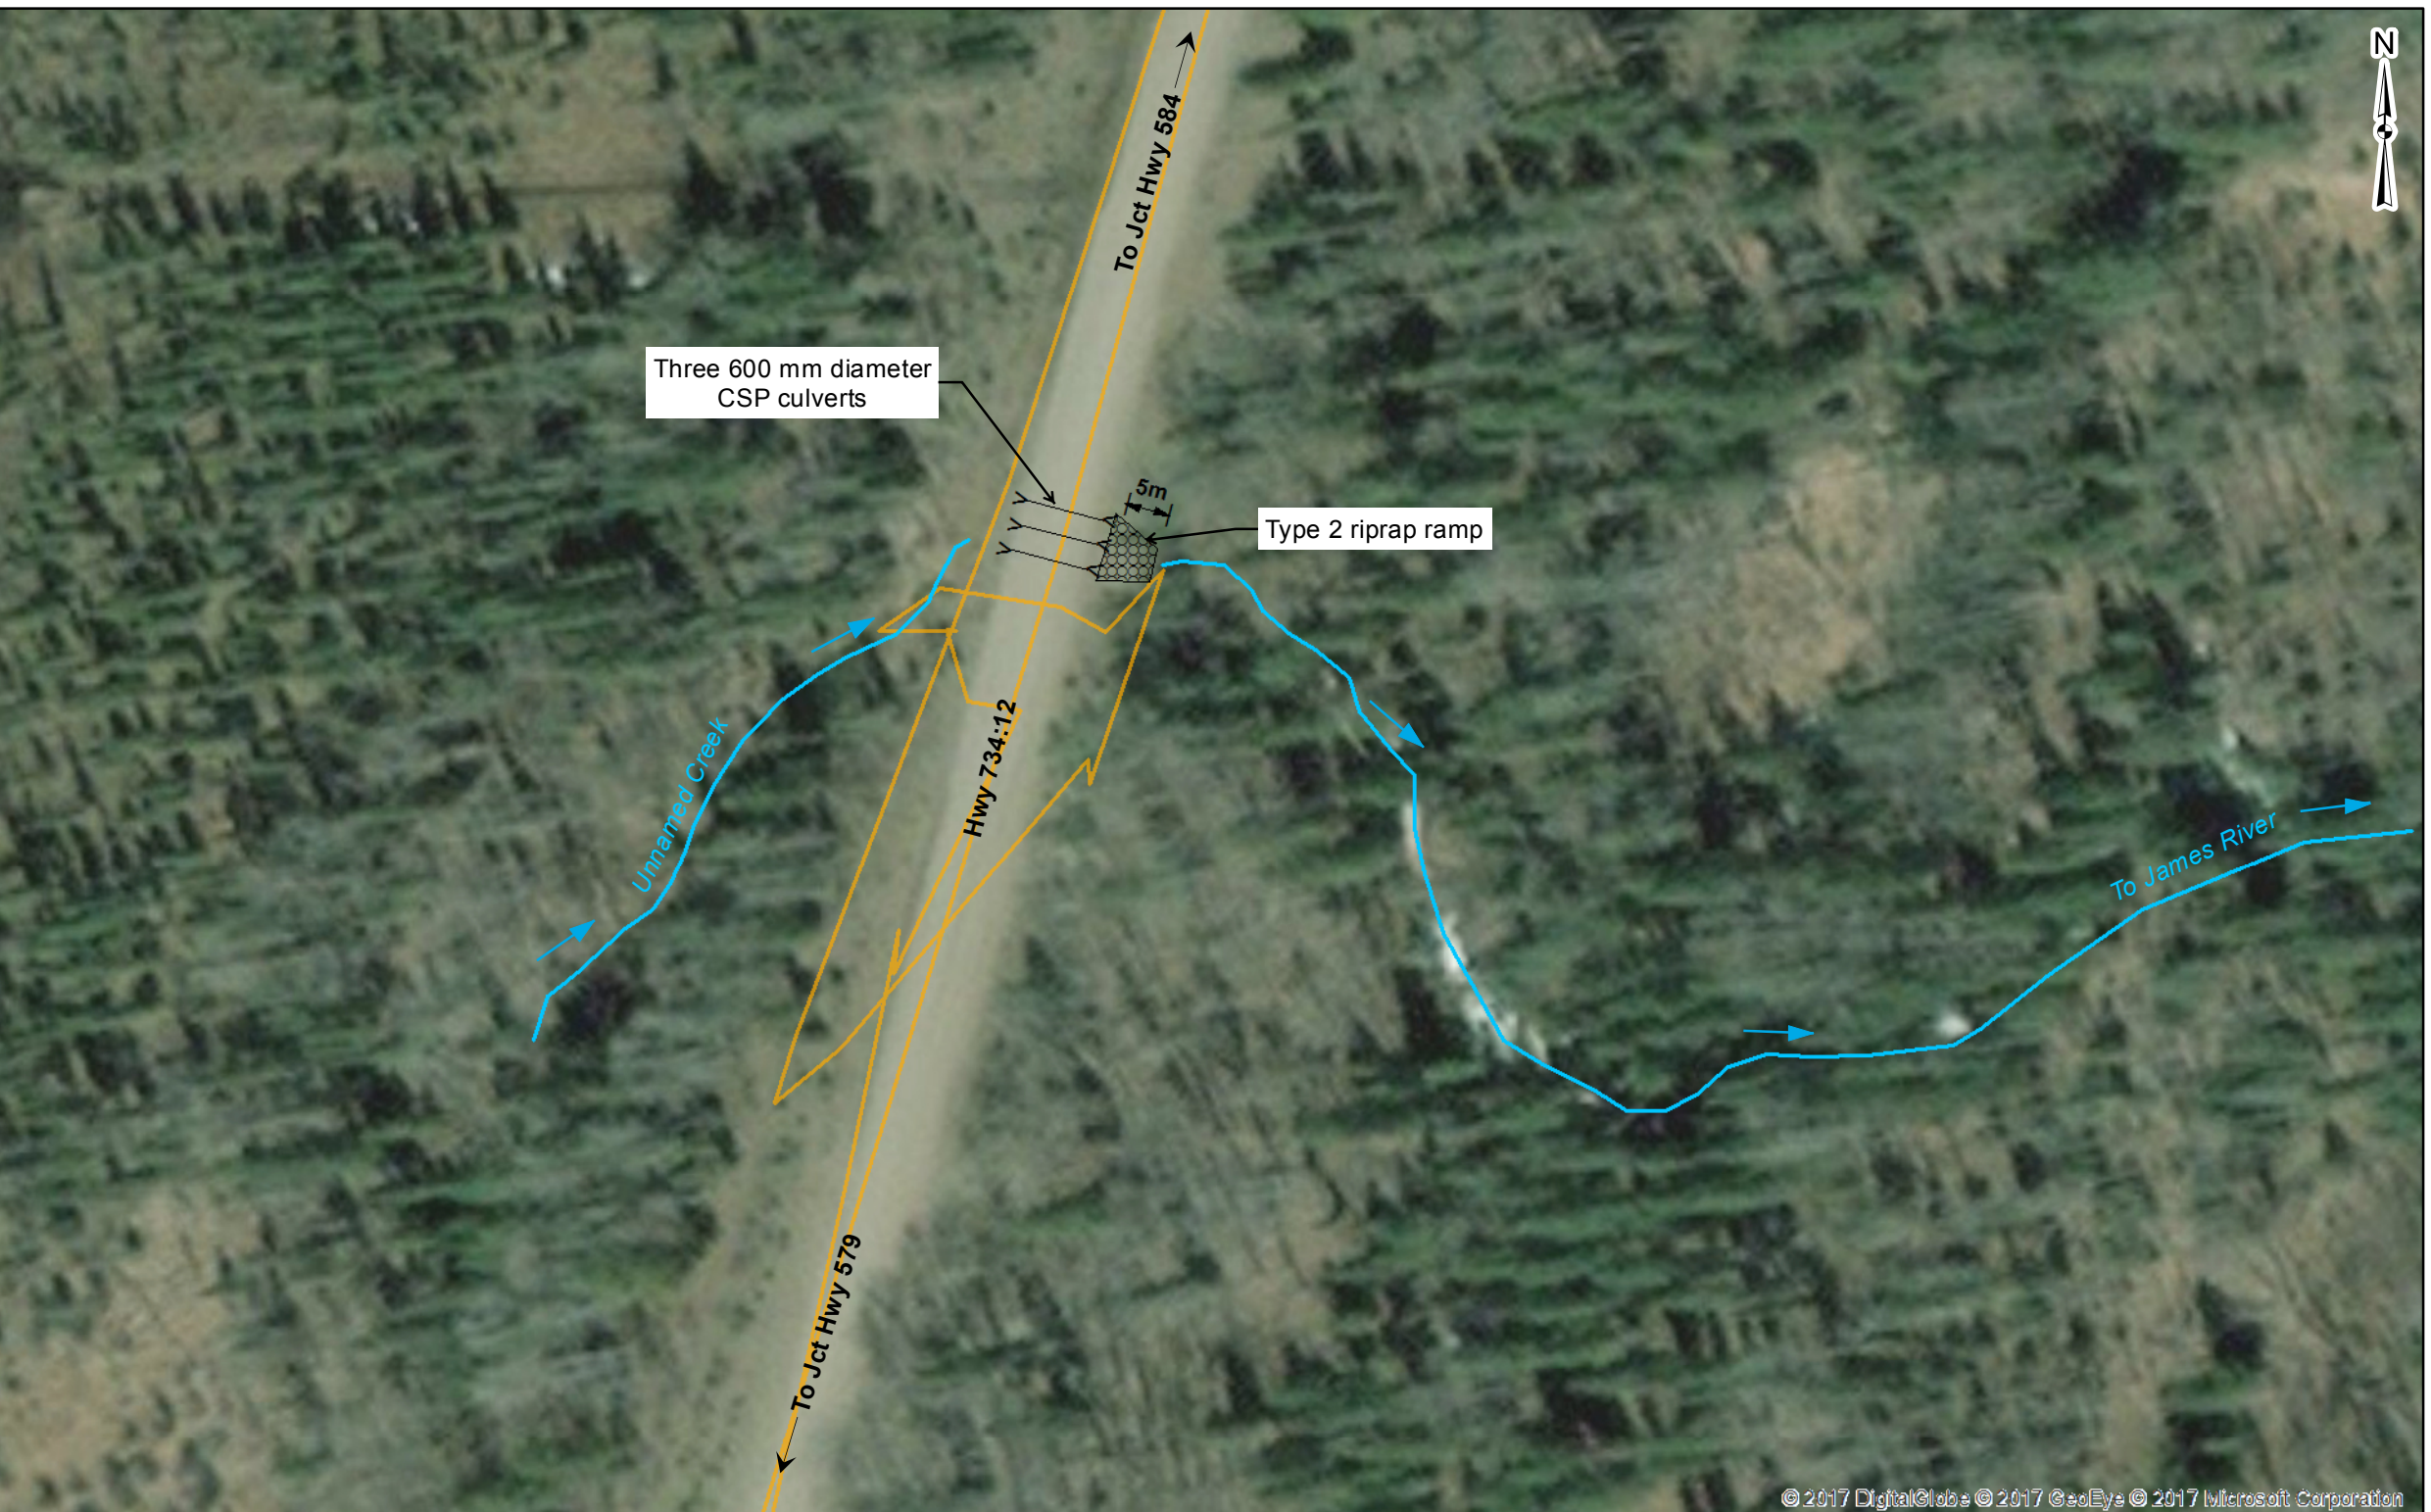
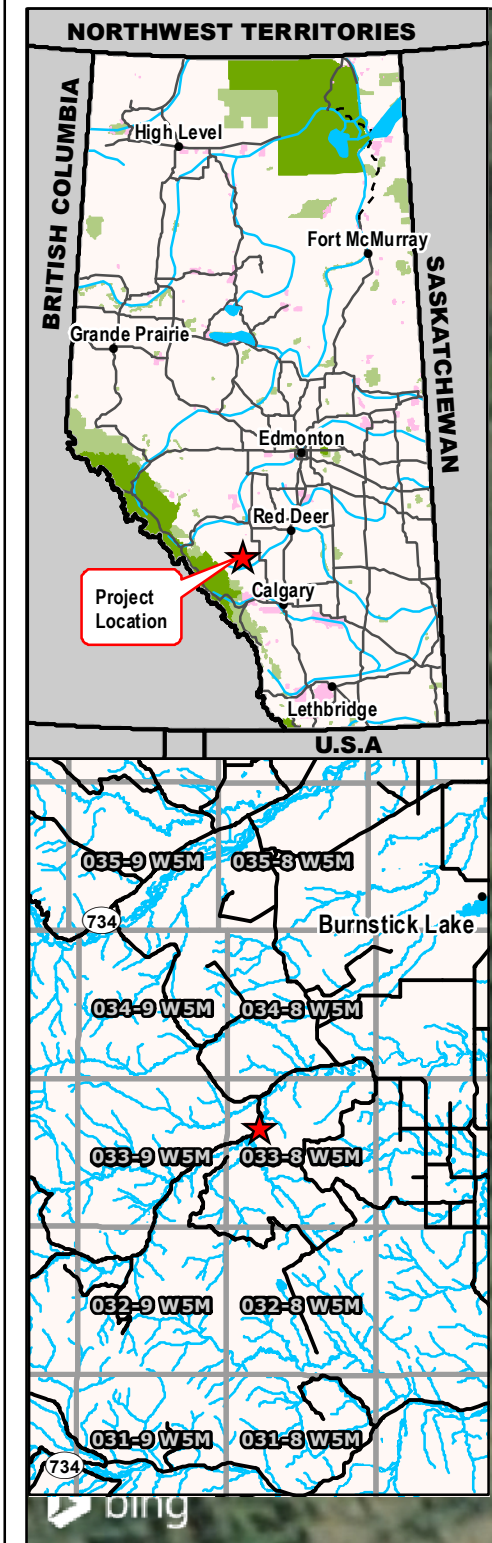
<b>COMMENTS</b>
At the C037 – I site, some undersized Class 2 riprap was placed at the culvert outlets. The MCI should monitor the culvert outlets for erosion after future flood events. Large riprap that was placed during a previous repair and removed during the 2016 repair and placed along the flanks of the riprap ramp, can be placed around the culvert outlets to repair erosion, as needed.
An old timber crib culvert was discovered at the C037-I site during construction in 2016. The timber culvert was excavated and replaced with coarse rockfill (gabion basket backfill) and covered with woven geotextile before the culverts were placed.
Prior to repair work being completed in 2016, the original highway geometry at the C037-II site had a steep super elevation. To eliminate some of the super elevation, additional gravel was added to the repair work contract, after the site was inspected during the 2016 GRMP tour, and subsequently placed during construction in 2016. Grading since 2016 appears to have re-established the super elevation that existed before construction.
