| <b>SITE NUMBER AND NAME:</b><br><b>C018 Red Deer Riverbank Slide</b> | <b>HIGHWAY &amp; KM:</b><br>837:02, 2.1 | <b>PREVIOUS INSPECTION DATE:</b><br>June 18, 2024 | <b>INSPECTION DATE:</b><br><b>June 10, 2025</b> |

| <b>PRIMARY SITE ISSUE:</b> Natural slope instability along a section of the west valley slope along Hwy 837:02 (C018-2) and highway embankment instability (C018-1). |

Site Plan  
C018 - Red Deer Riverbank Slide  
Hwy 837:02, km 2.100

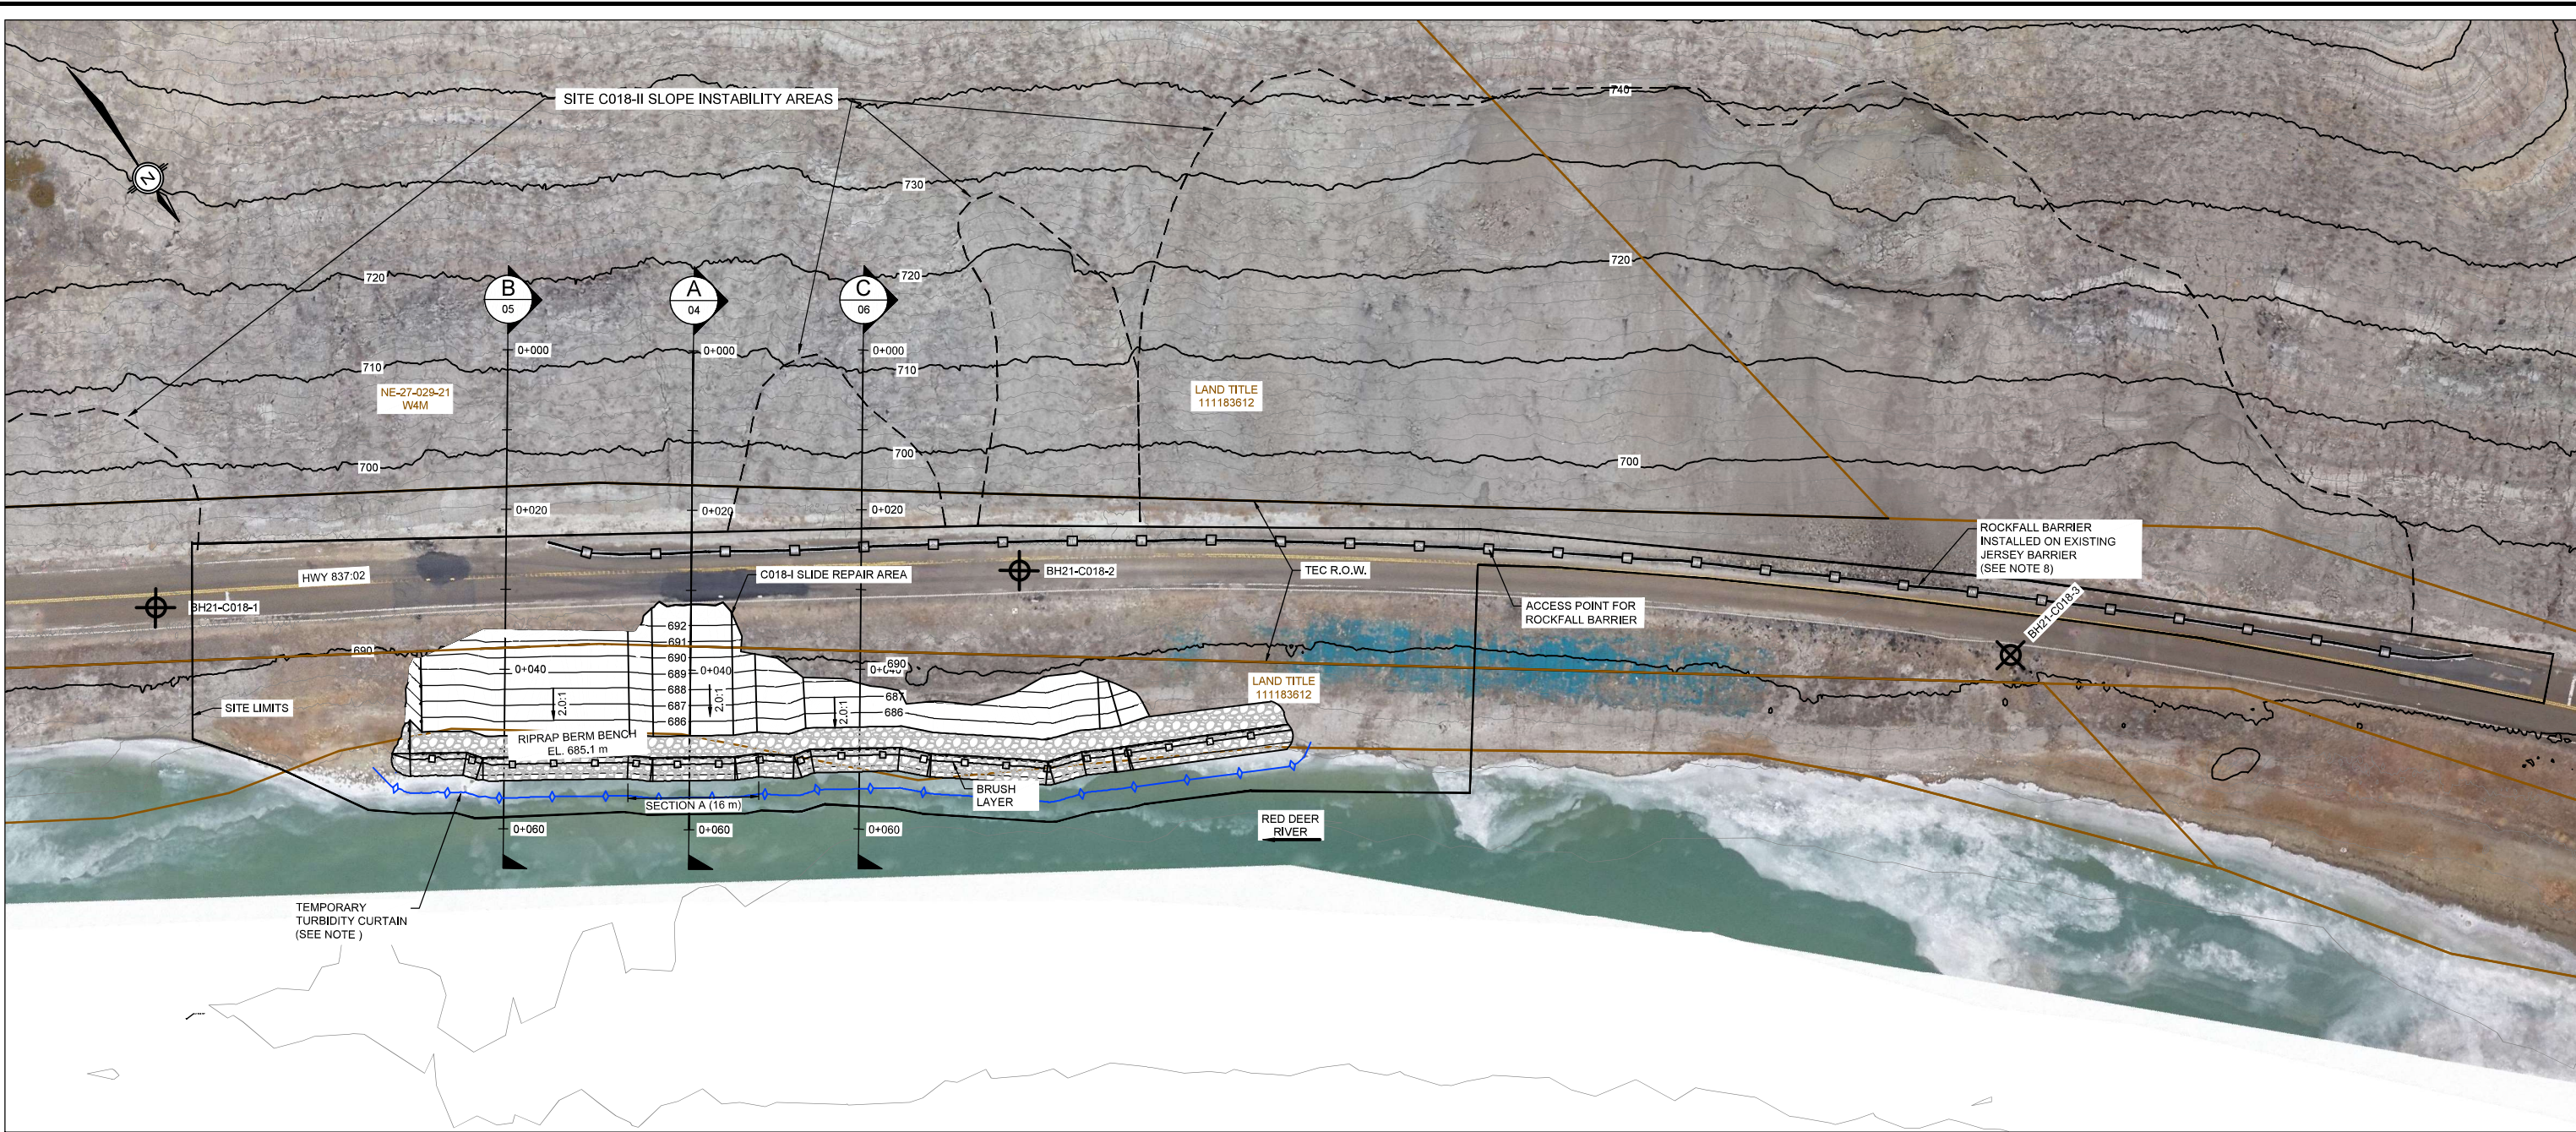
C018-I: REPAIR PLAN  
SCALE = 1:250

- The slope failure in the east highway embankment slope and riverbank erosion were repaired between October 2024 and June 2025 by PME Inc. as part of CON0022533. The repair consisted of excavation of slide material, slope reconstruction with geogrid-reinforced granular fill, riprap armouring (Class 2) in the lower portion of the slope, a brush layer within the riprap, and protecting the slope face with a RECP. The repair work is complete and appears to be performing well. Vegetation (grass) is beginning to grow through the RECP (Photo 1) and the brush layer appears to be in growing well (Photo 2).

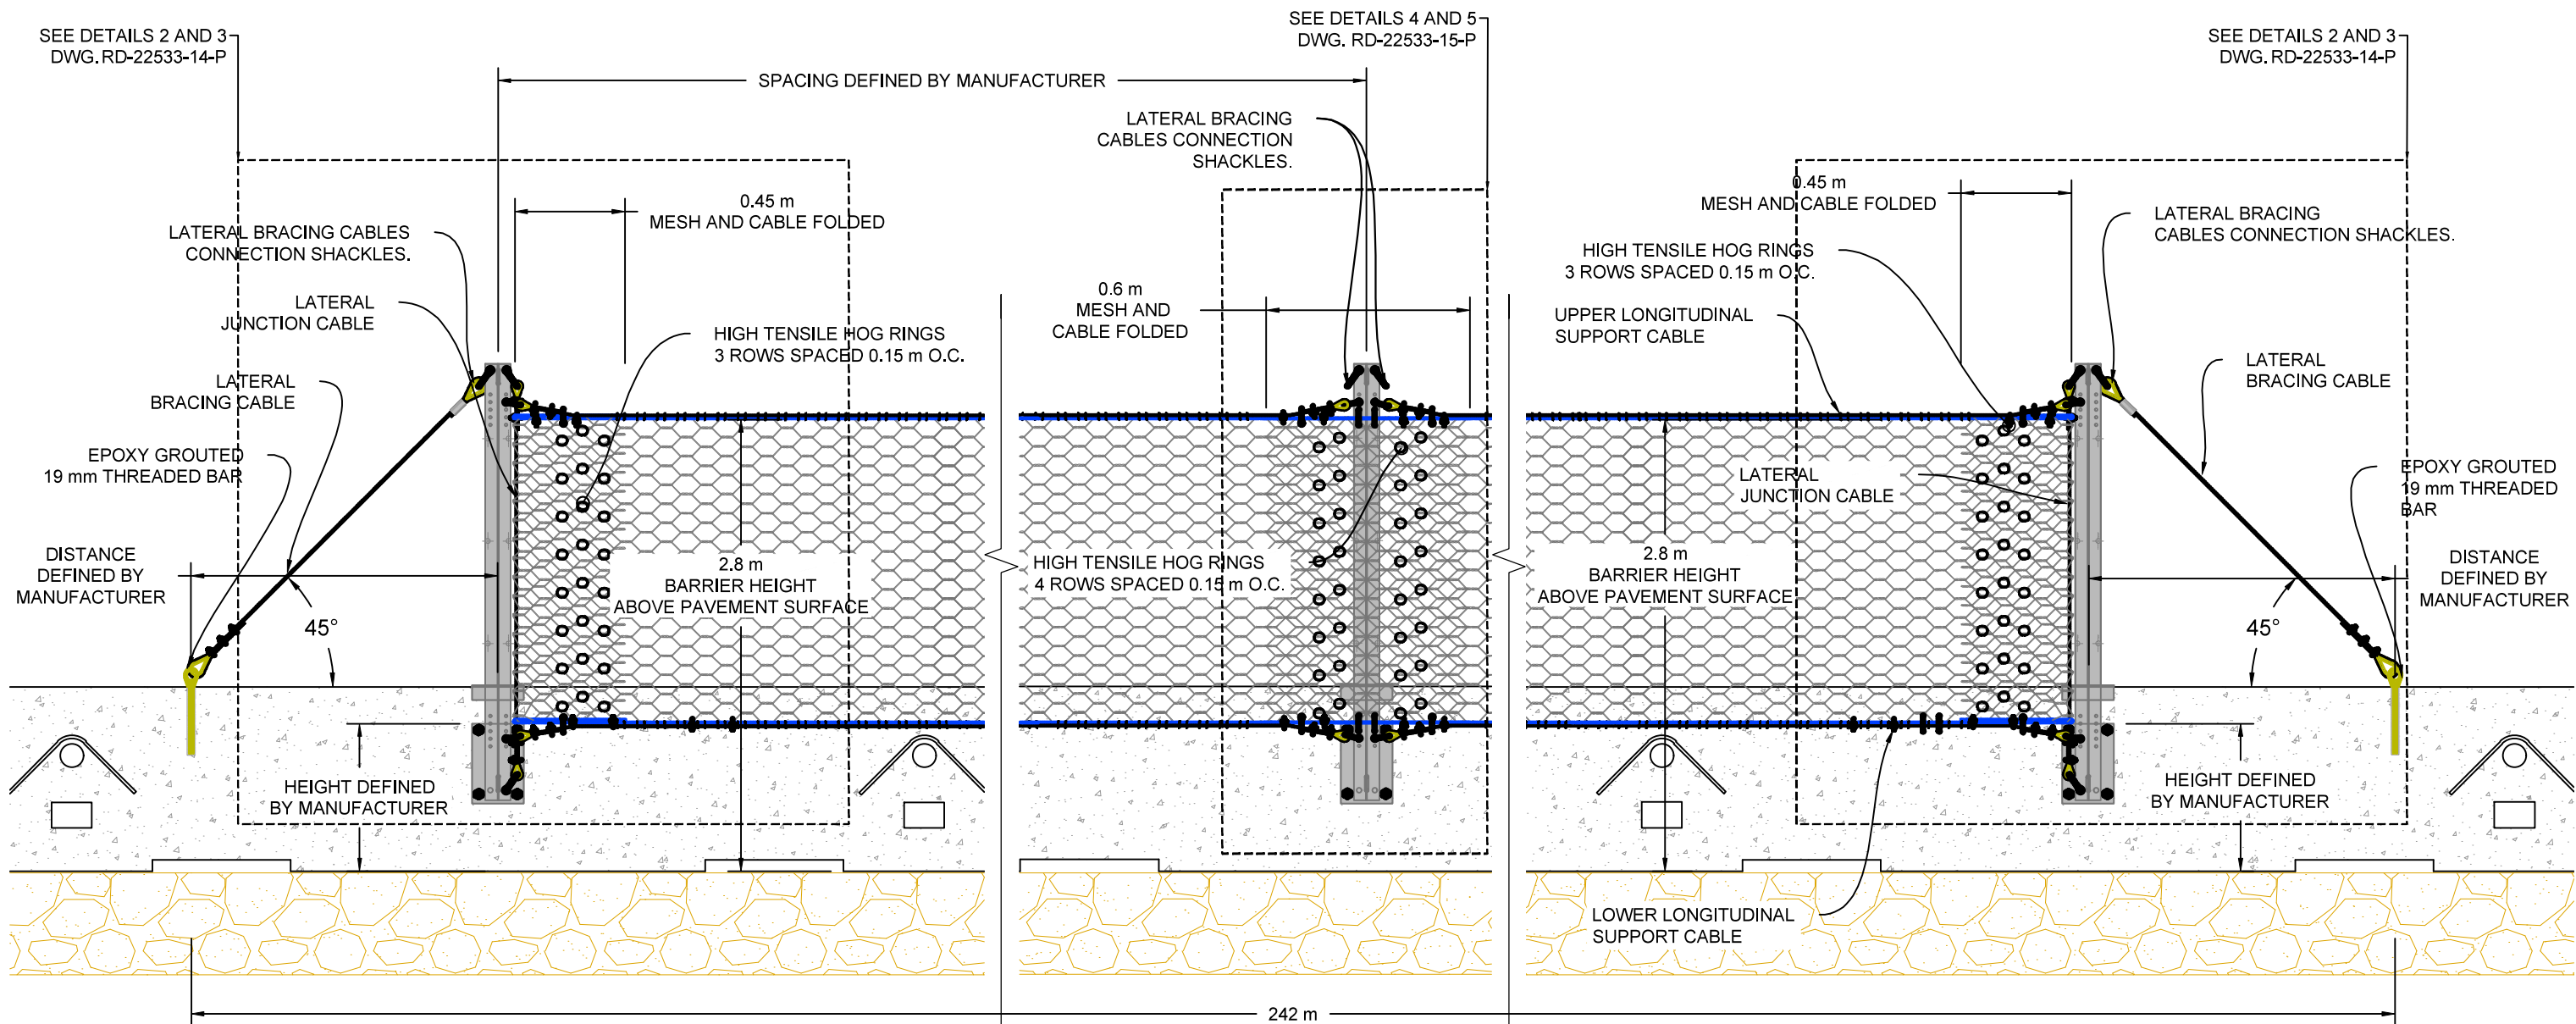
ELEVATION - 35 kJ ROCKFALL BARRIER

- In March 2025, a rockfall barrier was attached to the concrete barriers by PME as part of CON0022533 (Photos 3 through 6). The rockfall barrier appears to have been completed as per the design and is in good condition.
