SITE NUMBER AND NAME: C023-I Battle River Crossing Erosion C023-II Slope Failure		HIGHWAY & KM: 854:01, 14.017	PREVIOUS INSPECTION DATE: July 12, 2019	INSPECTION DATE: June 24, 2020
LEGAL DESCRIPTION: 16-07-043-17 W4M	NAD 83 COORDINATES: UTM Northing Easting 12 5839557 402074		RISK ASSESSMENT: C023-I PF: 10 CF: 3 TOTAL: 30 C023-II PF: 8 CF: 4 TOTAL: 32	
AVERAGE ANNUAL DAILY TRAFFIC (AADT): 140 (south) & 110 (north) (Ref No. 114370 & 997079)			CONTRACTOR MAINTENANCE AREA (CMA): 513

PRIMARY SITE ISSUE: C023 – I: Erosion on north bank of Battle River valley. West side of highway: erosion of unvegetated area upslope of Battle River. East side of highway: failure of gabion mattress armoured ditch chute. C023 – II: A small landslide on the south bank of the Battle River, partially beneath the bridge.

PROJECT	CENTRAL REGION GEOHAZARD RISK MANAGEMENT PROGRAM	
TITLE	Site Plan C023 - Battle River Crossing Erosion and Slope Failure Hwy 854:01, km 14.017	
SCALE	PROJECT No.	FIG No.
1:1,300	A05115A02	1

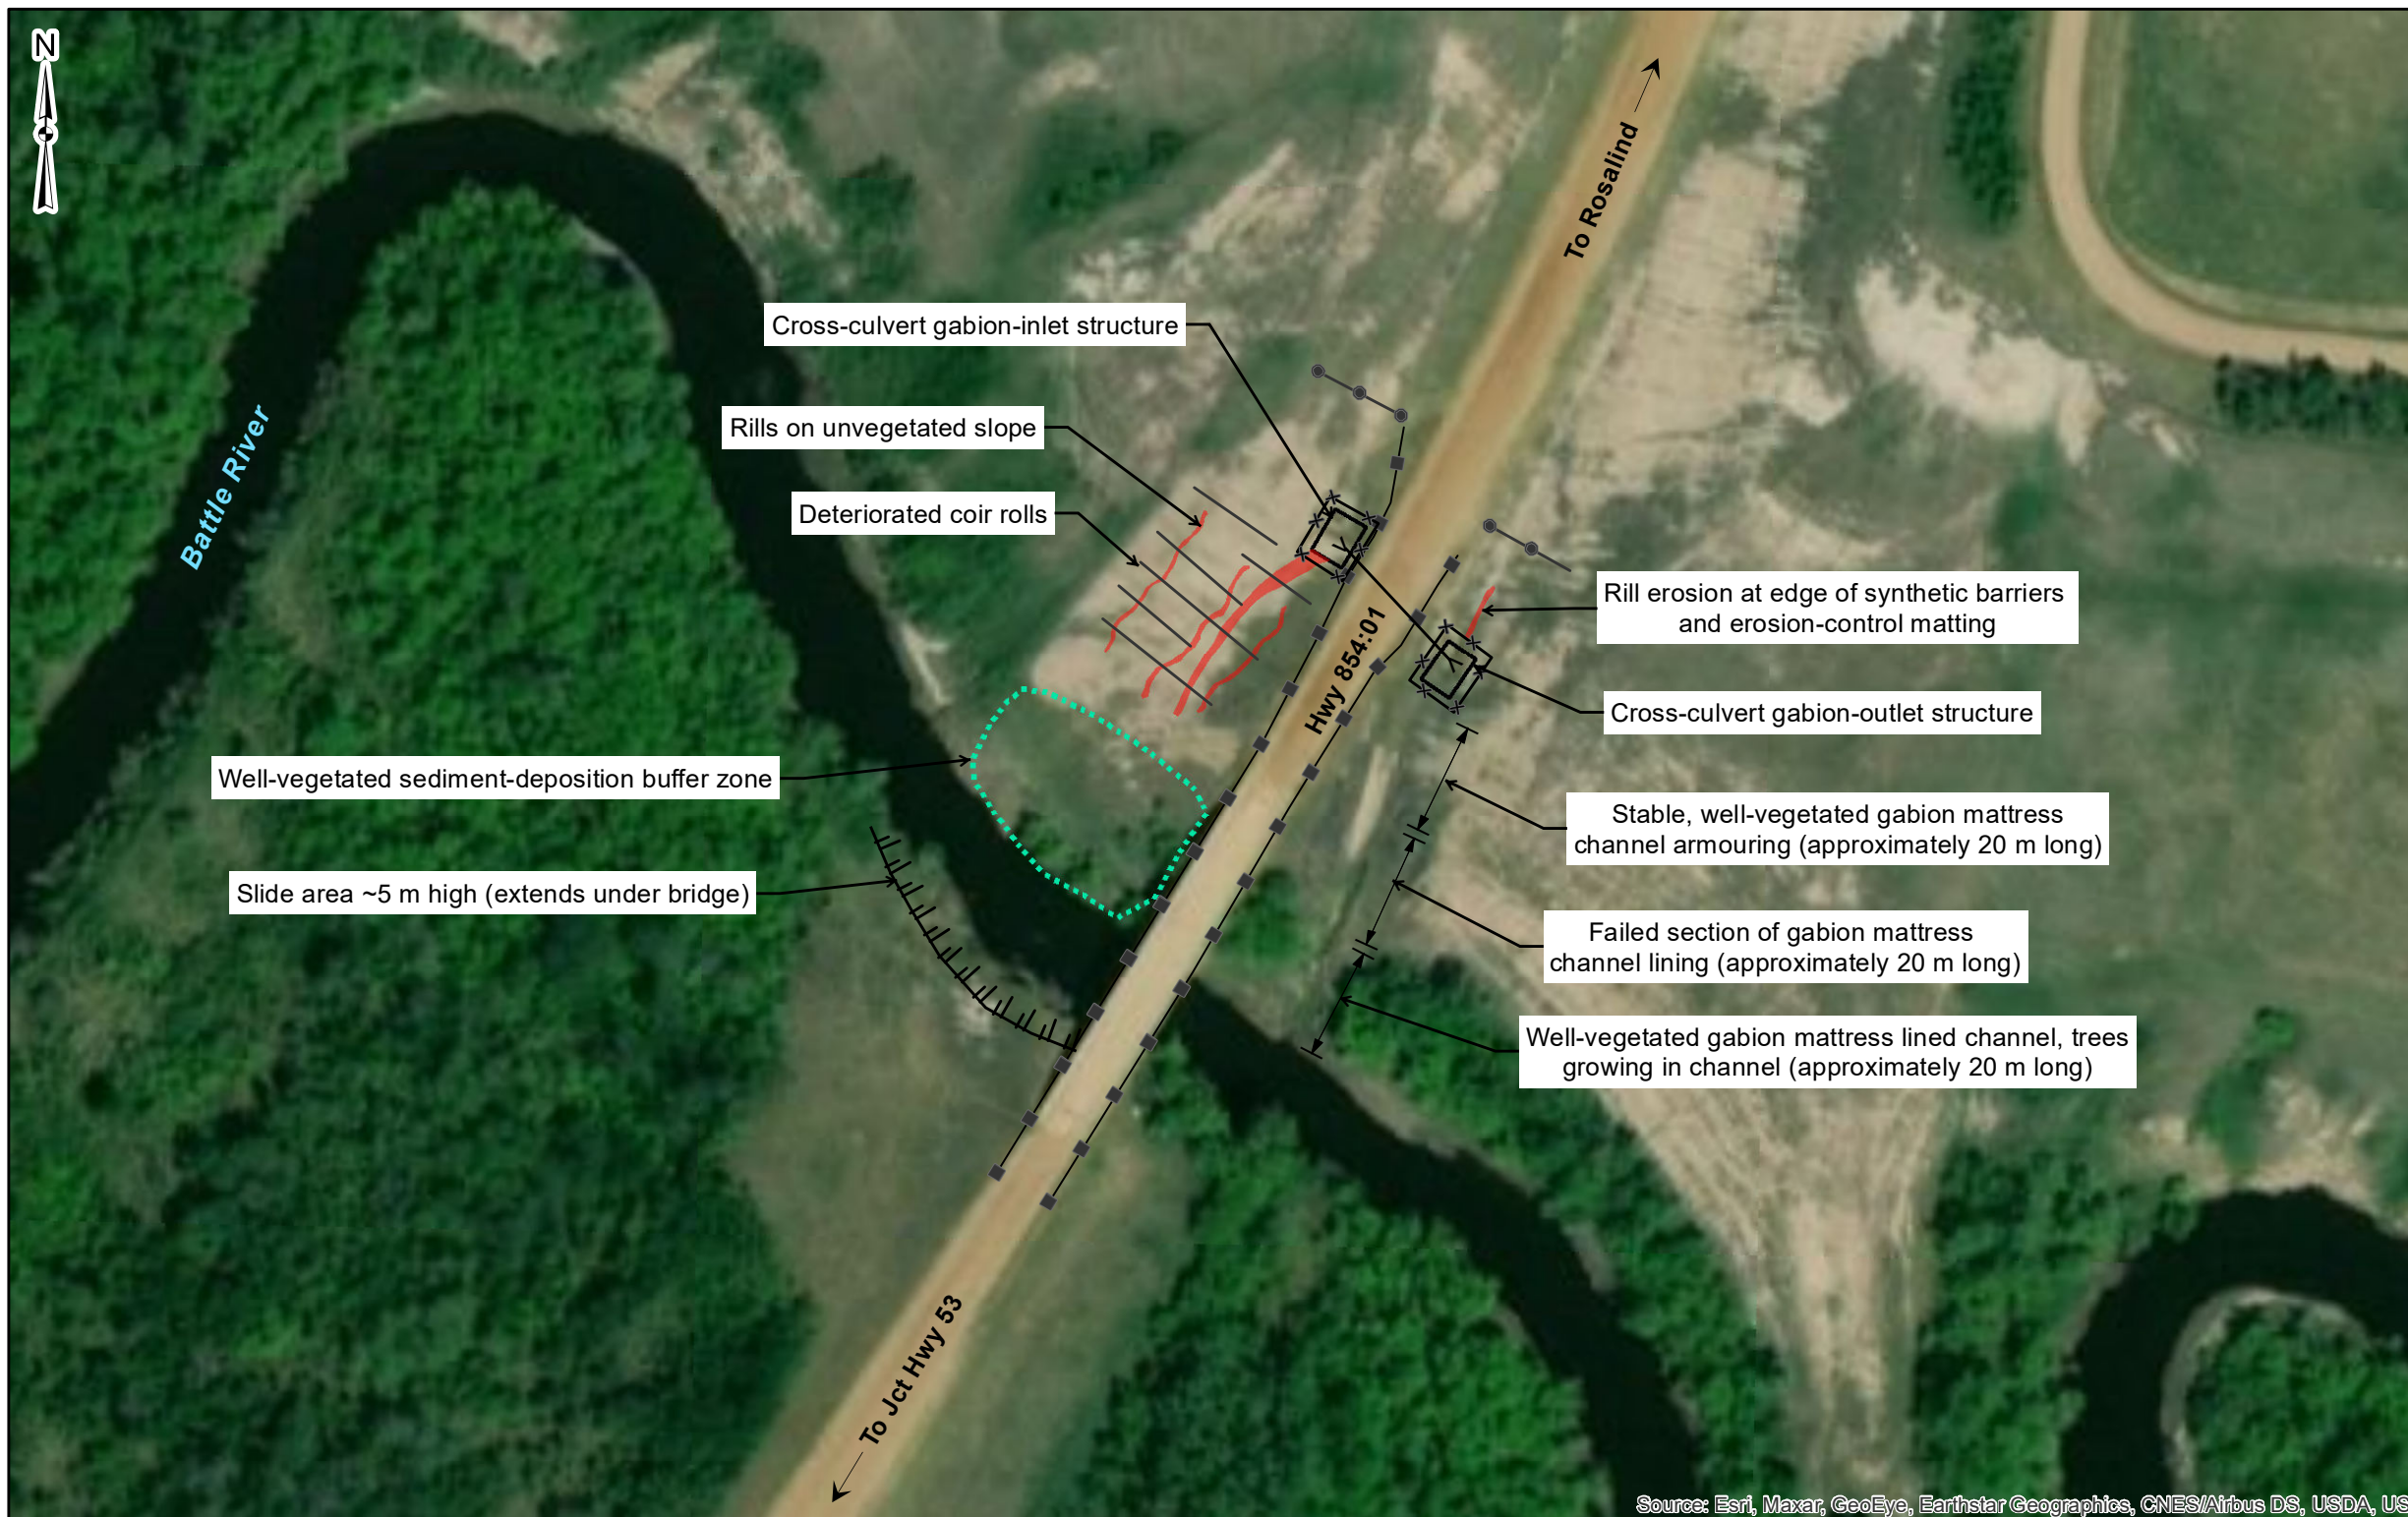
The riverbank along the south abutment directly below the bridge is showing signs of retrogressive slope failure. A steep (approximately 1H:1V) riverbank slope 4 to 5 m high is located at the edge of the river, with approximately 15 m between the crest of the slope and the bridge abutment.

The inlet and outlet gabion catch basin structures on the north side of the bridge remain clogged. The west side gabion catch basin inlet continues to overflow onto the unvegetated slope into the existing erosion gully observed during the 2018 inspection. Although the erosion gully has not expanded significantly since 2018, it will continue to expand if left unrepaired. Grass growth is limited to the areas where coir rolls, now deteriorated, that retained sediments and seeds from previous seeding.

Gabion mattress channel lining on east the side of highway has not been repaired. Water will continue to

undermine the mattress until it is repaired. Gabion mattress channel lining at the discharge point into the river is still in good condition.

- West-side repair should consist of drill seeding the exposed soil and then hydro-mulch the exposed area to promote grass growth. Alternatively, given that bedrock is exposed at surface, a bonded-fiber matrix, flexible growth medium and hydroseed treatment could be applied to the slope to give the seeds a better chance to germinate and form a stable vegetative cover on the western erosion site. The soil/bedrock chemistry should be tested to improve the likelihood that work results in stable vegetation

- Gullying downslope of the west side gabion catch basin should be repaired.
- Repair options for failed gabion mattress could include excavation of gabion mattress and replacement with rip rap with proper bedding and check trenches. Size of rip rap should be designed based on flow rate determined from required rainfall event return period and catchment area.

- The slope failure observed on the west side of and adjacent to the south abutment of the bridge should be monitored. Repair of the slope failure could start with armouring the riverbank to control erosion upstream of and underneath the bridge deck. Soil nailing could be used to stabilize the slide, or the slope below the bridge could be flattened with an excavator, with excavated material hauled away.
