September 12, 2022

Alberta Transportation
4th Floor, Provincial Building
4920 51 Street
Red Deer, Alberta
T4N 6K8

CON0022160 Central Region GRMP Instrumentation Monitoring
Site C074; H27:10, km 23.976 Red Deer River Bridge
Section C – 2022 Spring Readings

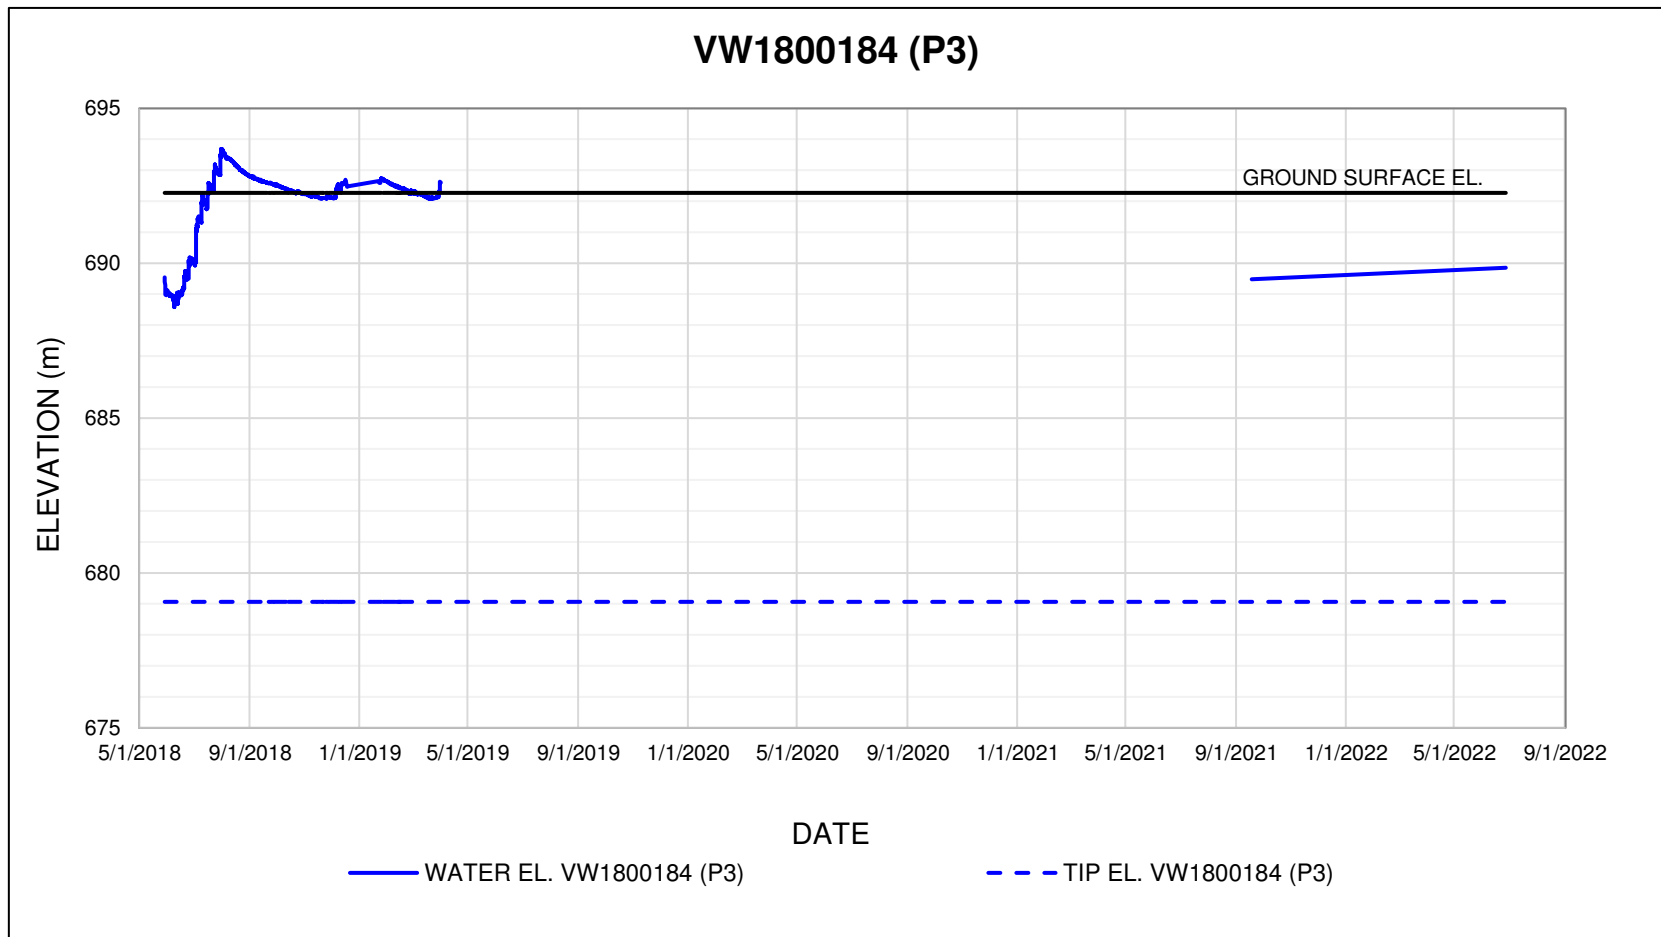
CENTRAL REGION GEOHAZARD RISK MANAGEMENT PLAN	
		TITLE	
		Piezometer Data C074 - Red Deer River Bridge Hwy 27:10, km 23.976	
SCALE	PROJECT No.	A05116A02	FIG No.

1. GROUND SURFACE ELEVATIONS OBTAINED FROM DATA PROVIDED BY THURBER ENGINEERING IN MAY 2019.
2. THE DATA LOGGER CONNECTED TO THE INSTRUMENTATION WAS INOPERABLE AFTER A FLOOD EVENT IN LATE-MARCH 2019.
3. MANUAL READINGS TAKEN SINCE SEPTEMBER 2021.

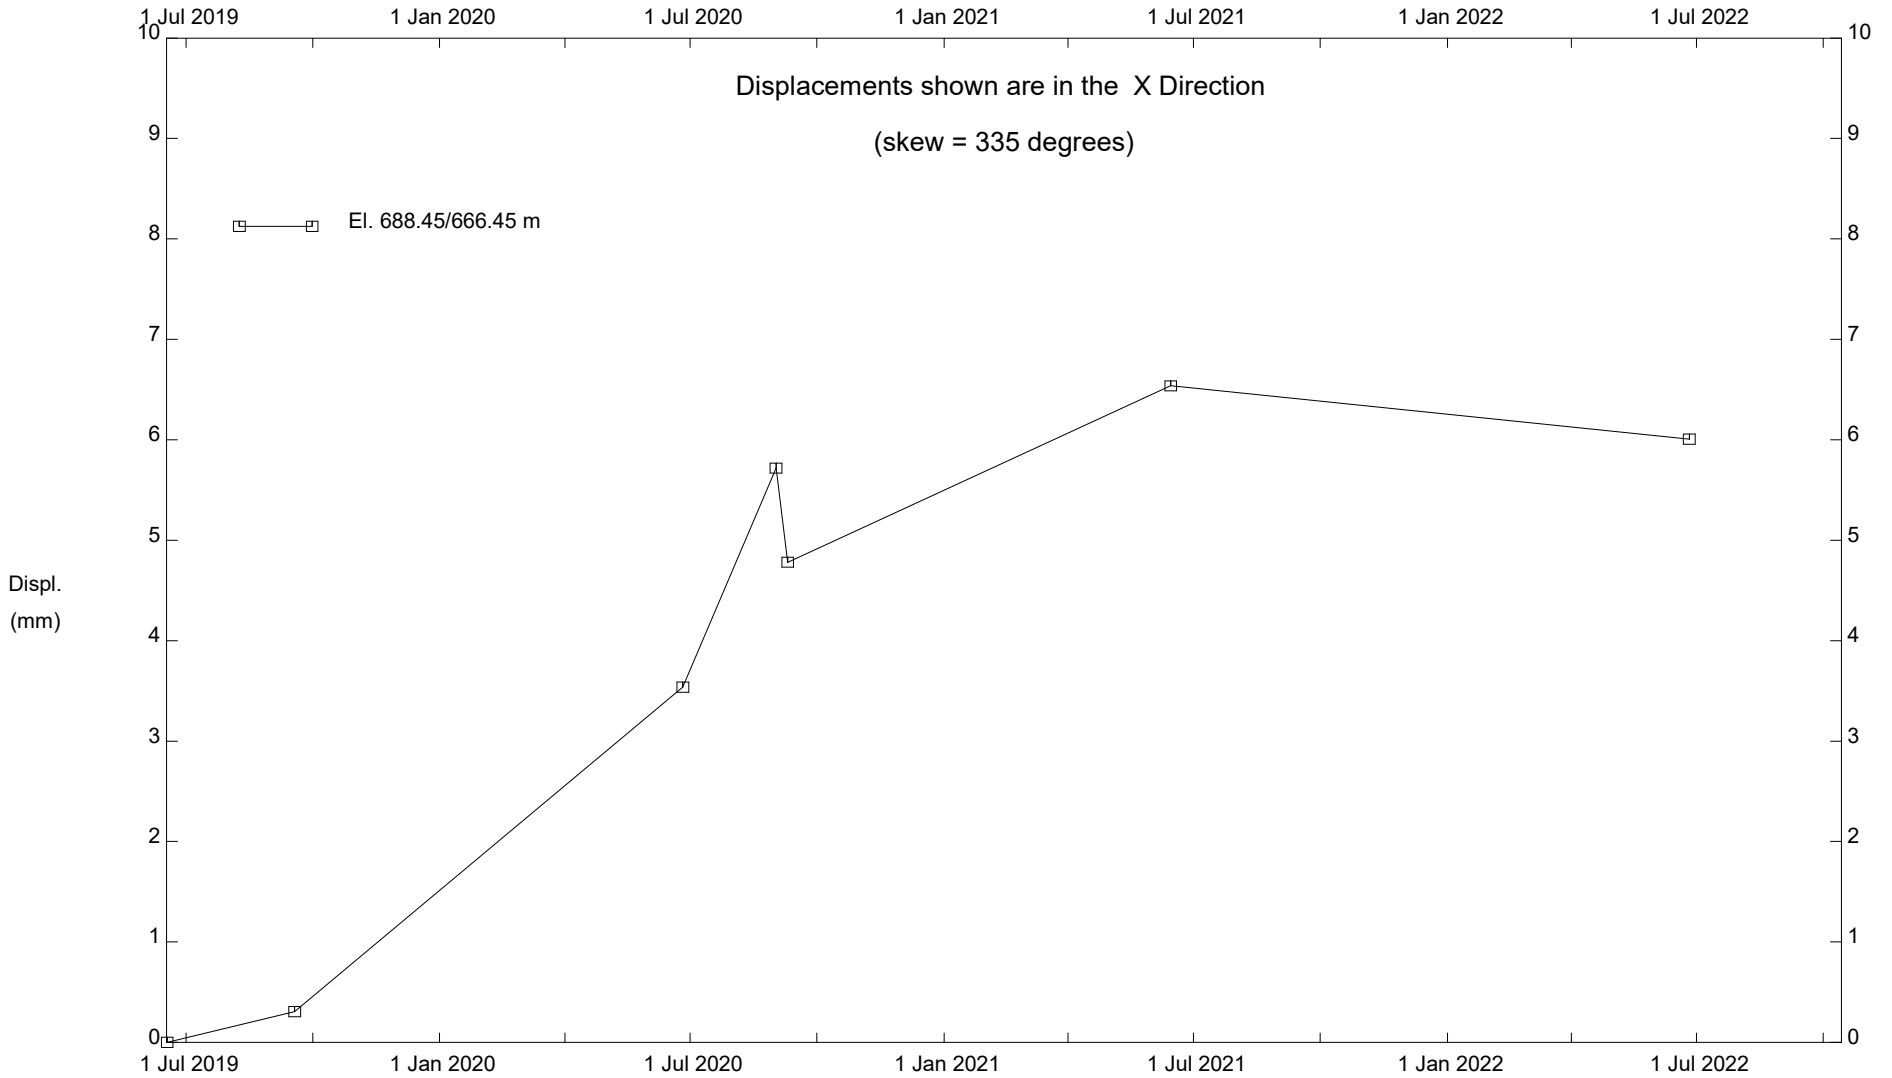
C074; H27:10, Morrin Bridge, Inclinometer SI-P01

The maximum rate of movement recorded in the X-direction of the pile-wall SIs was between approximately 128 mm/year and 229 mm/year. This maximum rate of movement was recorded between July and August 2018 during fill placement on the east abutment. The rate of movement has since decreased and is now less than 1 mm/year. Additional displacement of the pile wall may occur in response to periods of heavy or prolonged rainfall, resulting in higher groundwater conditions or river levels.

Since distributed movement is being recorded in SI-P01, SI-P06, and SI-P11 to the bottom of the SI casing and the depth to the design failure surface is unknown, KCB cannot conclude if the pile wall has intercepted the failure surface and whether loads are being transferred to depths below the failure surface as the piles stabilize the sliding mass.

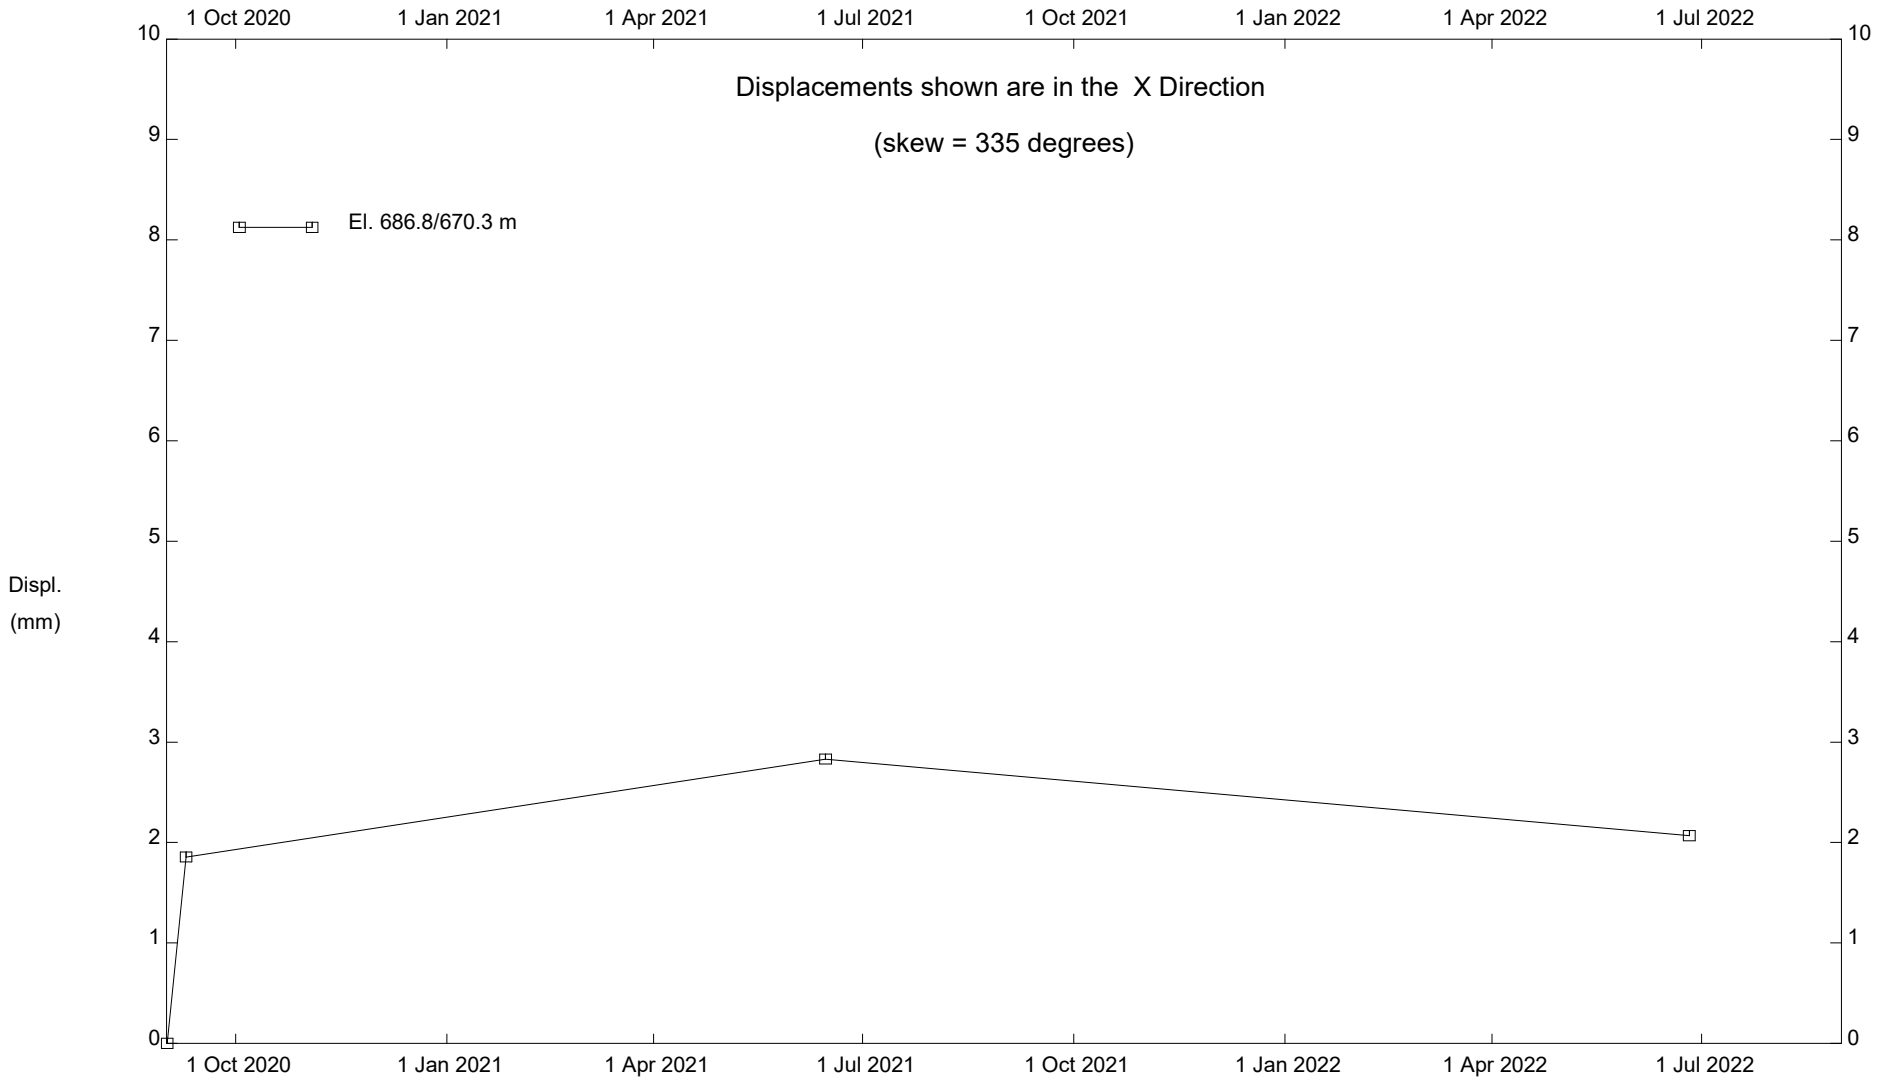
C0174; H27:10, Morrin Bridge, Inclinometer SI-P06

³ SI-P06 was re-initialized for a second time in September 2020 because the instrument was damaged between the September 2019 and June 2020 readings, and the top of the casing was cut off (not by KCB) between the June and September 2020 readings.

It also noted that the casing for SI-P11 was extended and then repaired by KCB in June 2019, and the casing for SI-P06 was damaged between the September 2019 and June 2020 readings, then cut off (not by KCB) between the June and September 2020 readings.
