| To: | Amy Driessen | From: | Leslie Cho and Lawrence Onwude |
| File: | 123315222 | Date: | October 31, 2025 |

**Reference: North Central Region, Edson, Site NC083 - Highway 40:30 West of Wildhay River, Fall 2025 Instrumentation Monitoring Report**

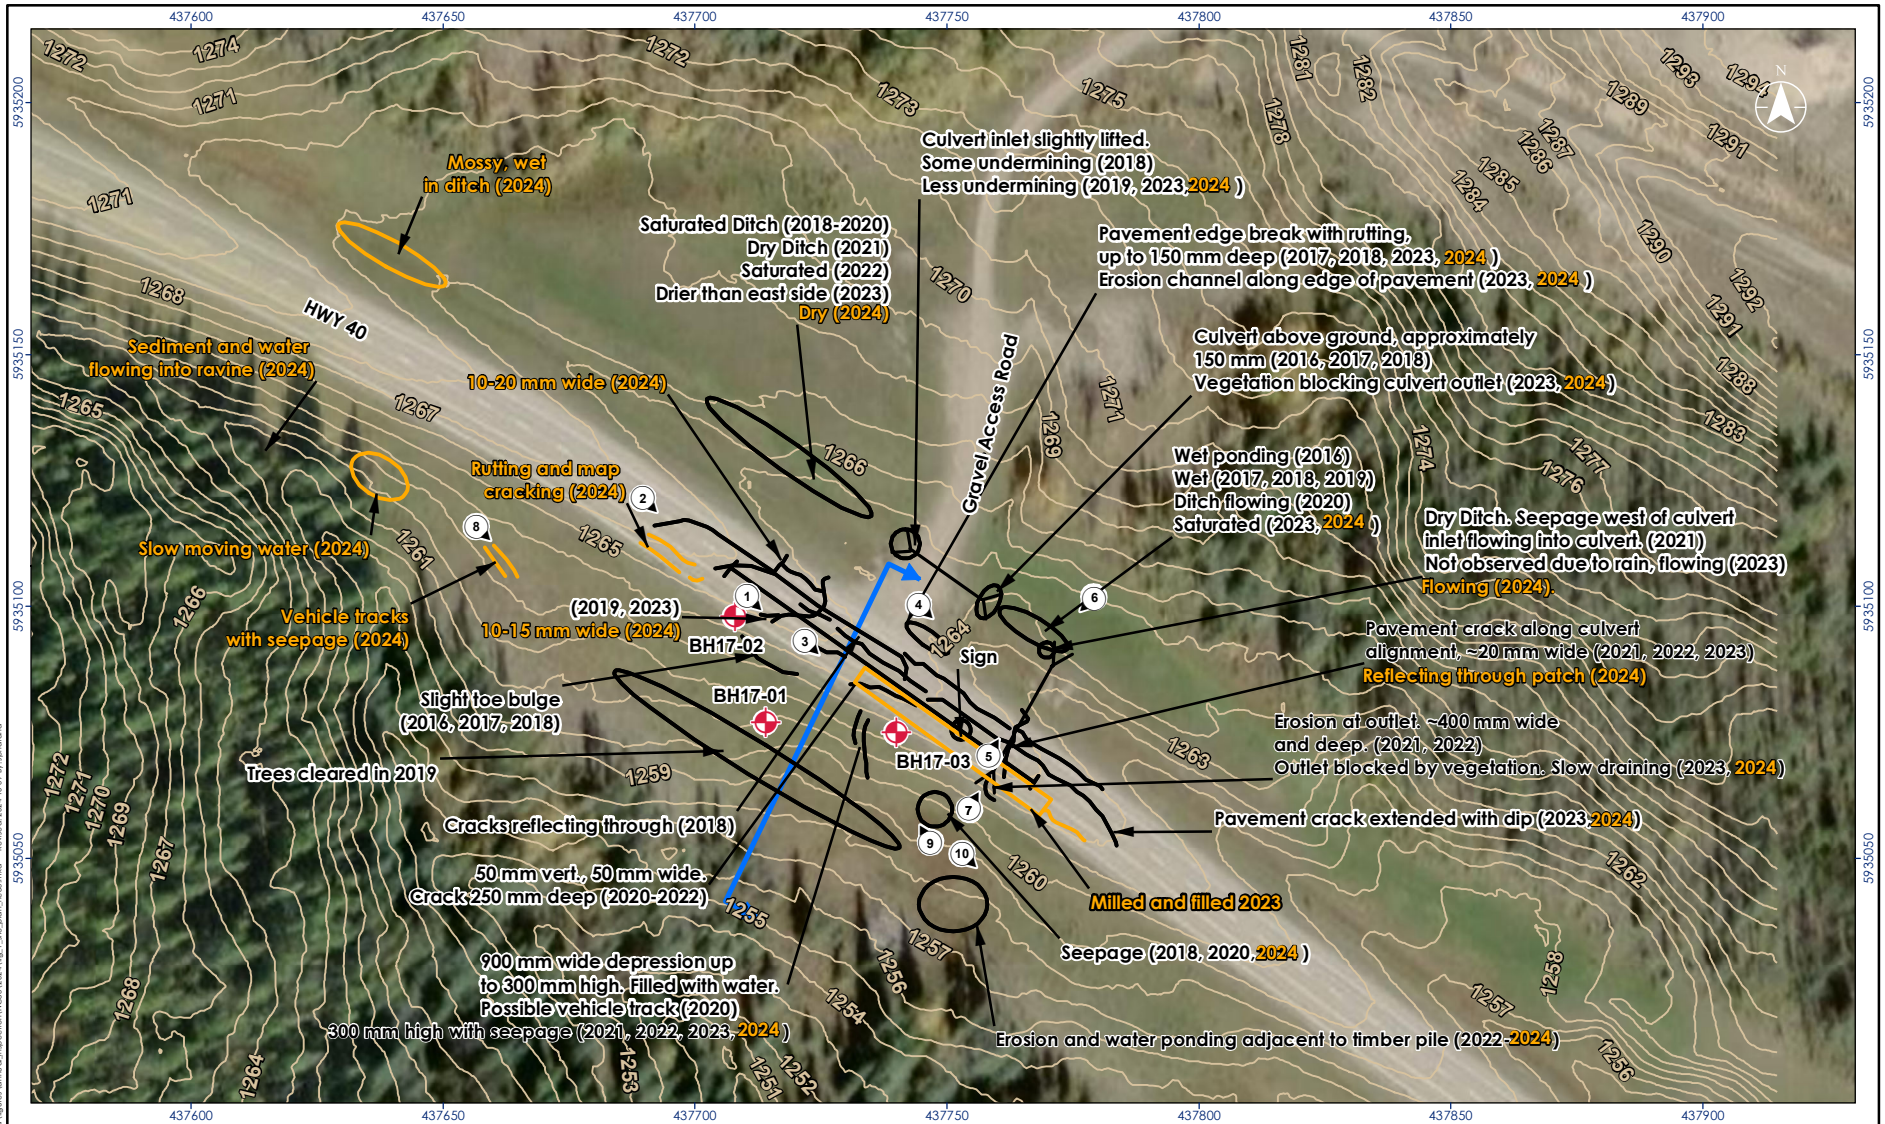
The Fall 2025 reading cycle consisted of instrument readings of three slope inclinometers (SI17-01, SI17-02, and SI17-03) and three vibrating wire piezometers (VW17-01, VW17-02, and VW17-03). **Figure 1** attached provides a schematic of the site. The instruments were read by Akintola Fakinlede, GIT and Adham Zahr, Geotechnical EIT and on October 2, 2025.
