SITE NUMBER AND NAME: NC092 – Cattlepass Culvert BF 80823	HIGHWAY AND KM: 37:02, km 23.855	PREVIOUS INSPECTION: June 20, 2024	CURRENT INSPECTION: May 21, 2025
LEGAL DESCRIPTION: NE 33-54-27-W4M	NAD83 COORDINATES: UTM12U 5955908N, 307552E		RISK ASSESSMENT: PF: 10 CF: 6 Total: 60
AVERAGE ANNUAL DAILY TRAFFIC (AADT): 3000 (2024)		CONTRACTOR MAINTENANCE AREA (CMA): 510

**NORTH CENTRAL REGION GRMP
EDSON / STONY PLAIN
SITE INSPECTION FORM**

Client/Project
Transportation and Economic Corridors
Geohazard Monitoring Program
NC92 - Highway 37:2 Cattlepass Culvert

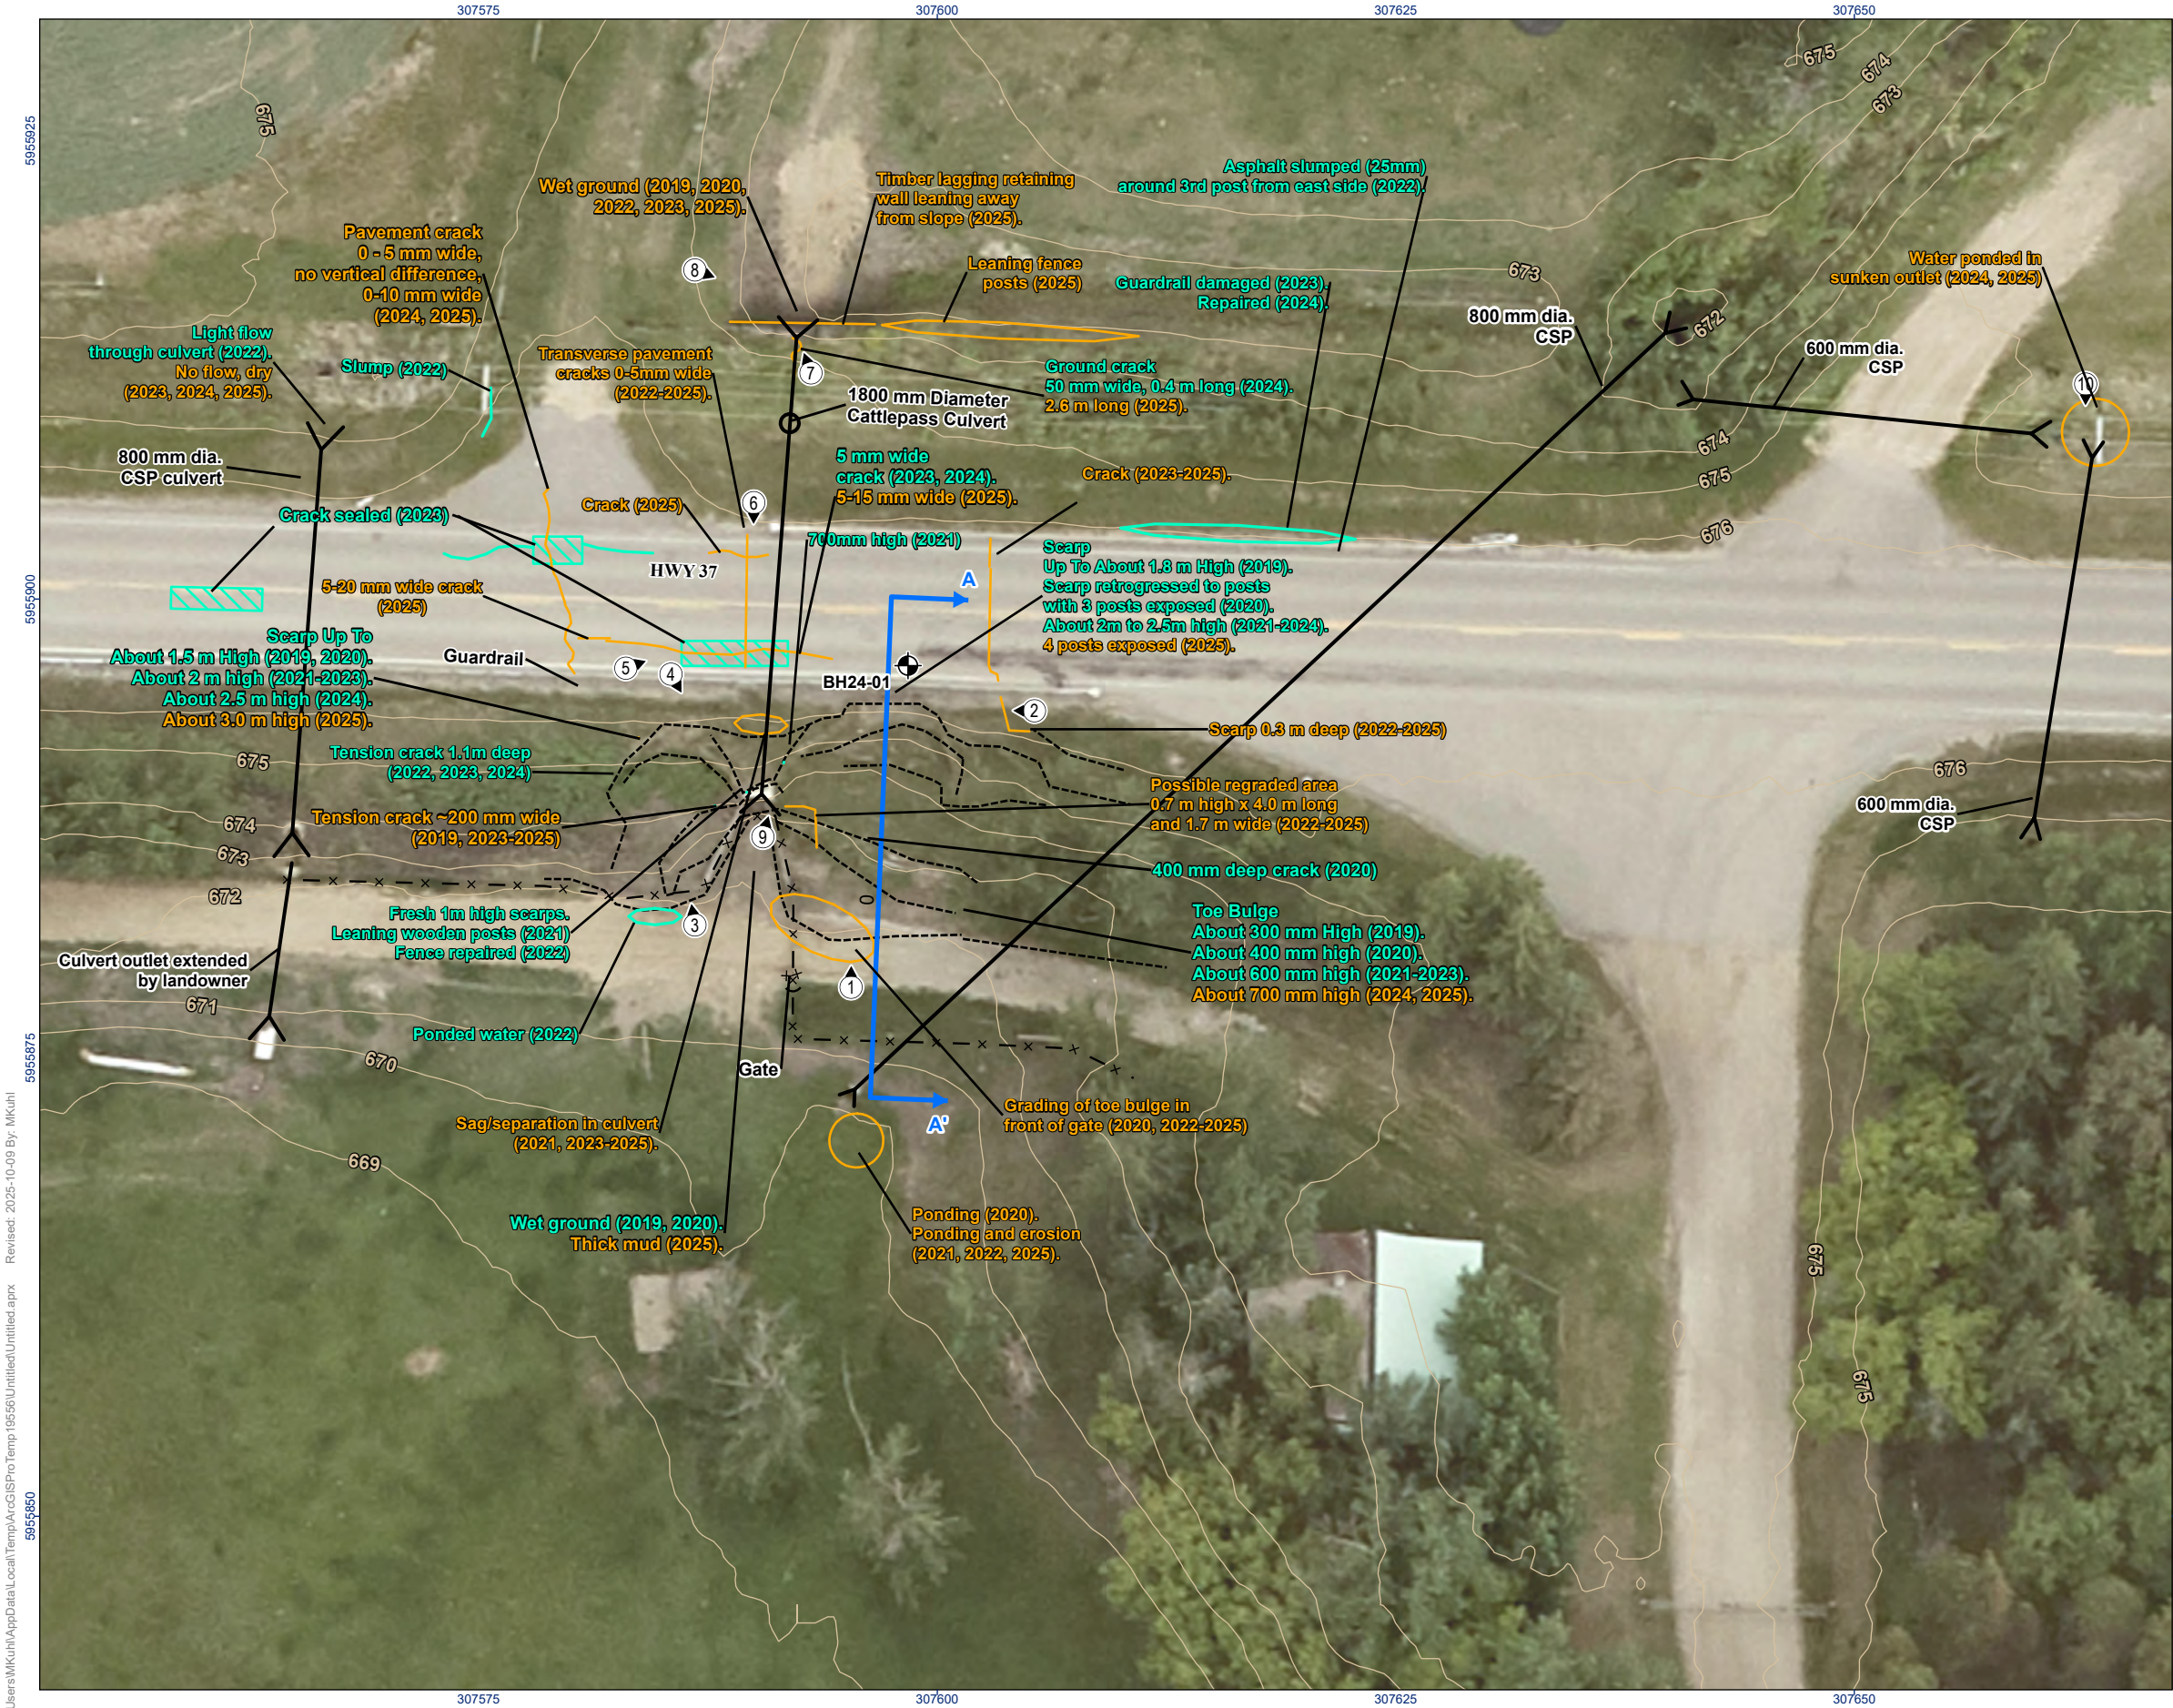
Figure No.
1

COMMENTS <ul style="list-style-type: none"> Little to no change was observed at the slump on the southeast side of the cattlepass, with the scarp up to about 2.5 m high. The scarp at the east extent next to the pavement remains approximately 0.3 m high (Photos 1 and 2). The height of the toe bulge was about 700 mm high, similar to observations in 2024 (Photo 1). Four guardrail posts have been exposed by the scarp, one more than observed in previous inspections. Ponded water was observed at the base of one guardrail post.
--

- The west slump appeared to have retrogressed compared to the 2024 inspection. The scarp west of the cattlepass was about 3.0 m high and 1.8 m away from the guardrail (Photos 3 and 4).

- A sag was observed about 3 m to 4 m inside the south end of the cattle pass culvert since 2021. The sag location appeared to be approximately in line with the two scarps and is potentially separated at the joint. A splice has been installed at this section as well (Photo 9).

- Regrading of the landslide toe on the east side of the cattlepass has been completed in the past, and may have taken place this year as well. The toe appears to have been cut back in an area 1.7 m wide, 4.0 m long, and 0.7 m high. A section of exposed soil was observed on the landslide toe during the recent inspection, which may be the result of recent grading (Photo 1).

- A ground crack approximately 50 mm wide was observed in 2024 above the north end of the cattlepass culvert, at the fence line (Photo 7). The crack has progressed and is now approximately 2.6 m long, 2.2 m longer than observed last year.

- Cracks in the pavement should be sealed to prevent surface water from entering the embankment.
- In the short-term, fill can be placed at the base of the slope failure to act as a temporary buttress. The nearby Calahoo pit may be a potential source of granular material for this purpose.

- Stantec has submitted a design and work order for remediation of the embankment slope by removing the failed soils and replacement with granular fill reinforced with geogrid.
