SITE NUMBER AND NAME: NC086 – Poplar Creek Slide	HIGHWAY AND KM: 39:06, km 4.915	PREVIOUS INSPECTION: June 14, 2024	CURRENT INSPECTION: May 20, 2025
LEGAL DESCRIPTION: SW 11-49-06-W5	NAD83 COORDINATES: UTM11U 5897673N, 648158E		RISK ASSESSMENT: PF: 9 CF: 3 Total: 27
AVERAGE ANNUAL DAILY TRAFFIC (AADT): 3,660 (2024)		CONTRACTOR MAINTENANCE AREA (CMA): 509

2025 Site Inspection Photos at NC086

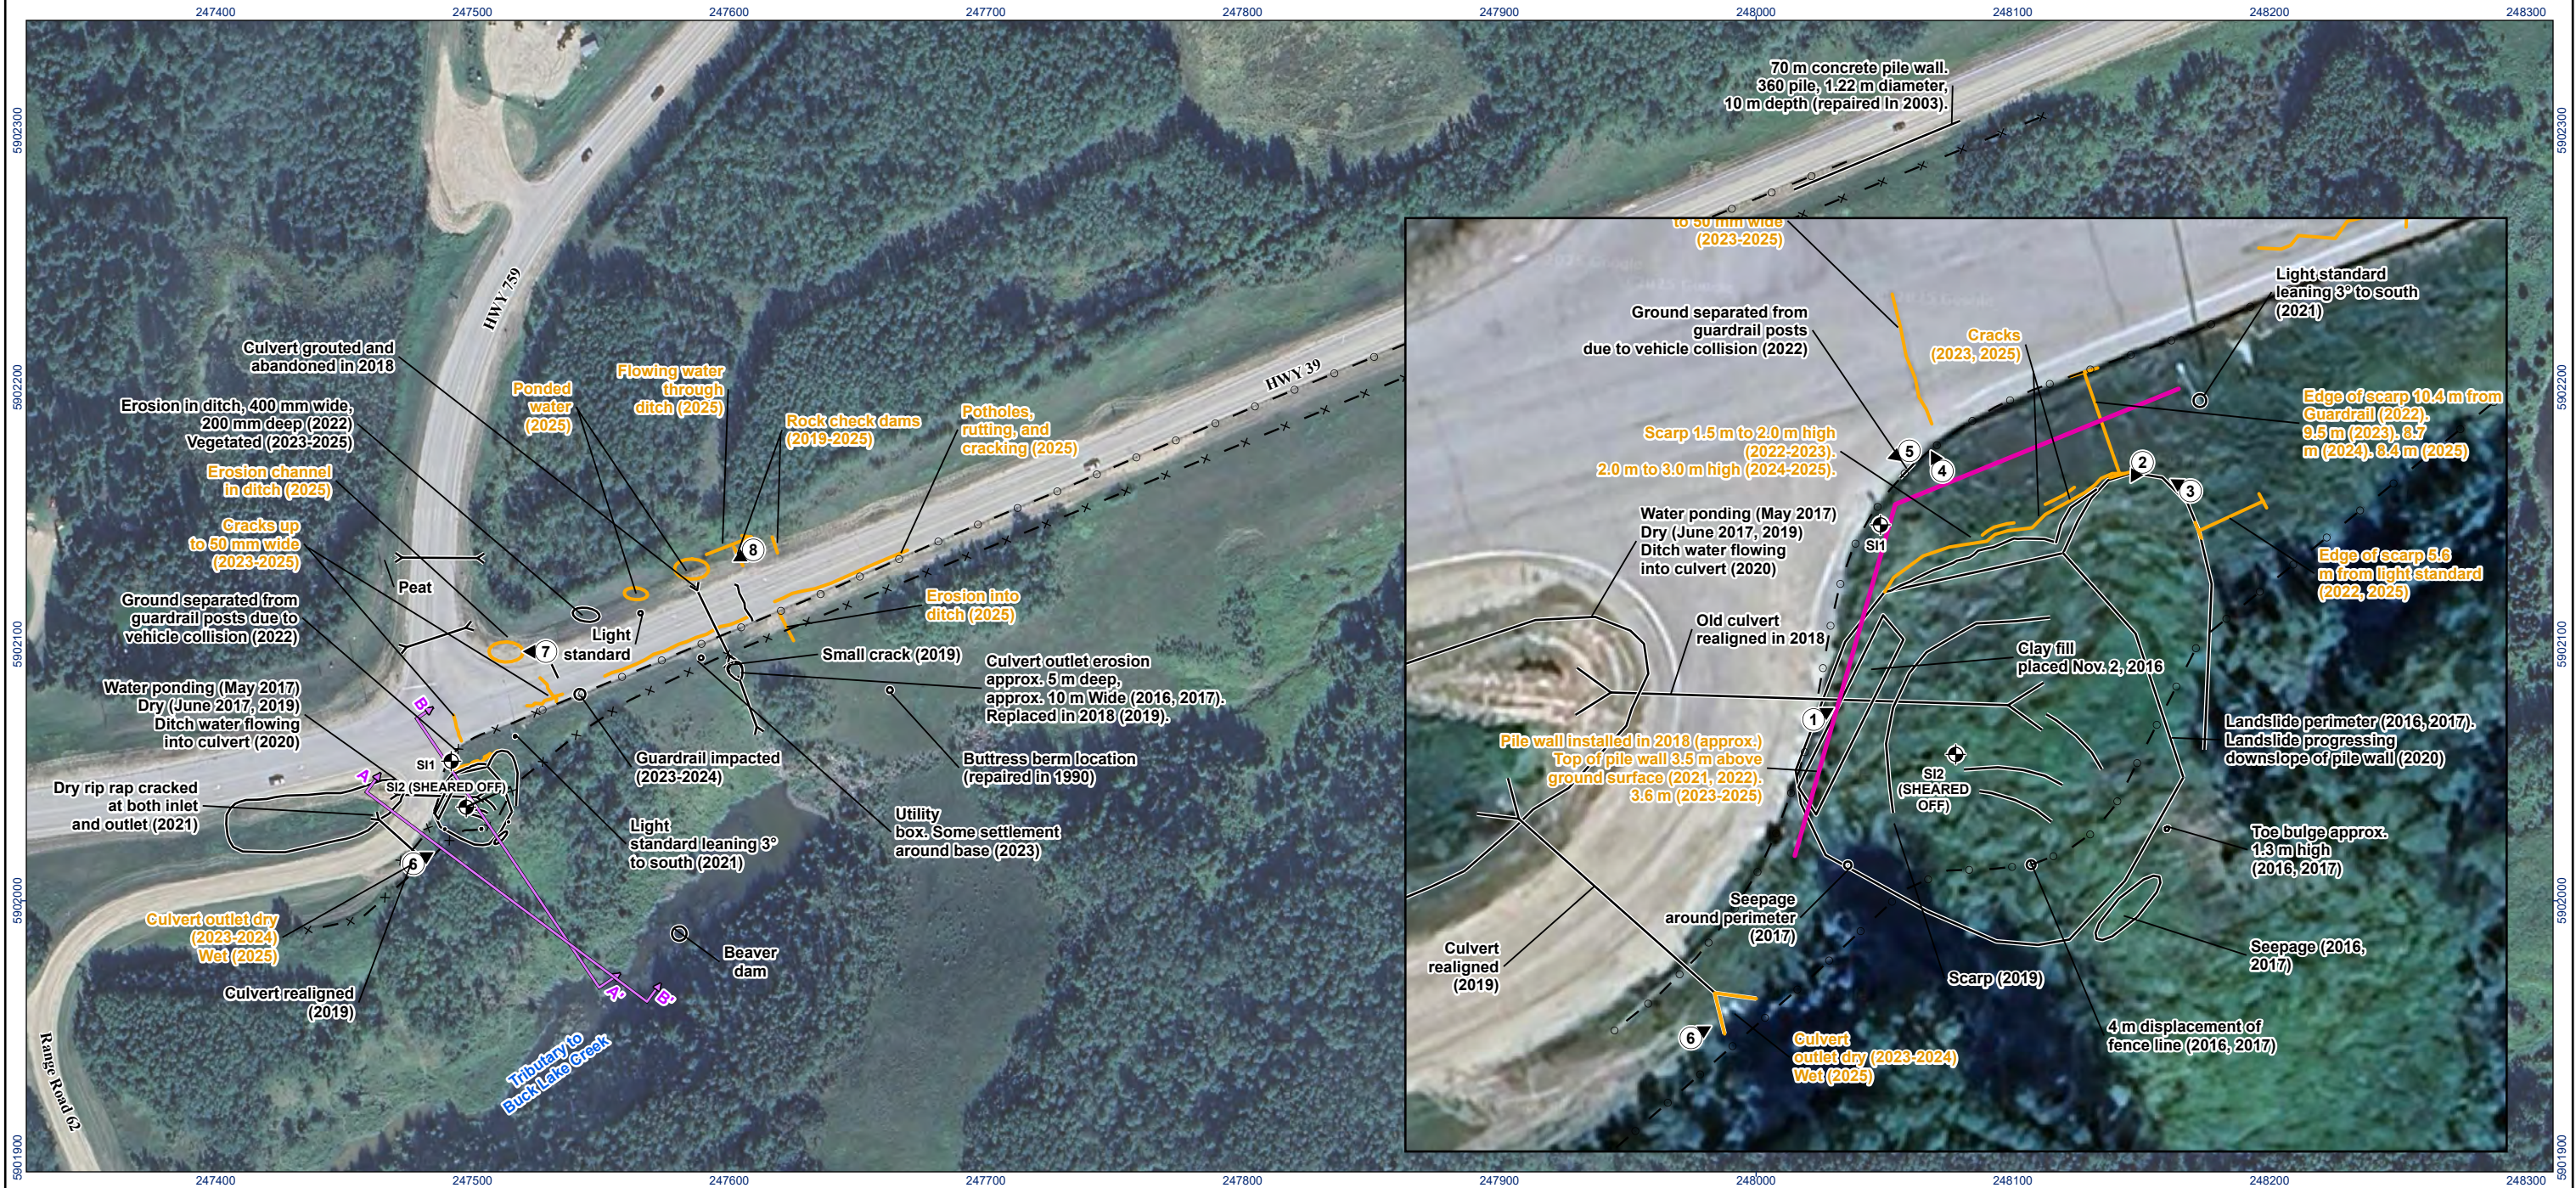
Figure No.
1

COMMENTS
<ul style="list-style-type: none"> The landslide downslope of the wall continues to progress slowly (Photos 1 to 3, 9 and 10). A measurement from the top of pile wall to the top of ground was taken between the 9th and 10th guardrail post south of the stop sign. The height was measured to be 3.6 m, same as the past two inspections. The landslide mass appears to have extended east beyond the limits of the pile wall. The current east limit is approximately 5.6 m east from the light standard. This is approximately in line with the east limit of the pile wall. The scarp is approximately 8.4 m south of the guardrail, meaning that the slide has retrogressed 0.3 m since the 2024 inspection. The height of the scarp remains similar to 2024, varying between about 2 and 3 m high. The southeast extent of the scarp extends into the tree line as noted in 2024. The scarp is less vegetated than observed during the previous inspection. The tension cracks above the current landslide scarp appeared similar to 2023 observations.

- SI1 showed a negligible cumulative movement of 1 mm at a depth of about 14 m in the clay shale since initialization in 2018.
- The light standard south of Highway 39 and about 20 m from the intersection had a 3° lean towards the slide mass. The MCI previously informed Stantec that many light standards in this area have a similar lean. The metal at the base of the light standard appears to be peeling and corroding, similar to 2024 observations.

- Settlement of the ground was noted around the base of the utility box to the east of the light standard on the south side of the highway, similar to 2024.

- The culvert and ditch across TWP RD 491A were wet (raining during site inspection). The riprap at both ends of the culvert was cracked (Photo 6).
- The separation between the new and old pavement could not be observed as the area was covered in dirt and gravel, similar to 2024.

- Transverse pavement cracks up to 50 mm wide were observed east of the intersection (Photo 4). A pothole around 0.1 m diameter and 50 mm deep was observed within one of the cracks. The cracking and rutting appeared to be extending further east.

- Longitudinal cracking of Highway 39 was observed and appeared similar to 2024, with cracks up to 10 mm wide (Photo 5). The observed cracking does not appear to be related to landslide activity (Photo 11).

- The north ditch of Highway 39 was wet, with some erosion and ponded water (Photo 7). One larger area of ponded water exists near the north end of the culvert that was grouted and abandoned in 2018 (Photos 8 and 11). Water was observed to be flowing east towards the check dams.

- Both check dams were observed to the east of the light standard, with the check dam furthest west partially obscured by vegetation (Photo 11).

- Pavement cracks should be sealed to reduce surface water infiltration into the slope.
- The ditch on the north side of Highway 39 should be regraded for water flow. Additional check dams or other structures should be installed to reduce surface water flow velocity.
