SITE NUMBER AND NAME: NC079 – Wedgewood Ravine Slides	HIGHWAY AND KM: 216:06, km 12.849	PREVIOUS INSPECTION: June 20, 2024	CURRENT INSPECTION: May 21, 2025
LEGAL DESCRIPTION: SE 28-52-25-W4	NAD83 COORDINATES: UTM12U 5927932N, 324250E		RISK ASSESSMENT: PF: 7 CF: 10 Total: 70
AVERAGE ANNUAL DAILY TRAFFIC (AADT): 86,620 (2024)		CONTRACTOR MAINTENANCE AREA (CMA): Anthony Henday Drive (AHD)

**NORTH CENTRAL REGION GRMP
EDSON / STONY PLAIN
SITE INSPECTION FORM**

Client/Project
Transportation and Economic Corridors
Geohazard Monitoring Program
NC79 Wedgewood Ravine Slides

2025 Site Inspection Photos at NC079

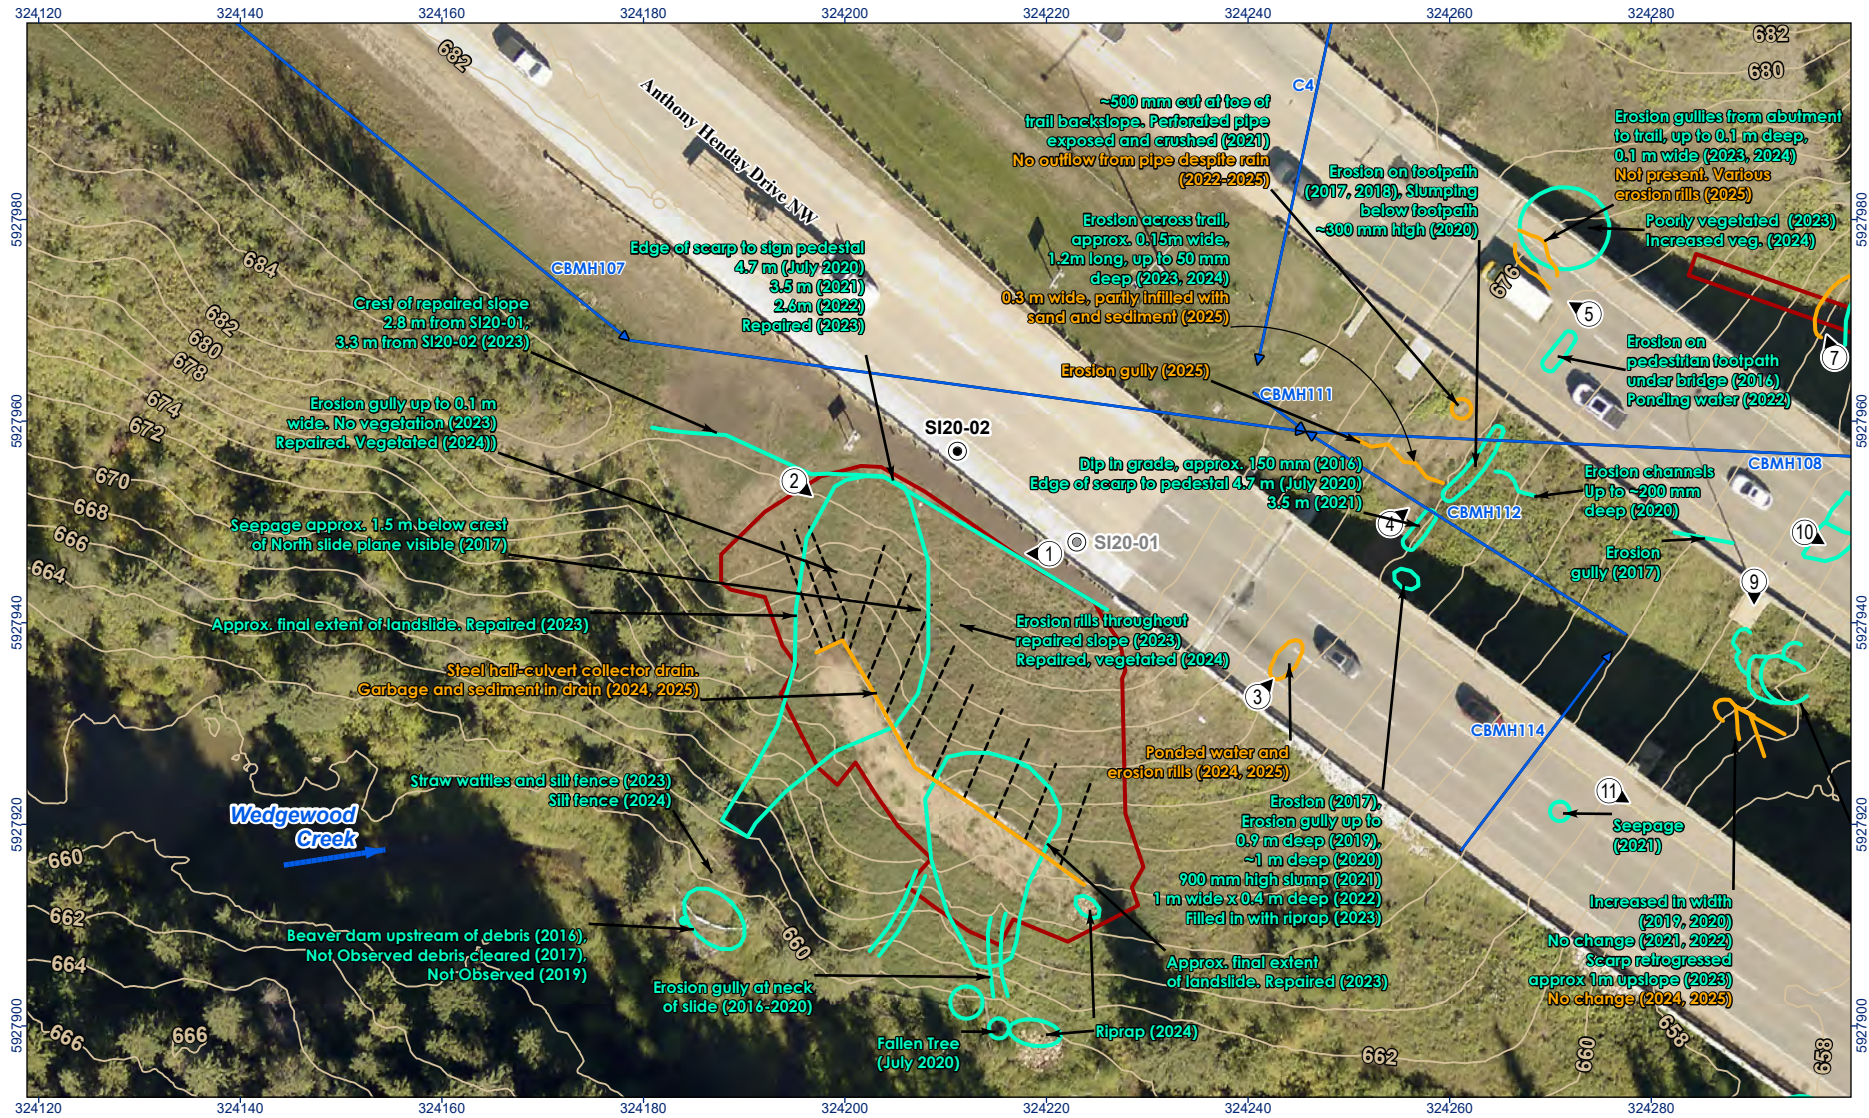
- Approx. Construction / Remediation Limit
- Instrument Location
- Non-operational Instrument Location
- Photo and Direction
- Buried Pipe
- Perforated Drains
- Previous Observation
- 2025 Observation
- Ground Elevation Contours (m AMSL, LiDAR April-May 2018)

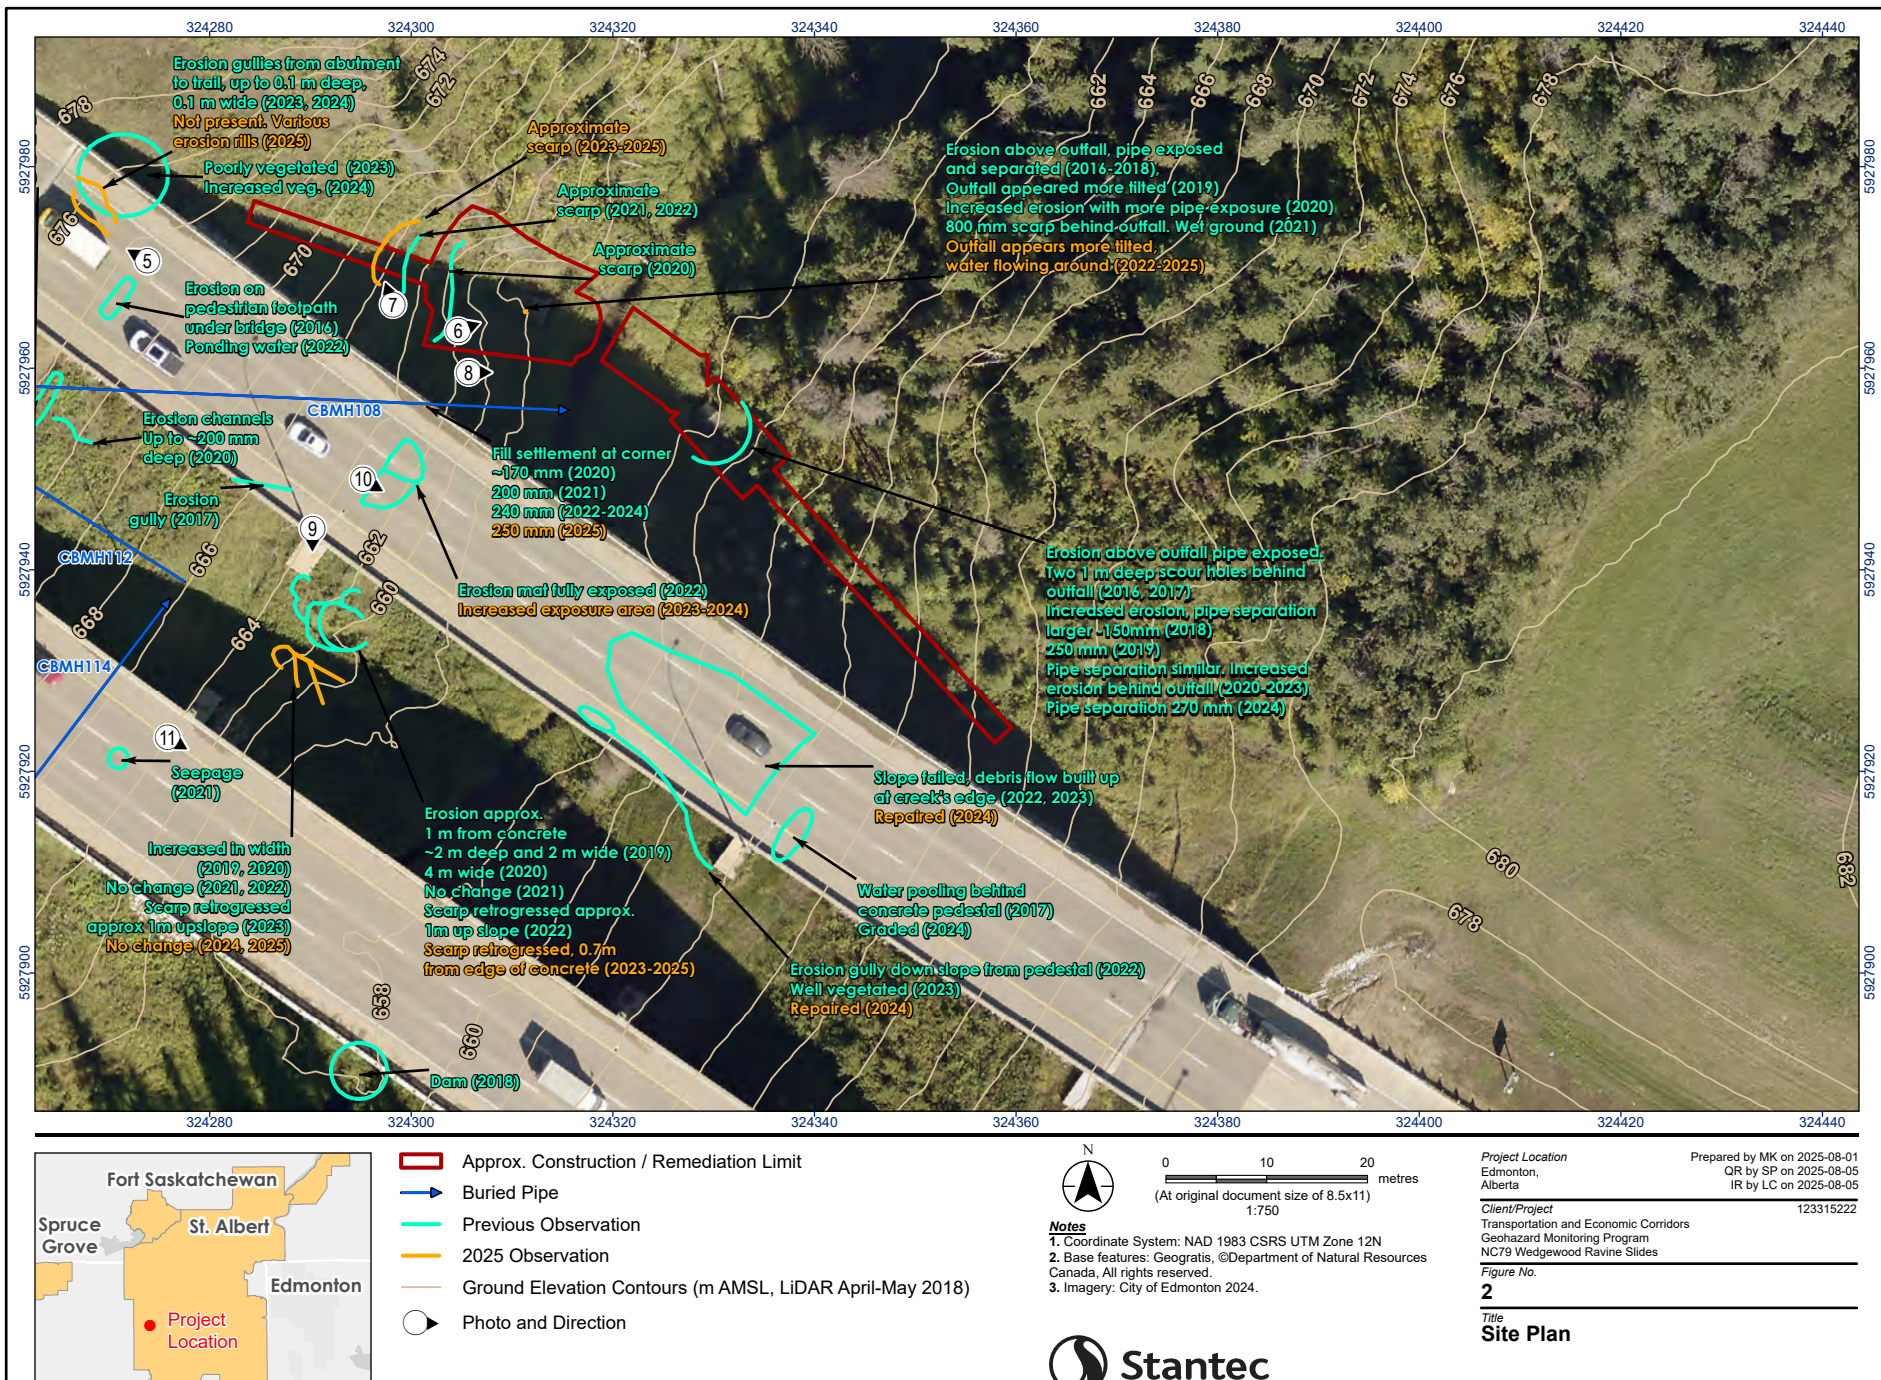
COMMENTS <ul style="list-style-type: none"> The repaired slopes near the northwest approach of AHD were well vegetated, and no significant erosion was observed. A steel half-culvert collector drain is present downslope to catch runoff and debris, and deposit the water into Wedgewood Creek (Photos 1 & 2). The crest of the regraded slope is approximately 2.8 m south from SI20-01 and 3.3 m south from SI20-02 (Figure 1). Garbage and sediment was observed within the half-culvert collector drain below the slope repair, similar to the previous inspection (Photos 1 & 2).

Photo 2: Soil nailed slope at north and south slide area, collector drain installed at toe of repaired slope. Looking southeast.
