| <b>SITE NUMBER AND NAME:</b><br>NC094 – 100 Ave at NB AHD | <b>HIGHWAY AND KM:</b><br>216:06, km 20.550 | <b>PREVIOUS INSPECTION:</b><br>June 20, 2024 | <b>CURRENT INSPECTION:</b><br>May 21, 2025 |

| <b>PRIMARY SITE ISSUE:</b><br>Slumping of the side slope embankment south of 100 Ave between two overpass bridges (81038 S2-7 and 81038 N1-1) for the Anthony Henday Drive (AHD). | |

Client/Project  
 Transportation and Economic Corridors  
 Geohazard Monitoring Program  
 NC094 – 100 Ave at NB AHD

2025 Site Inspection Photos at NC094

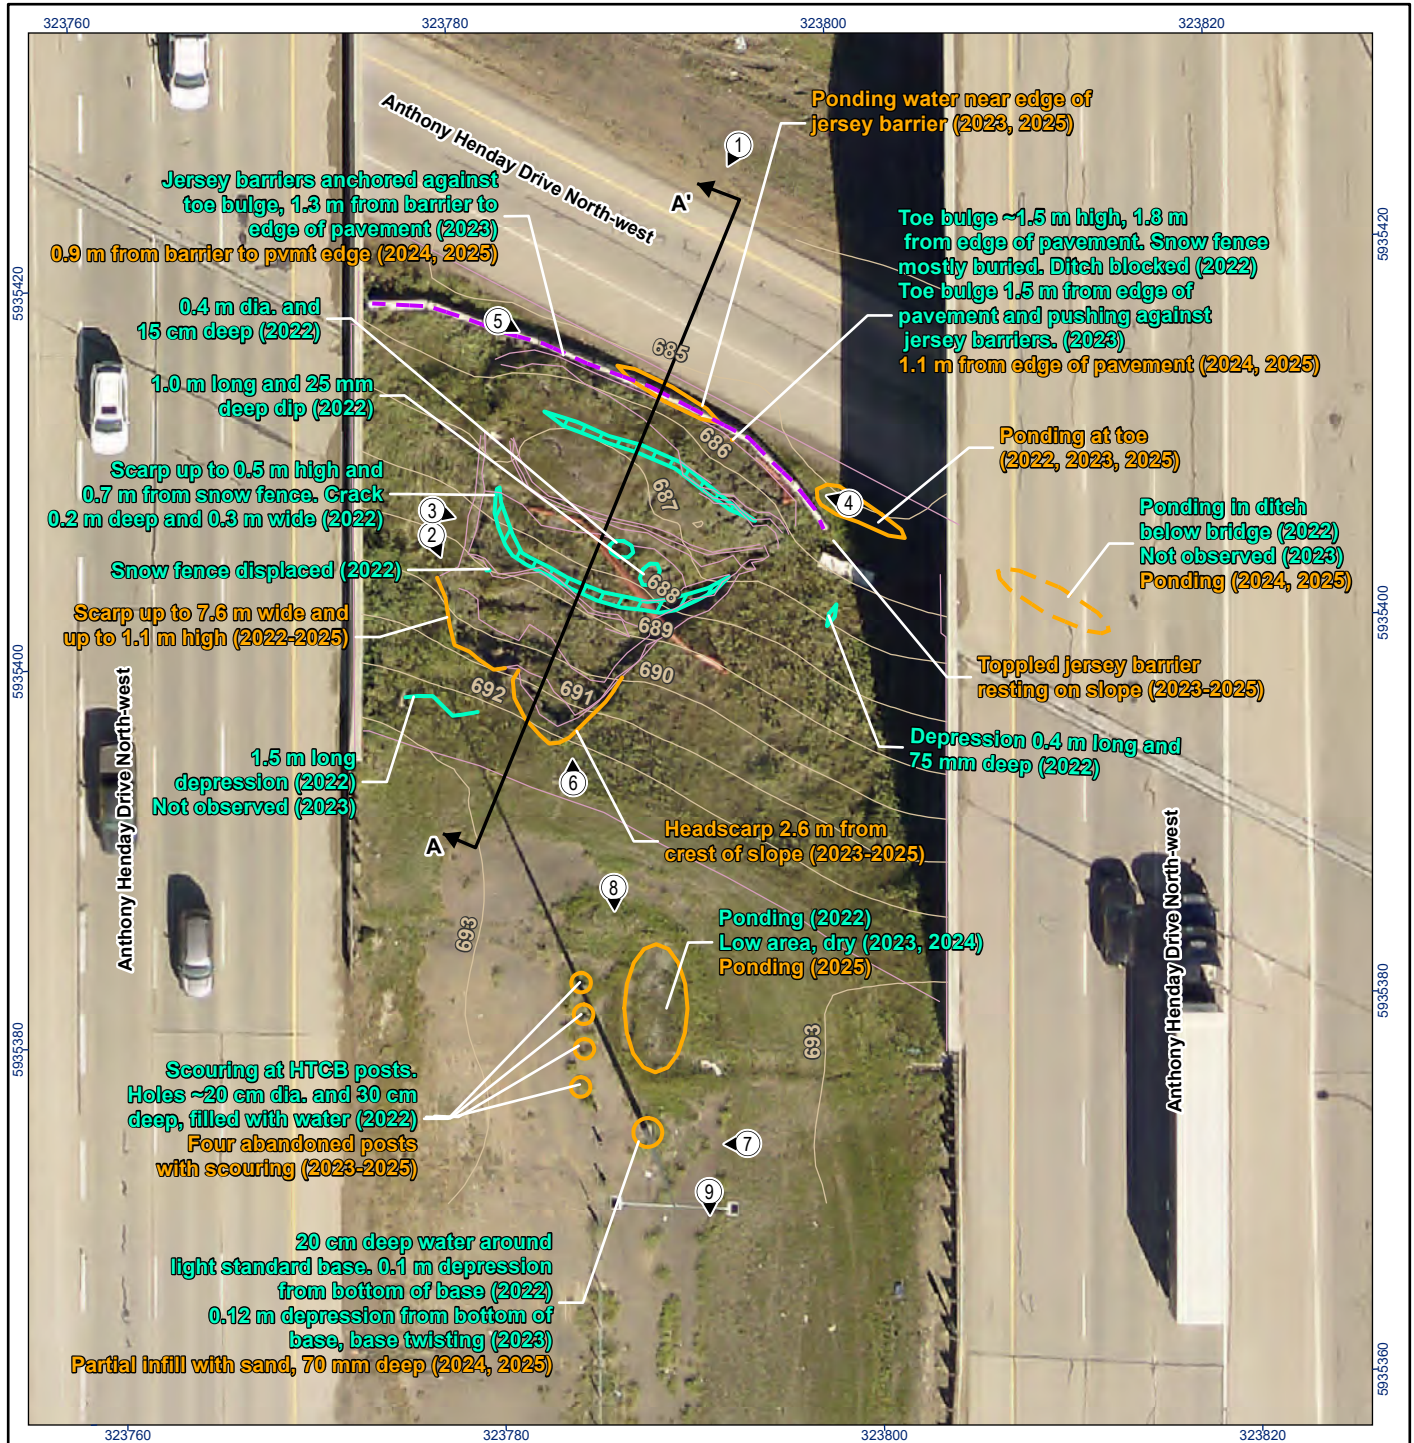
Figure No.  
 1

| <b>COMMENTS</b> <ul style="list-style-type: none"> <li>The overall embankment is about 33 m wide and 8 m high. The slump exists between the two bridge abutments south of the 100 Avenue on-ramp to AHD northbound (Photo 1).</li> <li>The landslide is slightly west of center of the embankment. The scarp was measured to be approximately 2.6 m from the crest of the embankment, similar to the previous two inspections. The scarp was observed at the upper portion of the embankment and remains up to 1.1 m high (Photos 1 to 6).</li> <li>The east and west flanks of the landslide are approximately 12.5 m and 4.6 m from the east and west bridge abutment walls, respectively. These measurements have not changed since the 2022 investigation.</li> <li>The toe bulge appears relatively unchanged, with a distance of 1.1 m to the edge of pavement. The toe bulge remains approximately 1.5 m high (Photos 4 and 5).</li> </ul> |

- Surface material within the slide has moved further downslope, exposing more material near the scarp (Photo 2).
- Ponding water was observed to the east of the embankment toe.

- Ponded water was observed north of the light standard within the low area during this site visit. Water appears to be directed to this location from the overpass bridges from both sides of the embankment (Photo 8).

- An area within the highway median, south from the light standard near the crest of the embankment, is lacking vegetation (Photo 9).
- During the call-out inspection in 2022, the exposed soils within the slump appeared wet and pieces of concrete and occasional pockets of grey fill material were observed throughout the slope. The grey fill material is believed to be from the bottom ash used during bridge abutment construction.

- The MCI and/or HMC should monitor the slump for progression towards 100 Avenue and the jersey barriers should be adjusted or maintained, as necessary.
- Stantec has completed the landslide remediation design for removal and replace. The design includes excavating the landslide mass in benches with an overall slope of 2H:1V followed by rebuilding the embankment with granular fill reinforced with geogrid.
- TEC could consider annual surveys to monitor the movement of the slide.
- Site inspection frequency should continue annually.
