SITE NUMBER AND NAME: Highway 22 Slide South of TWP 522	LOCATION: Highway 22 southbound, across from 52115 Highway 22, Entwistle, Alberta	HIGHWAY: 22:30:C1	KM: 42.513
LEGAL DESCRIPTION: SW-09-52-07-W5M, SE-08-52-07-W5M	NAD83 COORDINATES: UTM11U 5927044 N, 633771 E		
AVERAGE ANNUAL DAILY TRAFFIC (AADT): 3,340 (2023)		CONTRACTOR MAINTENANCE AREA (CMA): 509

DATE	PF	CF	TOTAL
PREVIOUS INSPECTION:	May 14, 2019	7	2	14
CURRENT INSPECTION:	June 14, 2024	11	4	44
INSPECTED BY:	Stantec: Leslie Cho and Sonja Pharand TEC: Kristen Tappenden			
REPORT ATTACHMENTS:	Figure 1 – Site Plan Figure 2 – Site Cross-Section Site Photographs

PRIMARY SITE ISSUE: Landslide resulting in differential pavement cracking in the southbound lane
APPROXIMATE DIMENSIONS: 20 m long by 33 m wide
SITE BACKGROUND AND HISTORY: <ul style="list-style-type: none"> Fenton, M.M., Waters, E.J., Pawley, S.M., Atkinson, N., Utting, D.J. and McKay, K. (2013): Surficial geology of Alberta; Alberta Energy Regulator, AER/AGS Map 601. <ul style="list-style-type: none"> Surficial geology consists of glaciolacustrine deposits comprising primarily of fine-grained, distal sediments deposited in or along the margins of glacial lakes. Prior

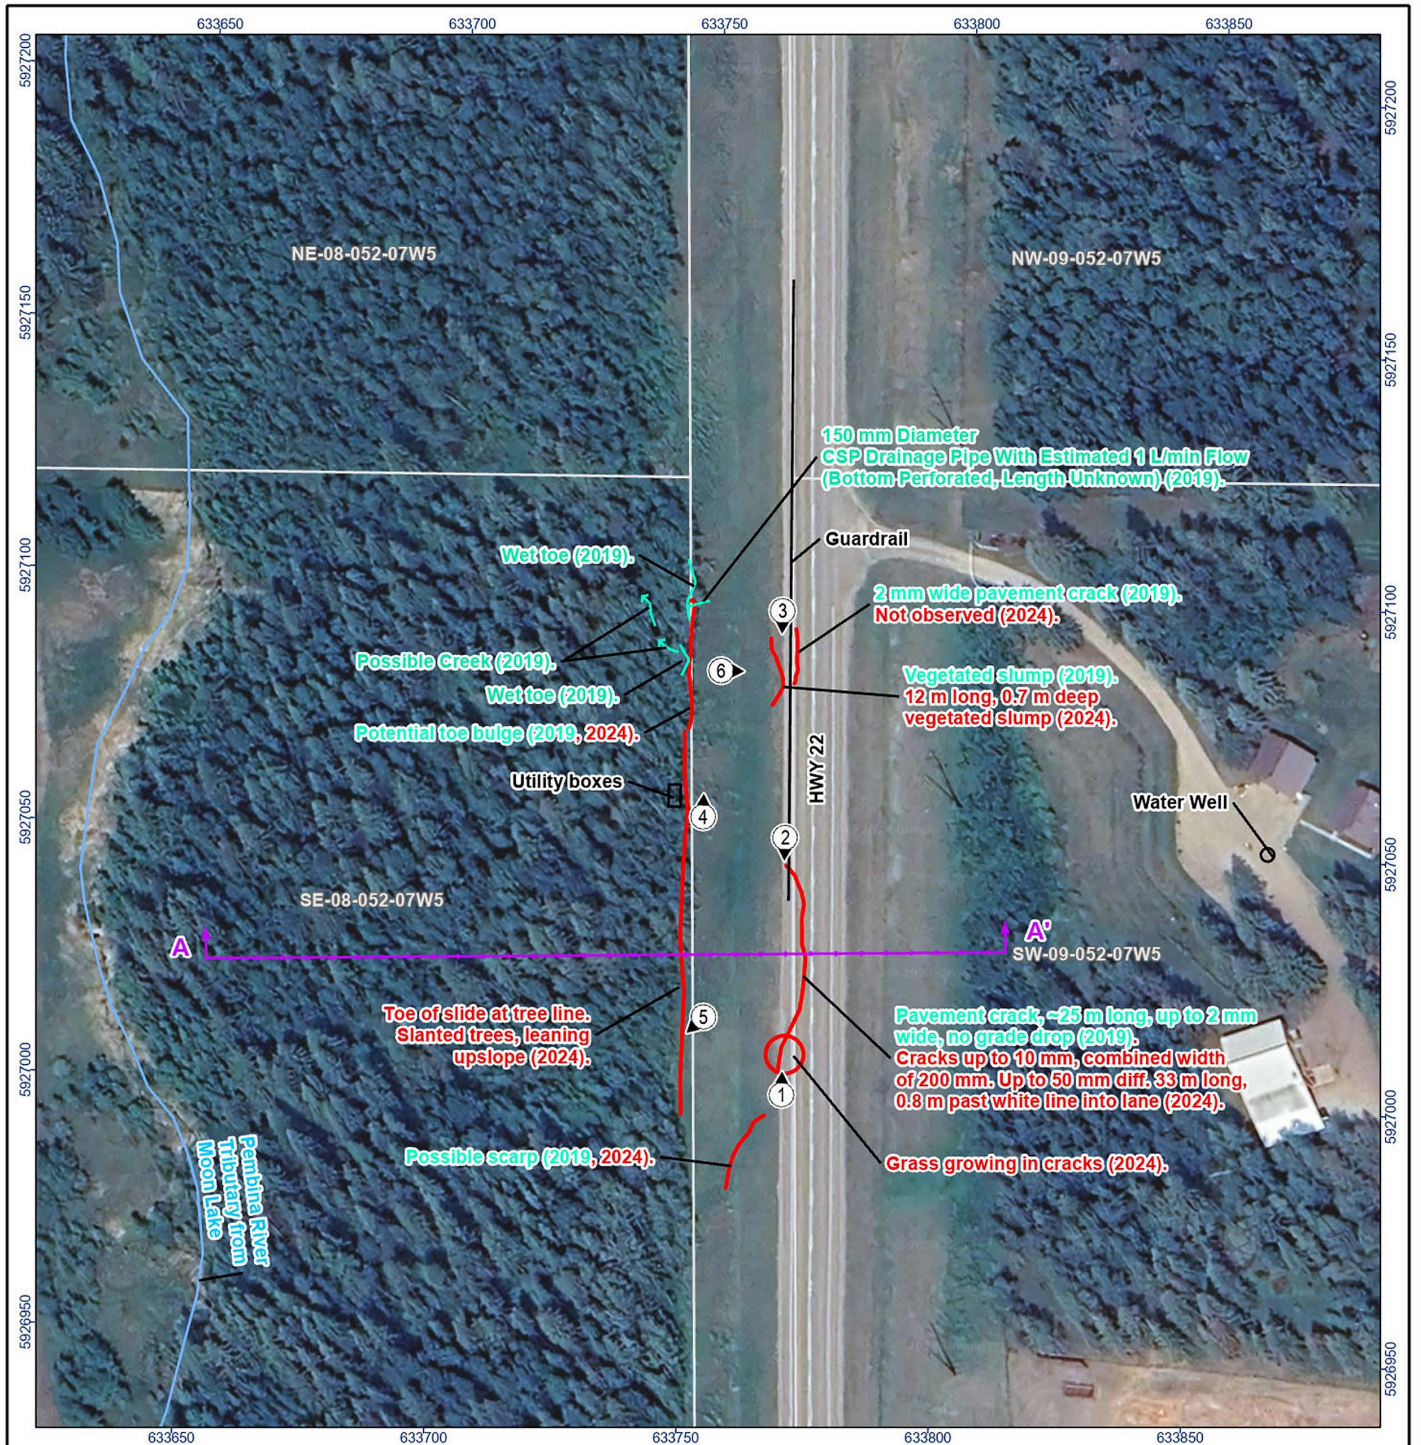
Figure No. 1
Title

- Highway 22 appears to be constructed as a sidehill cut-fill based on the surrounding topography.
- The crest of the landslide appears to be within the southbound lane of Highway 22, approximately 0.8 m east from the painted white line.

- Pavement cracking is apparent within the southbound lane of Highway 22, with cracks up to 10 mm wide, collectively creating a curved cracking path up to 200 mm wide and 33 m long. In 2019, no vertical difference was observed in the pavement cracking; however, a vertical difference up to about 50 mm was observed on either side of the cracks during the current inspection. The cracks start and stop at the edge of the pavement. Vegetation is growing out of the cracks toward the south end of the crack (Photos 1 & 2).

- The toe of the landslide appears to be just beyond the western tree/fence line. Many of the trees are leaning upslope (Photos 4 & 5).
- A vegetated slump approximately 12 m long and 0.7 m deep is located on the upper west slope, approximately 0.5 m to 1.0 m from the edge of the pavement. This slump is north from the pavement cracking (Photos 4 & 6). Little to no change was observed at the vegetated slump since 2019.

- A bulge, approximately 0.5 m high and 4 m long is present on the upper west slope to the south of the pavement cracking.
- 2014 LiDAR shows two features downslope from the pavement cracking and highway Right of Way that appear to be drainage channels. It is possible that subsurface water continues to flow through the old drainage channels leading to the softening of the foundation soils at this section of Highway 22, and resulting in the observed slope failure.

- In the short term, the pavement on the highway surface could be milled and re-paved to reduce any hazards the pavement difference and cracking may present to road users. The final paved surface should not be higher than the current roadway surface such that no net addition of load is applied to the embankment slope.

Furthermore, pavement crack sealing could be completed to prevent surface water infiltration into the embankment.

- A geotechnical investigation should be undertaken at the site prior to any long-term remediation. It is recommended that at least 2 slope inclinometers are installed, along with piezometers to monitor conditions within the slope as part of the geotechnical investigation to better characterize the landslide for remediation design.

- Long-term landslide remediation could consist of the following:
 - The slide material could be removed and replaced with well-draining granular fill accompanied by subdrains. Assuming just the south slide area is to be repaired, the high-level cost of construction is \$325,000 to \$425,000 including contract administration costs. The cost estimate is based on a 23 m wide x 45 m long excavation and includes repairing the southbound lane of Highway 22.
