To:	Amy Driessen	From:	Leslie Cho and Lawrence Onwude
	Transportation and Economic Corridors		Stantec Consulting Ltd.
File:	123315222	Date:	October 31, 2025

Reference: North Central Region, Stony Plain, Site NC052 - Highway 621:02 Pembina River Bridge Abutment, Fall 2025 Instrumentation Monitoring Report

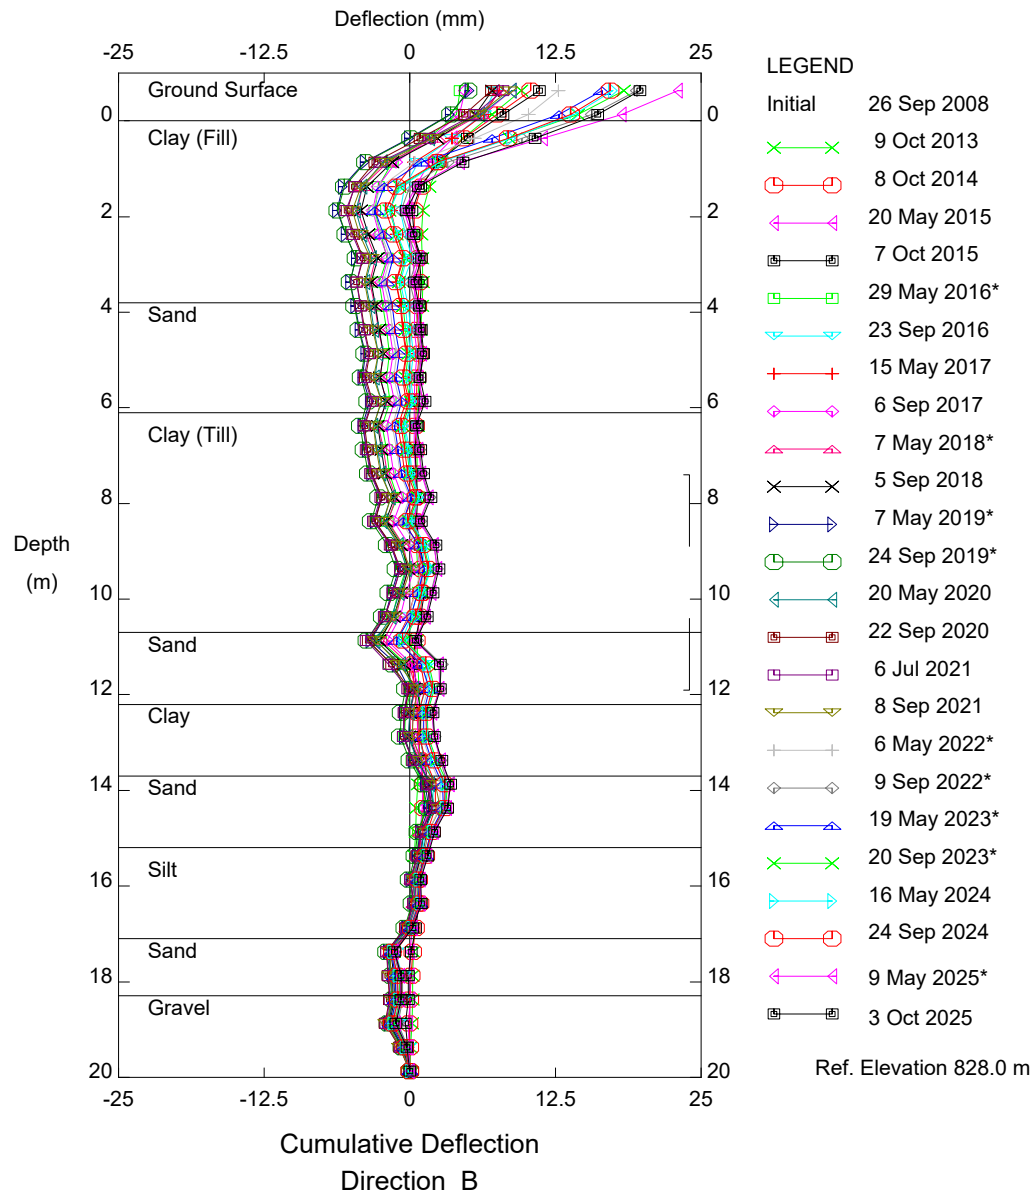
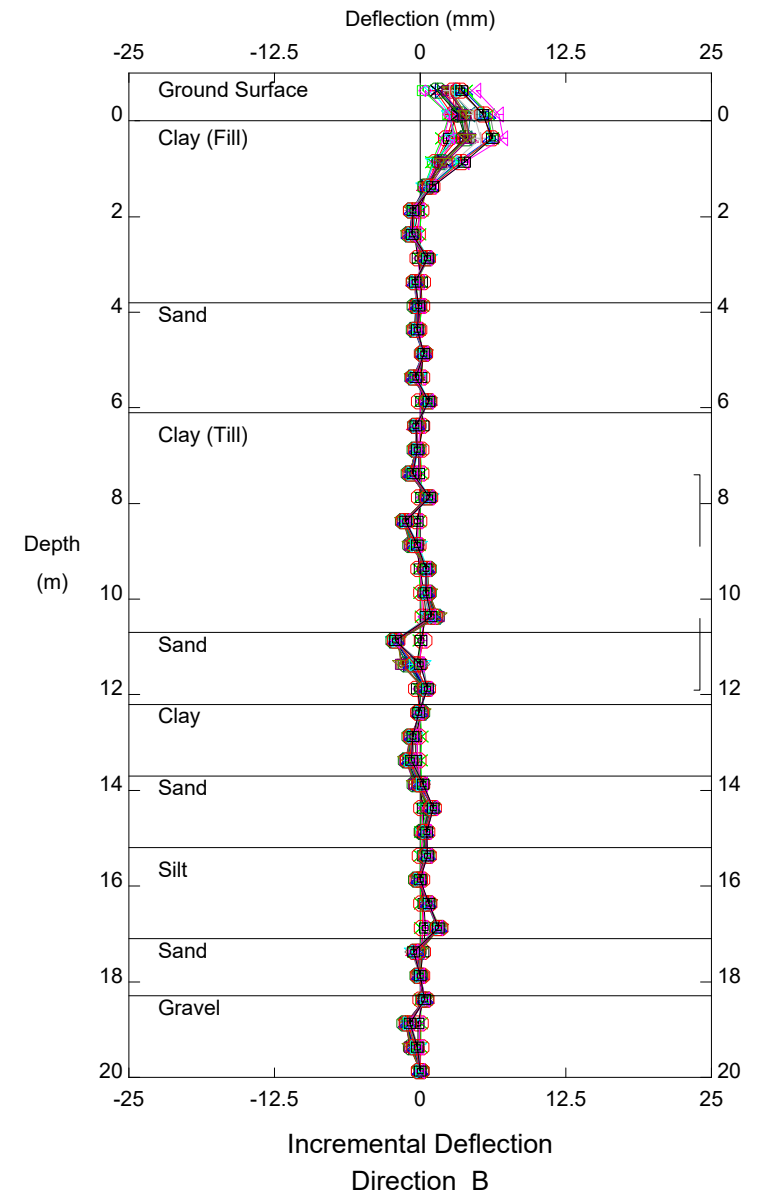
NC052, Inclinator SI-1

SI-1 shows negligible movement over the zone of movement at about 11 m depth. Total cumulative movement observed since 2006 is about 3 mm.

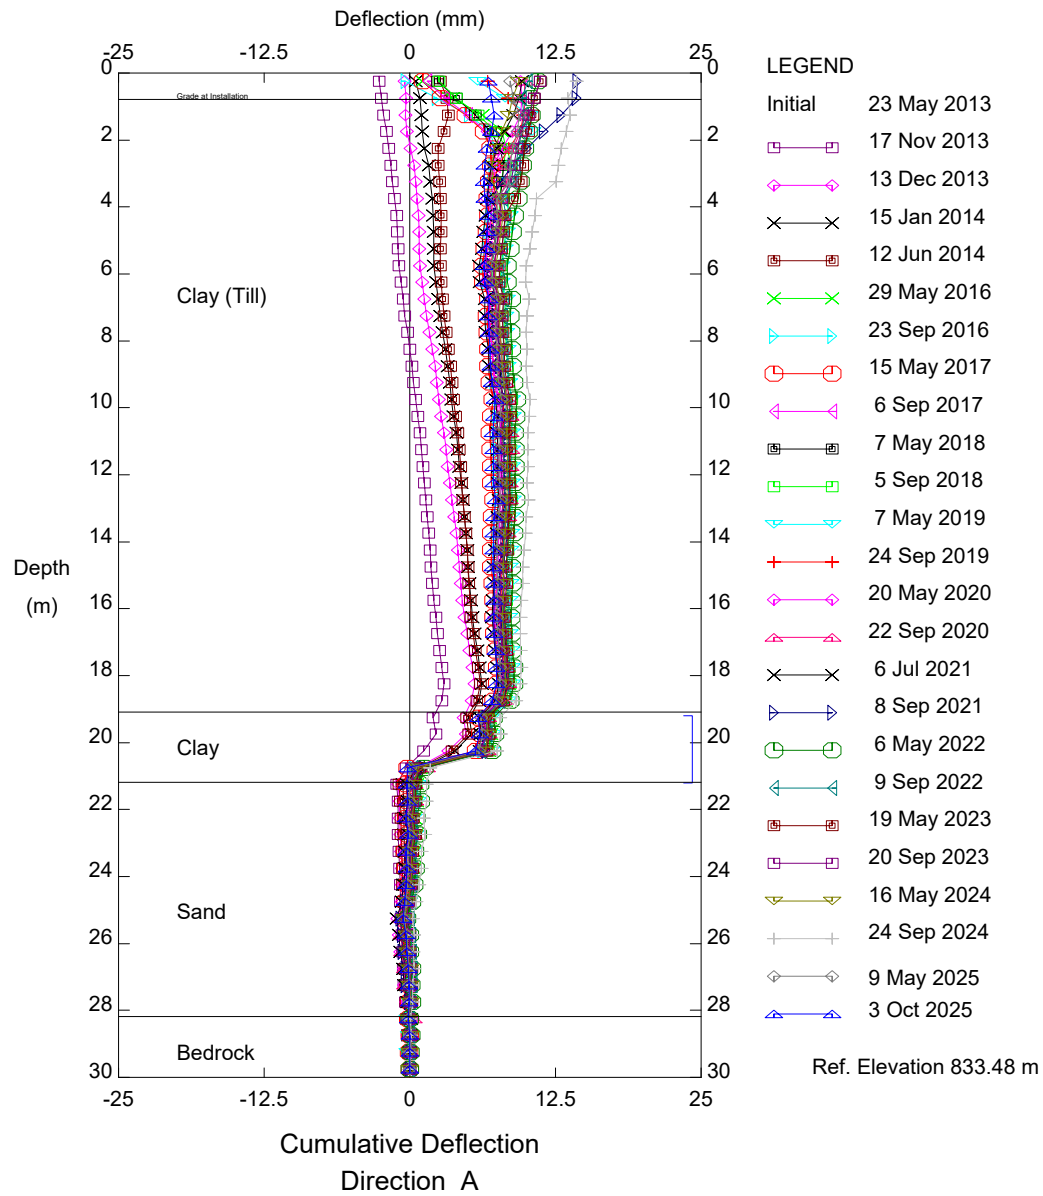
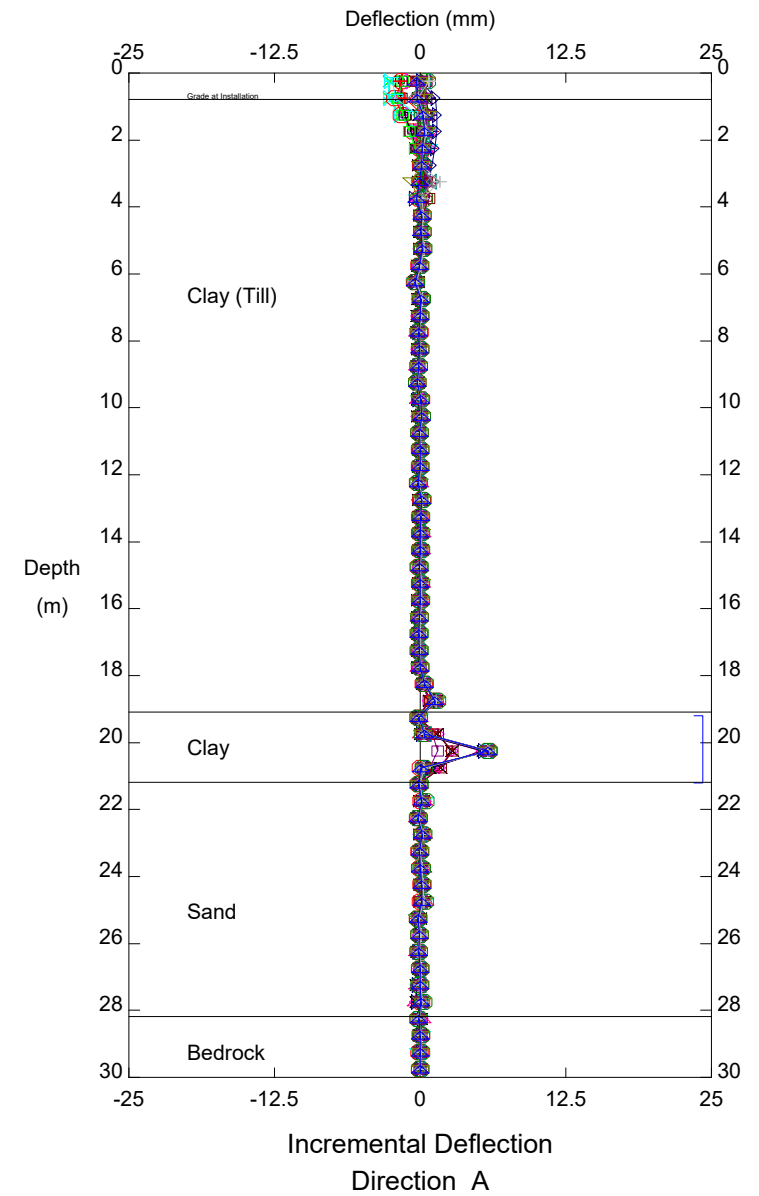
NC052, Inclinator SI13-3
Transportation & Economic Corridors

SI13-3 has recorded about 6 mm of cumulative movement since 2014. The recorded movement is likely related to construction activities in winter 2014. Little to no movement was observed since 2016.

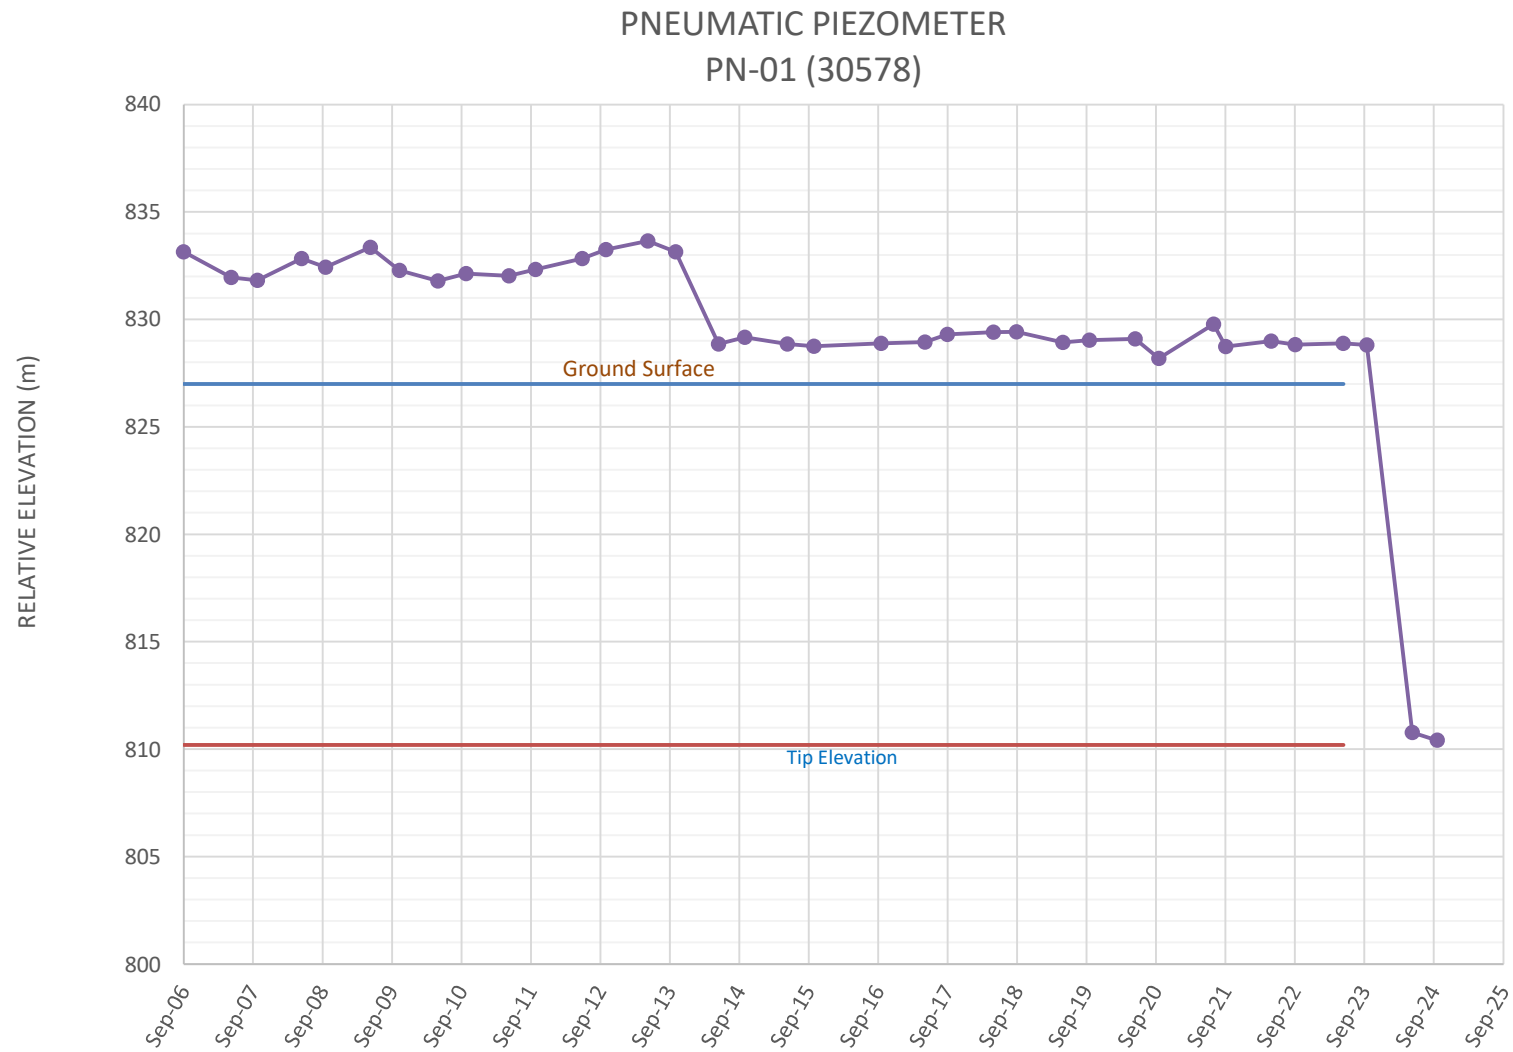
In Spring 2024, **PN-01** showed a significant decrease in piezometric elevation of about 18 m (El. 810.4 m) which is close to the piezometer tip at elevation 810.2 m. The data is likely erroneous due to a leak within the pneumatic piezometer tubing. In Fall 2024, PN-01 was confirmed to be non-operational.

PN-02 had artesian conditions until 2014 when the pore pressure decreased because of remedial work to relieve pore pressures in the east slope. Current reading indicates a significant drop in piezometric elevation of about 20 m (El. 809.3 m) which is close to the piezometer tip at elevation 808.8 m. This result is likely erroneous due to a leak from the pneumatic piezometer tube related to the damage to the SI since they share the same installation location.

PN-01 appears to have sustained damage since the Spring 2024 cycle as it was leaking and made a hissing sound. An attempt to repair PN-01 could be made since the ability to hear the hissing sound suggests the leak is within the exposed portion of cabling. If the leak location is identified, PN-01 could potentially be repaired by splicing below the leak.

PN-02 was inferred to be leaking during the 2025 Fall reading cycle. If the leak location is identified, PN-01 could potentially be repaired by splicing below the leak.
