ALBERTA TRANSPORTATION AND
ECONOMIC CORRIDORS GRMP
PEACE REGION
(GRANDE PRAIRIE DISTRICT - NORTH)
INSTRUMENTATION MONITORING - SPRING 2025

Site Number	Location	Name	Hwy	km
PH037	Station 1+250 to 2+000	Dunvegan South	2:68	Km 15.7
Legal Description: 4-7-80-4 W6		UTM Co-ordinates		
		11U E 398593.62	N	6197597.09

Current Monitoring:	18~19-June-2025	Previous Monitoring	26-Sep-2024
Instruments Read By:	Mr. Niraj Regmi, G.I.T and Mr. Godfred Etiendem, of Thurber

SITE PH037: HWY 2:68, DUNVEGAN SOUTH

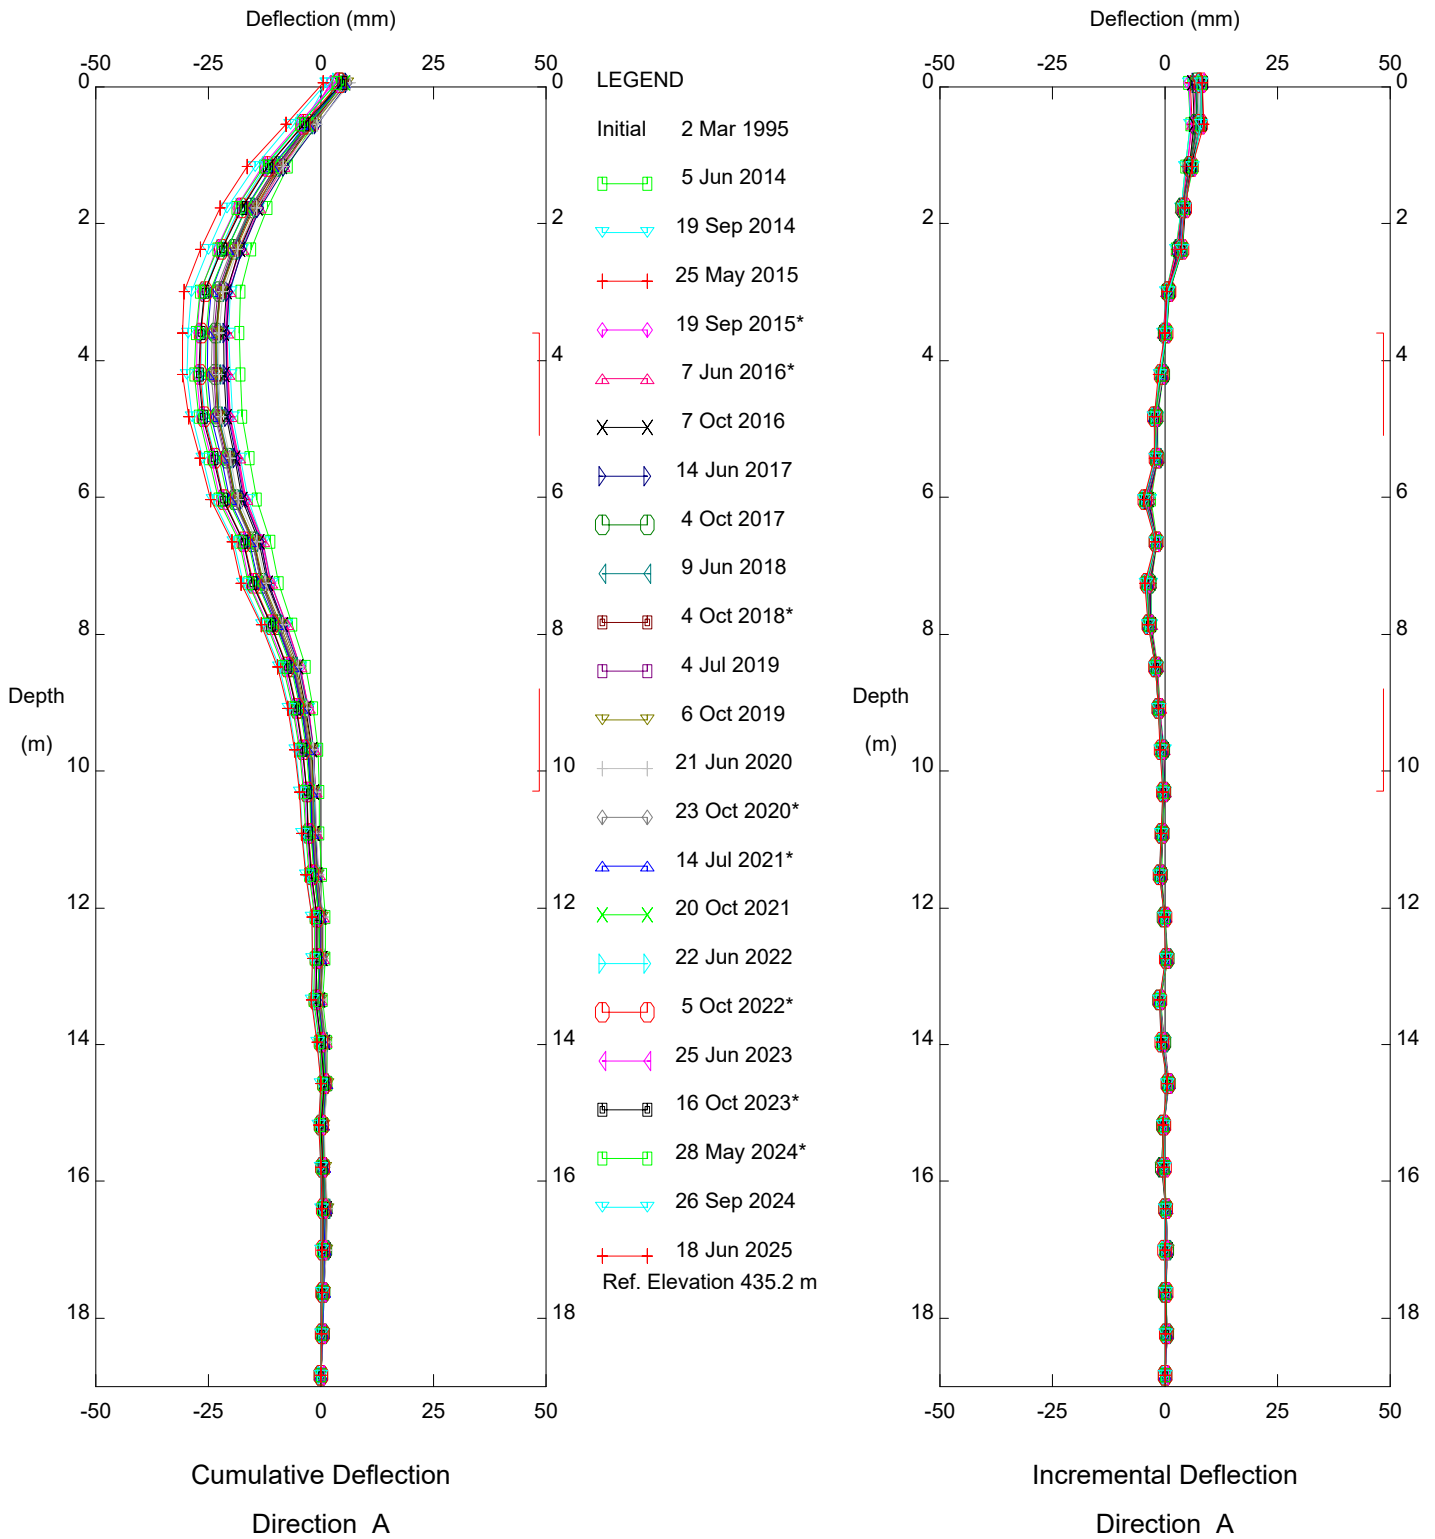
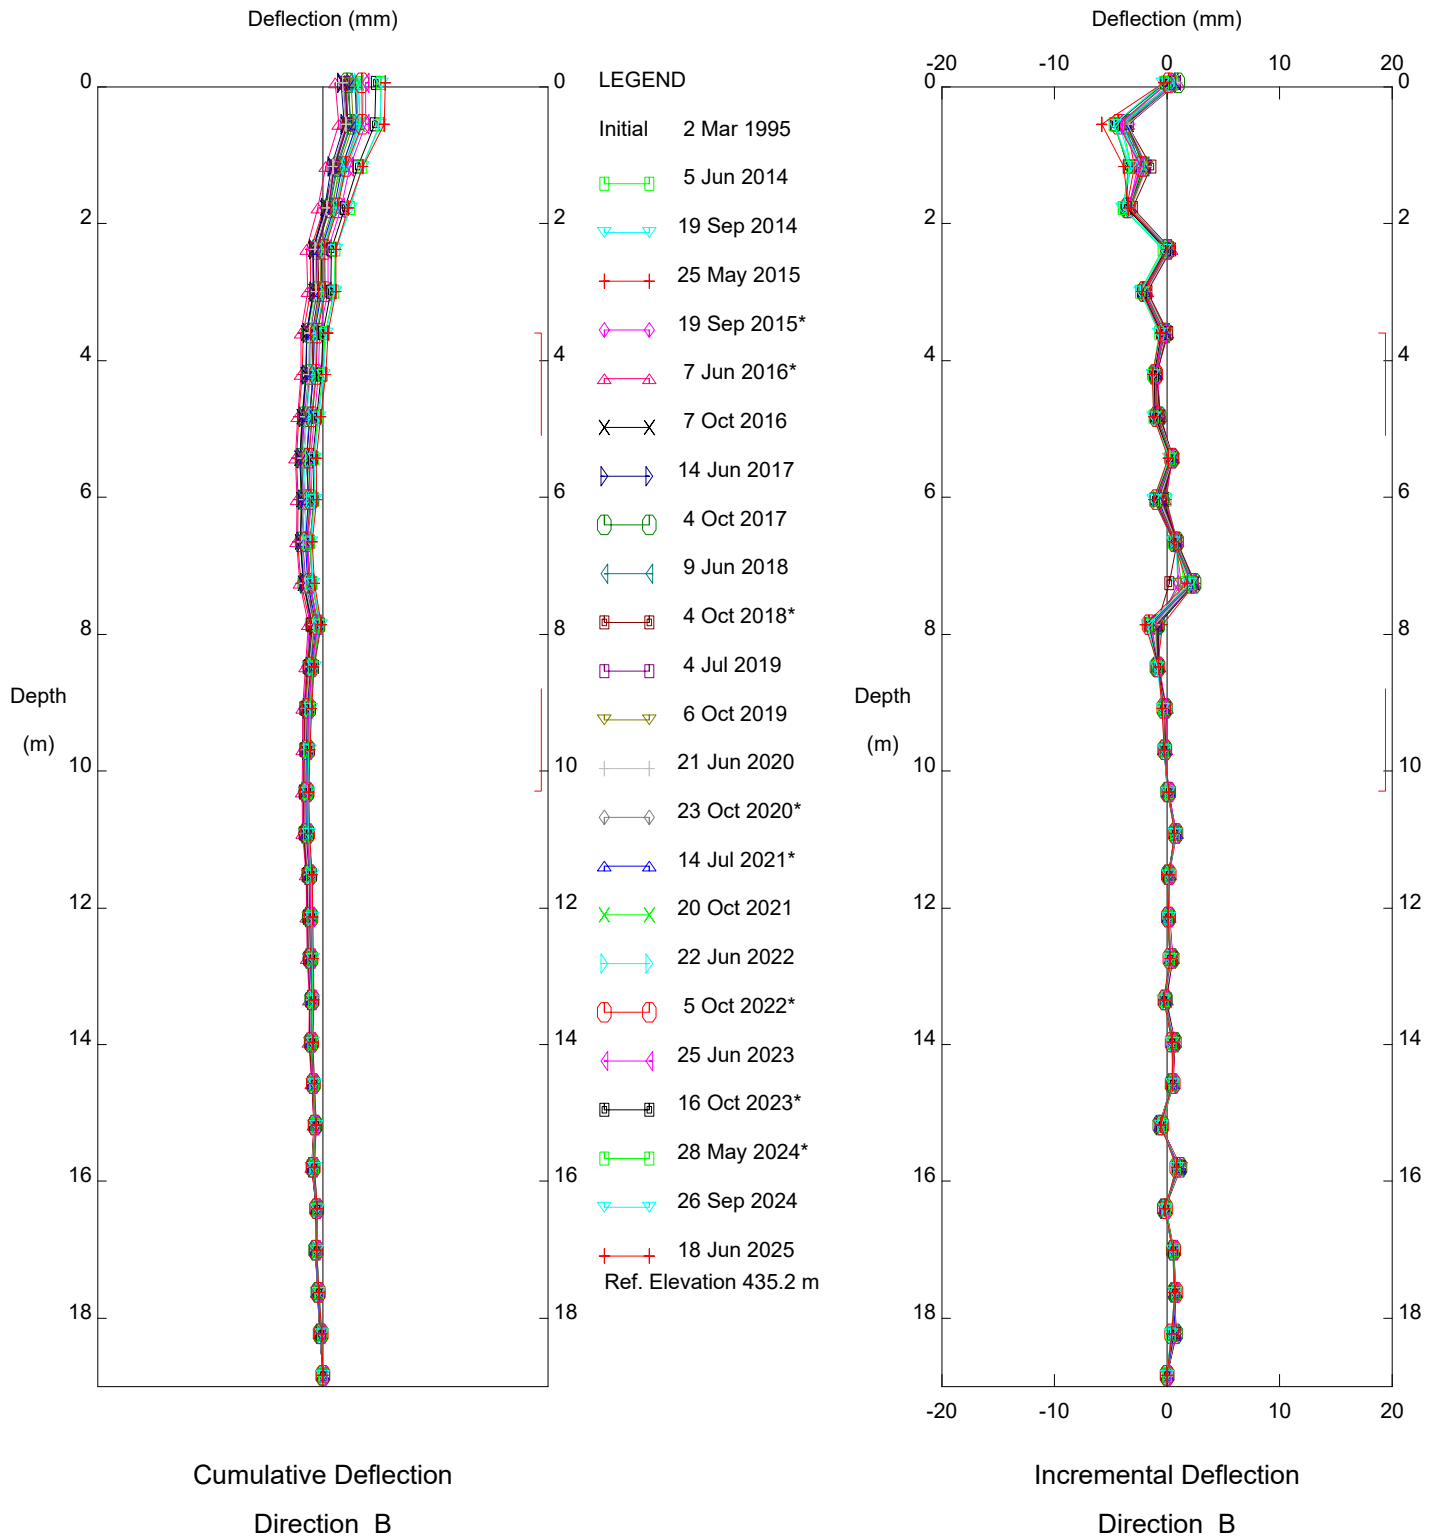
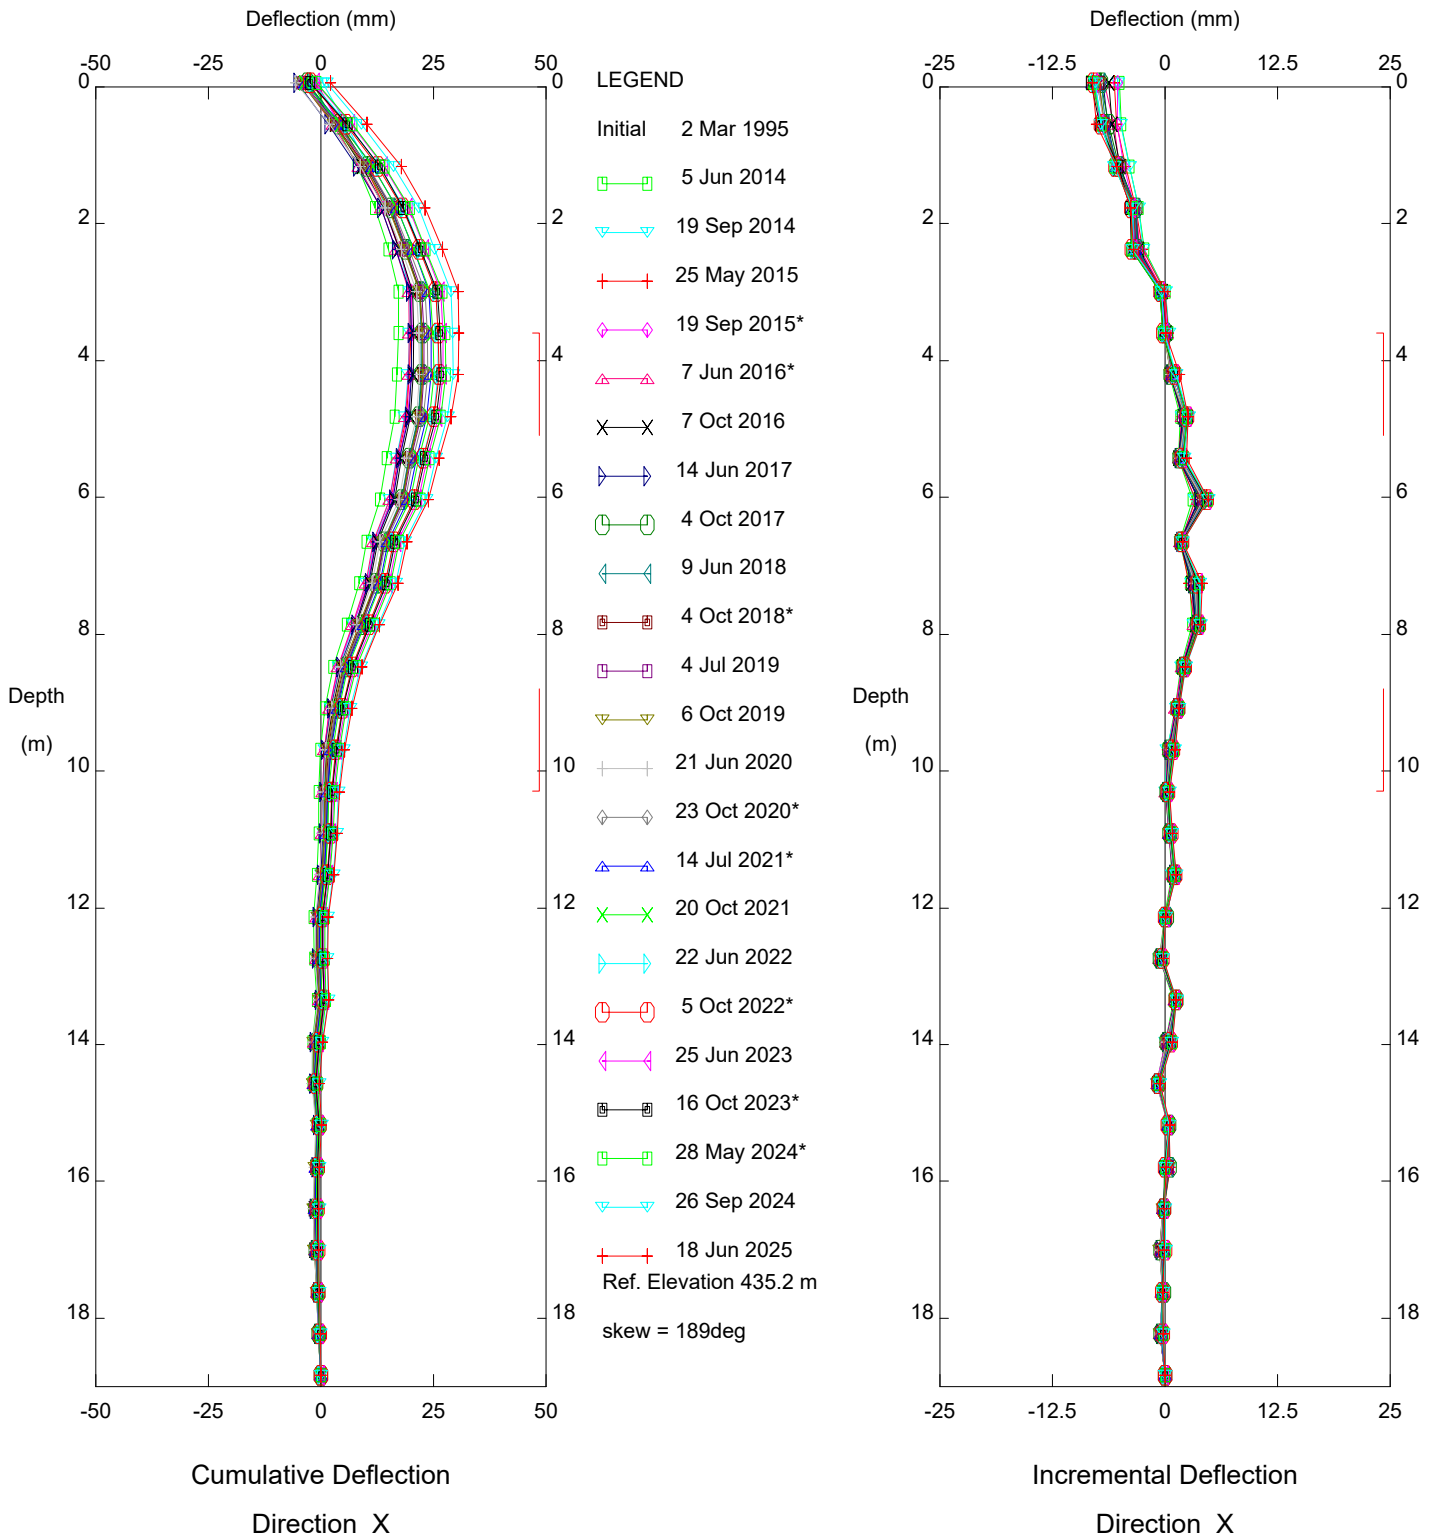
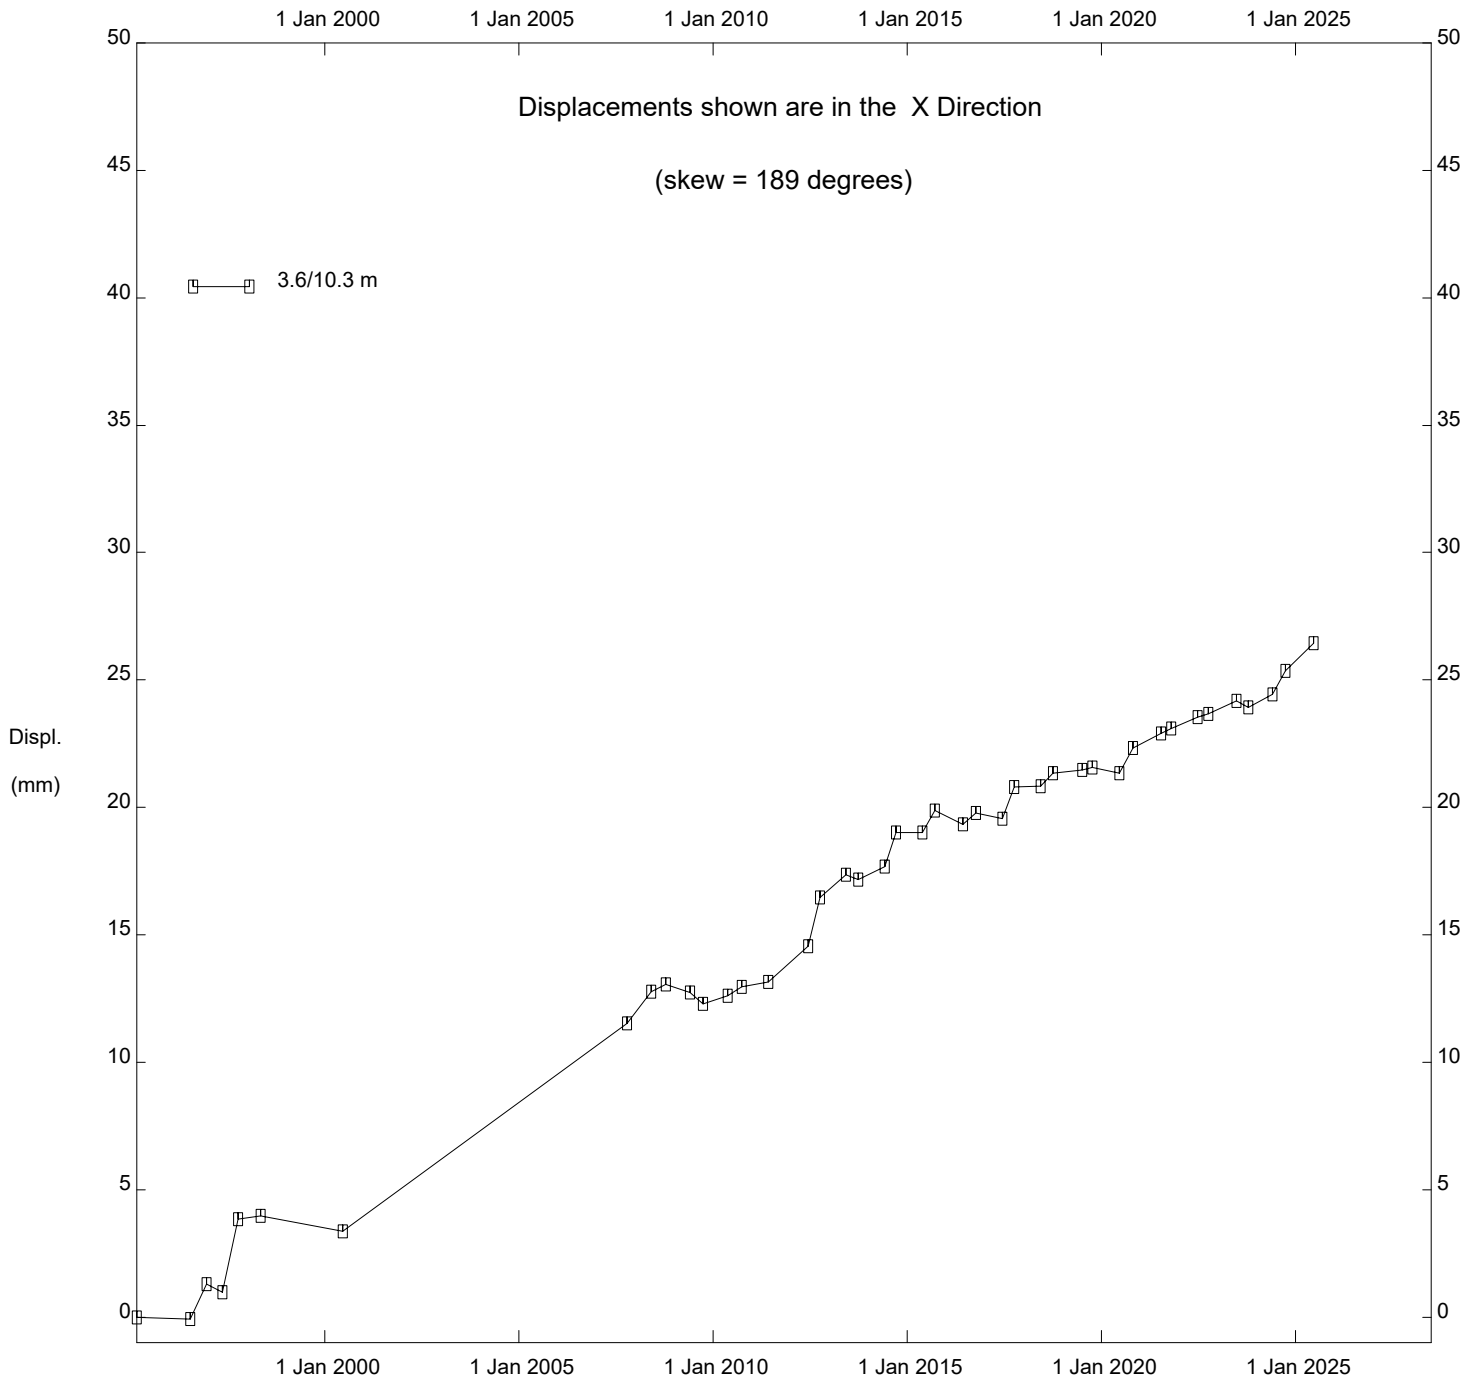
HWY 2:68 (PH037), Inclinometer SI-61

*SI-61 Hard to pull from 26-24 ft, use dummy probe
*** Slope Direction is 270 degree
SI -59 Damaged during construction broken about 2.0ft from top of casing, can be repaired without mechanical assistance, this time SI read from 74.0 ft
SI-55 DAMAGED can be repaired without mechanical excavation, its broken at 1 foot below ground surface see photo
SI-56 Wiped out during construction, no trace of SI in ditch see photo
