November 22, 2022

### ALBERTA TRANSPORTATION GRMP (CON0022165) PEACE REGION (GRANDE PRAIRIE DISTRICT – NORTH) INSTRUMENTATION MONITORING RESULTS – FALL 2022

### SITE GP004A: HWY 49:06, BURNT RIVER BRIDGE

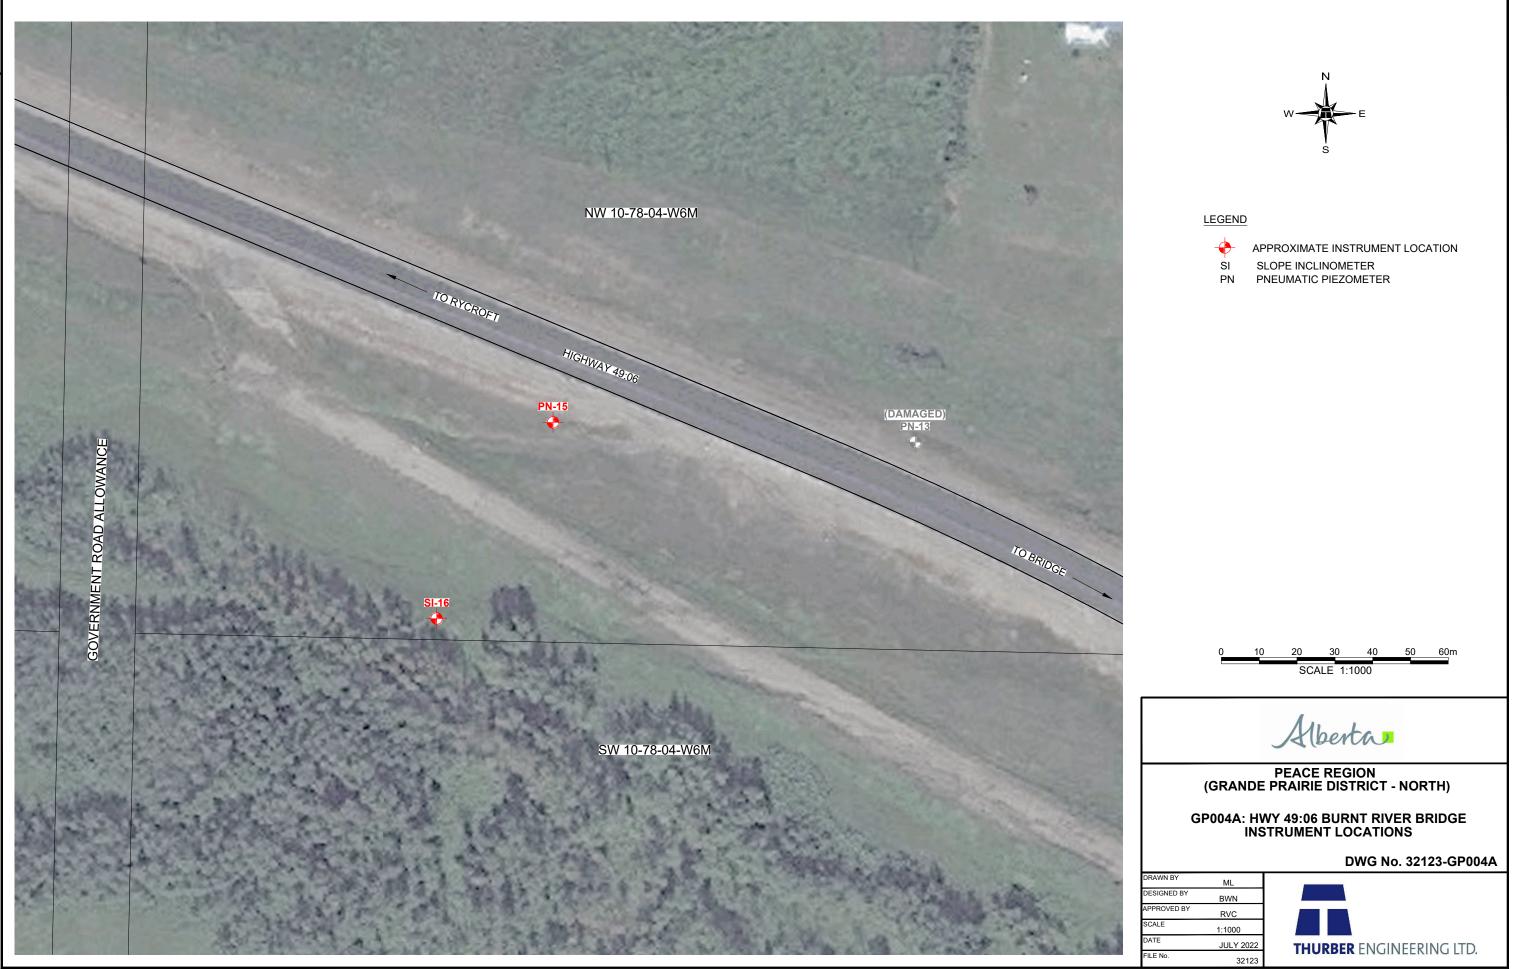
* SI-16 is hard to pull from	94-92' and 74-70' depth.	Use dummy probe readings
Both PN laying on grass, new	eds stickup protector
