**ALBERTA TRANSPORTATION AND  
ECONOMIC CORRIDORS  
GEOHAZARD ASSESSMENT PROGRAM  
PEACE REGION (GRANDE PRAIRIE DISTRICT - NORTH)  
2025 INSPECTION**

Site Number	Location	Name (Old Site 5)	Hwy	km
PH023	12 km W. Cleardale	Clear River East Hill-Twin Pipes	64:02	23.4-24.1
Legal Description		UTM Co-ordinates (NAD 83)		
NE28/NW27-84-11-W6		11 N 6244273	E 335460

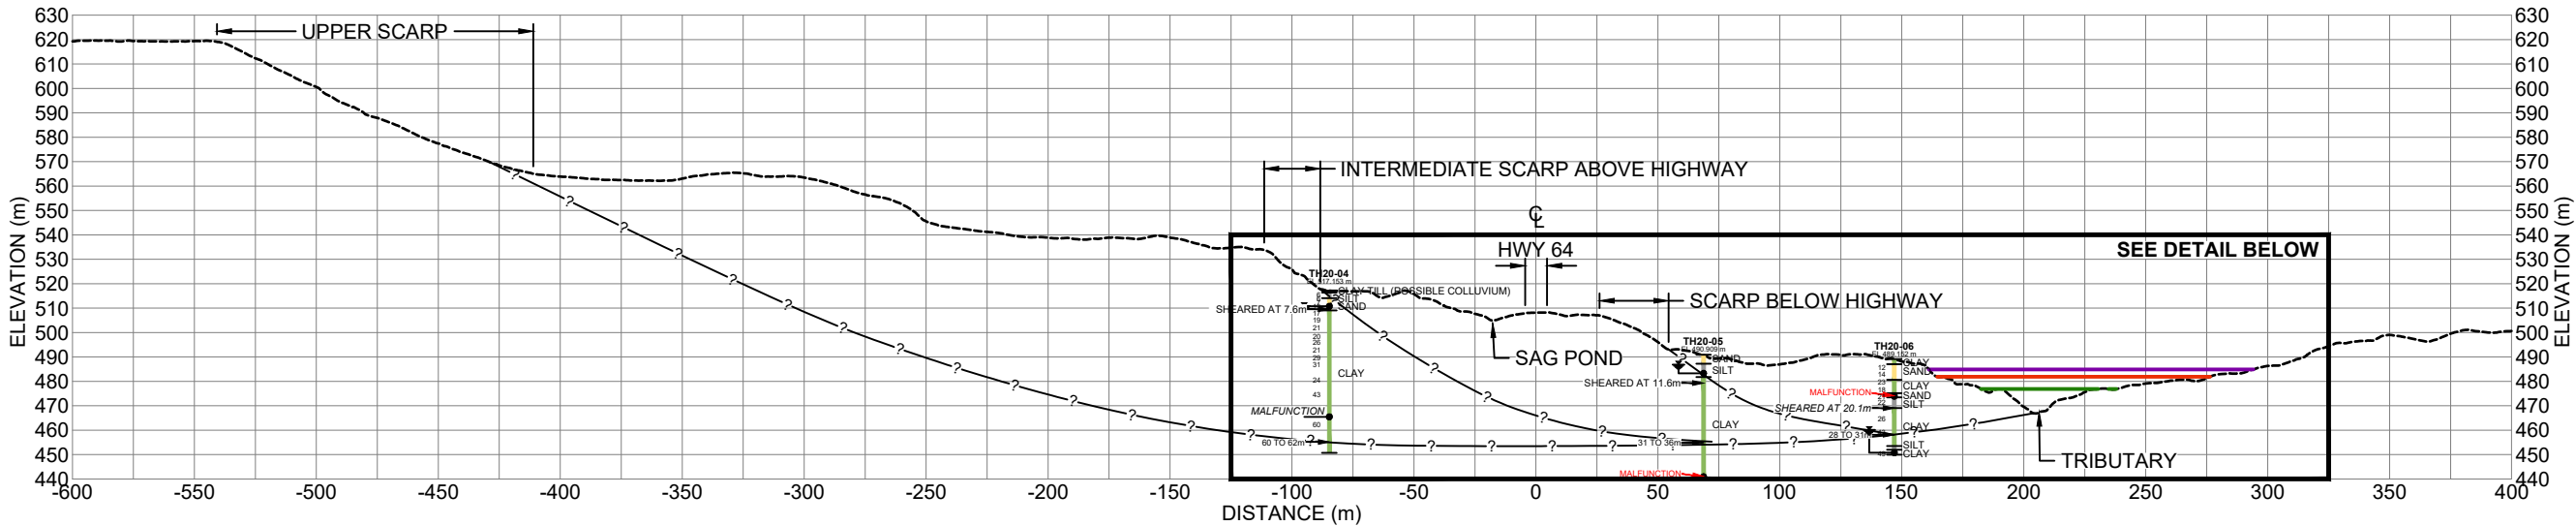
**CROSS-SECTION B-B'**  
SCALE 1:3000

**Instrumentation:** Last read June 15, 2025 - The inclinometer movement zones, and piezometer tip depth measurements are shown on the cross-sections attached (Drawings PH023-4 to -6).
